MARINE ACCIDENT
INVESTIGATION BRANCH

SAFETY DIGEST

**Lessons from Marine
Accident Reports
3/2004**

No 3/2004

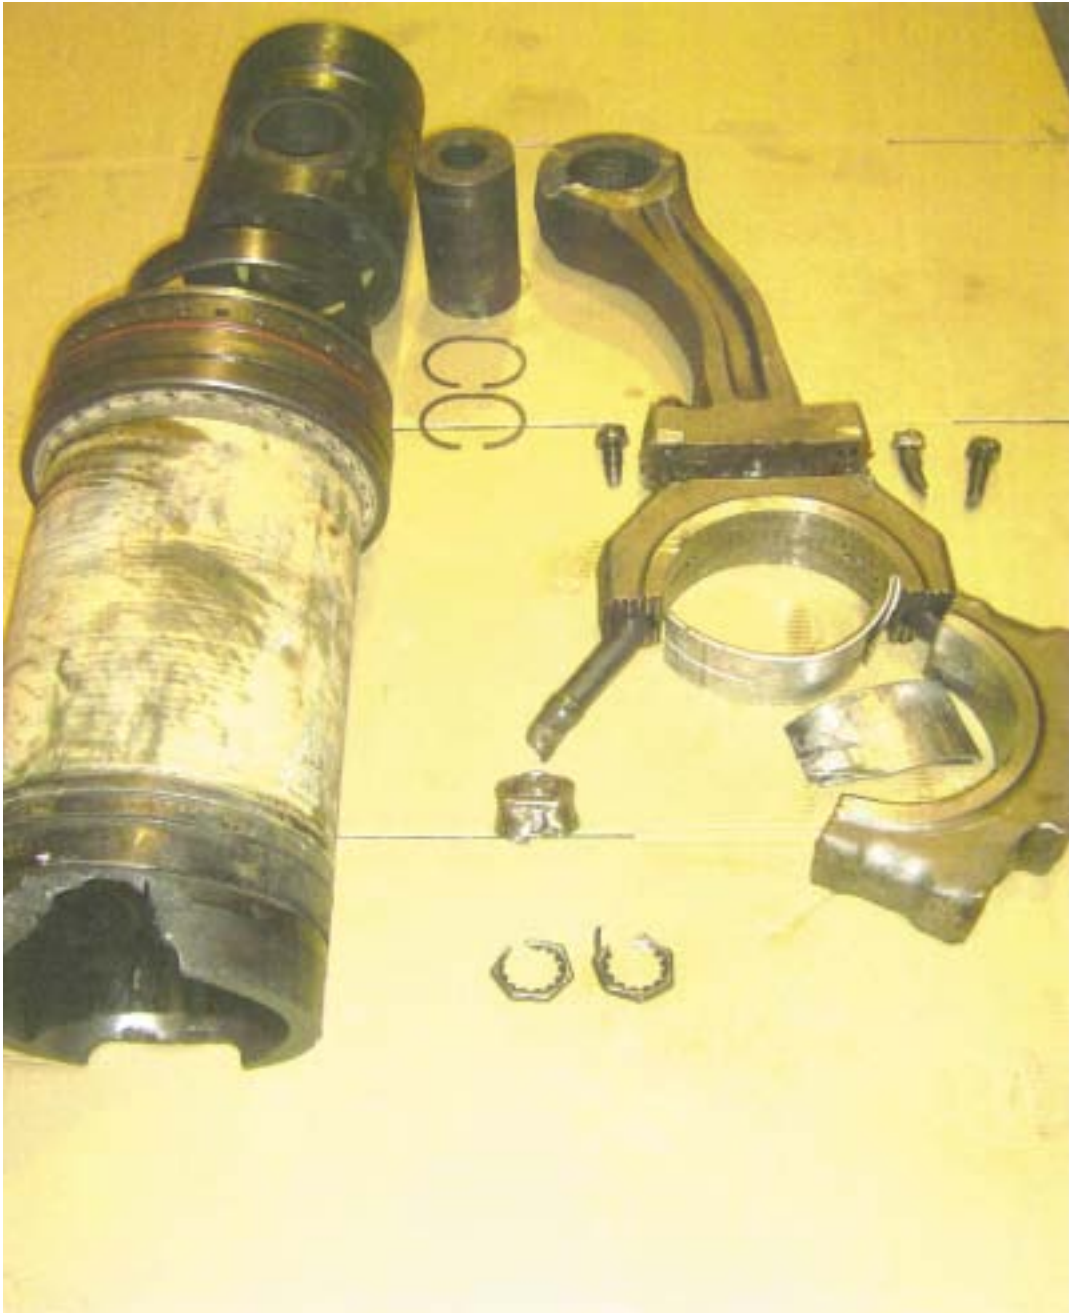
When the machinery space was entered, the engine’s No 6 cylinder large end bearing assembly was found to have passed through the port crankcase door, and to have come to rest immediately outside the engine. The piston and severely distorted connecting rod were hanging from the cylinder liner. A small amount of soot and fire damage was also evident on the port side of the engine.

Once the cylinder liner, piston, and connecting rod were removed, the full extent of the damage could be assessed. This is clearly shown in the figure.

During the investigation, it was found that the lower half of the large end bearing shell had been fitted to the upper section, and vice versa. Despite the presence of bearing location tangs, it was still possible to fit these incorrectly and tighten the bearing cap. This blanked the oil supply to the small end bearing and cooling oil to the underside of the piston, resulting in overheating and seizure of the piston in the cylinder liner. The continued crankshaft rotation caused the large end fastenings to fail, and the assembly to pass through the crankcase door.

Damage to No 6 Cylinder Components

1. The importance of a thorough understanding of the instinctive actions to be taken in the case of a main machinery space fire cannot be overstressed. Clearly, in this case, prompt action prevented the strong possibility of a major fire developing – with its potential catastrophic consequences.
2. Those undertaking maintenance activities should have a thorough understanding of the function of components, and how they operate, and should follow the manufacturers’ or company-specific instructions. Where there is a possibility of components being fitted incorrectly, or where there is ambiguity, this should be brought to the attention of management and, where appropriate, additional maintenance instructions should be promulgated.

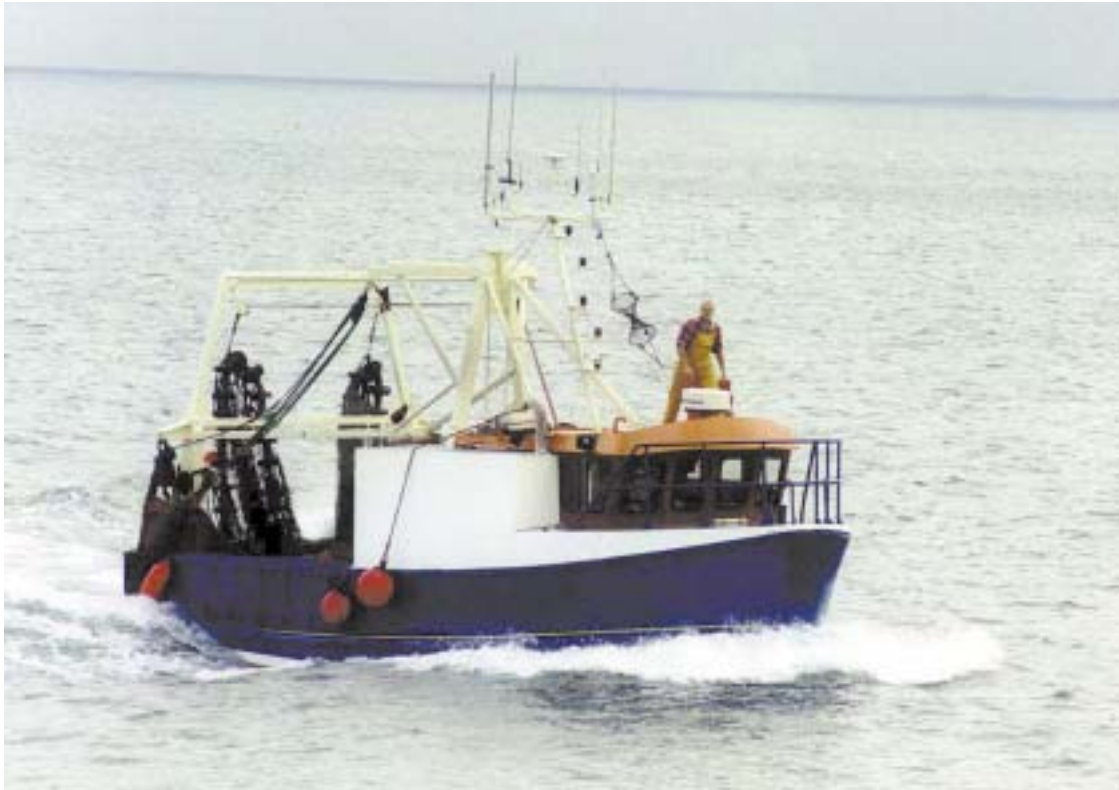
Photograph of fishing vessel and coaster showing relative sizes

1. This incident is another one of the many near misses the MAIB receives between coastal vessels and vessels engaged in fishing. When navigating in coastal waters, always be aware that the majority of fishing vessels, while engaged in fishing, are hampered by their gear and will be slow to react when altering course, whether it be through evasive action or not. The best solution is to give these vessels a wide berth at all times. Resist the temptation to get close.

2. It is impossible to both maintain a proper lookout and work at the chart table for any length of time. In accordance with Rule 5 of the Collision Regulations, a proper lookout should have been maintained at all times by all available means. An additional person should always be employed on the bridge as a dedicated lookout when the officer of the watch has other duties to attend to. Doing so, would have averted this near miss.

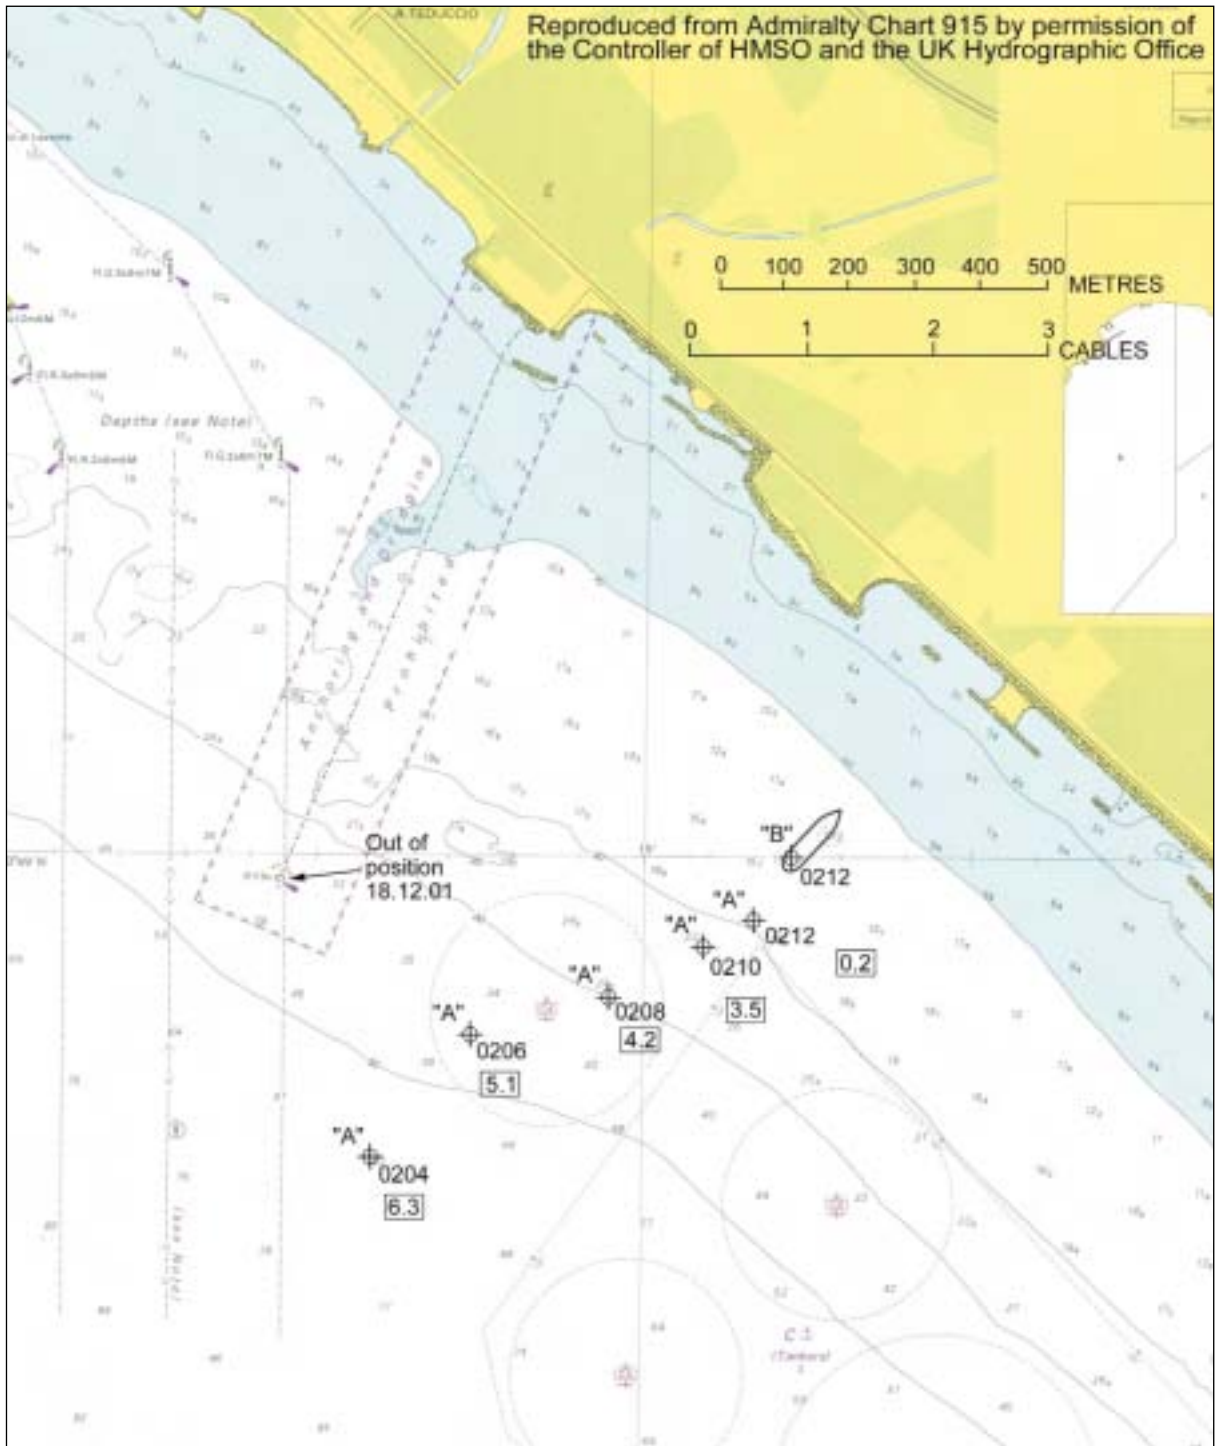
to ring slow astern, he noted that the let go position on the radar appeared to be too close to the land. He asked the second officer to check the radar mark. This distraction delayed the astern movement until 0204. The master still expected to be able to stop the vessel in time, but had failed to recognise that the astern movement was applied 3 cables further on than intended.

From data logger reconstruction of track. 'A' are uncorrected for GPS/chart datums, 'B' is corrected and shows bow in relation to GPS receiver

6. The use of large-scale charts can give a false impression. When using smaller scale charts, the size of the vessel is generally not plottable at the scale of the chart. When navigating on a large scale plan, the vessel's size can now be plotted. On the larger scale charts the position plotted is effectively the bridge of the vessel or wherever the GPS aerial is sited. A position that appears to be inside the navigable water may hide the fact that the other end of the vessel is outside, and what at first appears to be a safe condition, in fact is a dangerous one.

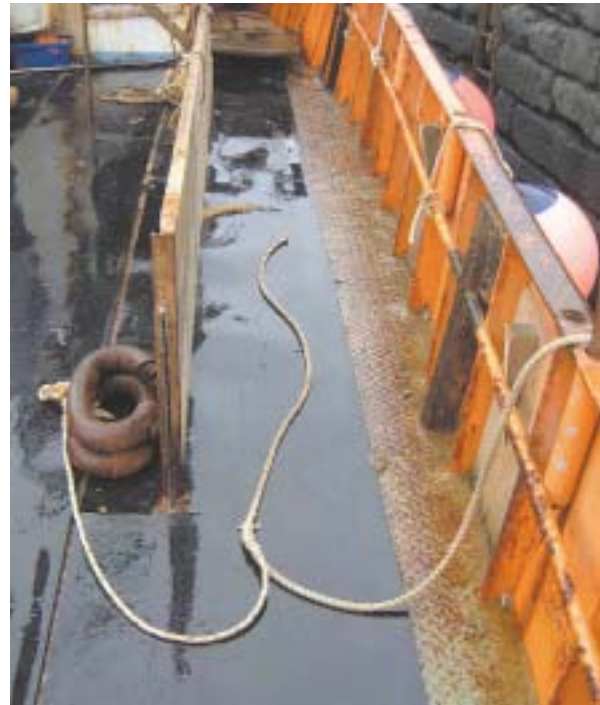
After the last of a fleet of creels had been shot over the side, a deckhand shot a 56Kg drag anchor from the bulwark just forward of the shooting post. The deckhand's right ankle was instantly trapped in a bight of either the back line, or the line securing the anchor to the back line. He was dragged hard up against the top of the steel bulwark. The skipper immediately put the engine astern, and a second deckhand rushed to the wheelhouse to fetch a knife.

Working deck area showing configuration of back line

2. When working in a dangerous environment, keep an eye on the people you are working with. Two pairs of eyes are better than one.
3. Having a sharp knife within arms reach when working on deck is a simple precaution, and one which has saved many lives in the past, and hopefully will do so in the future.

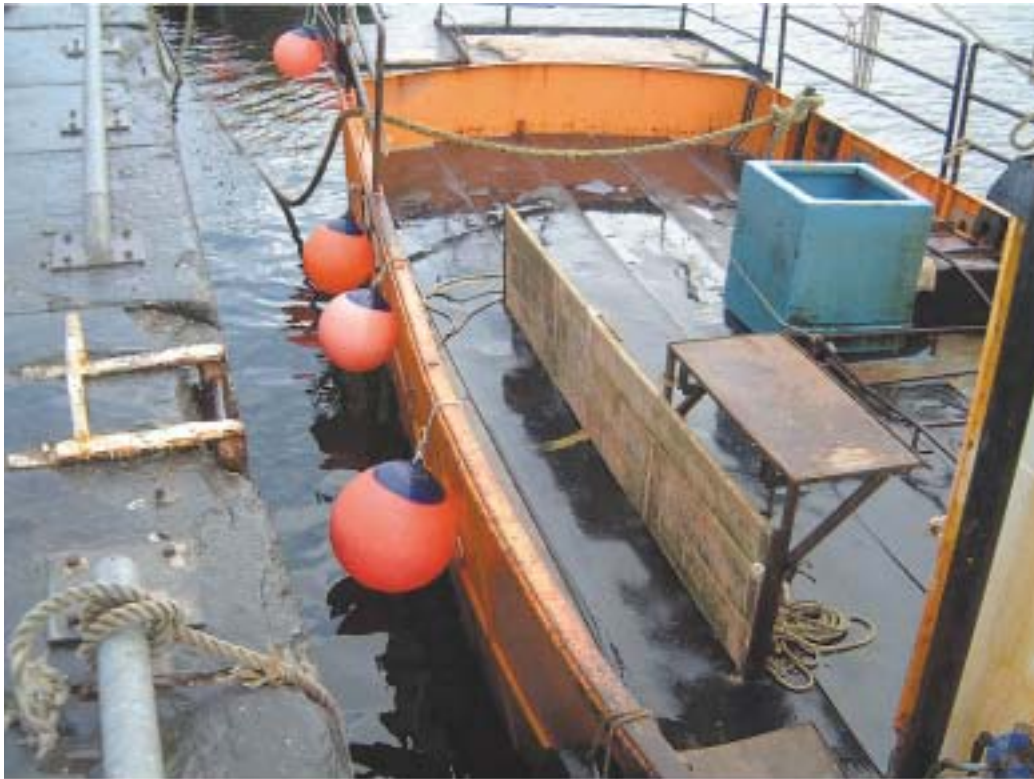
Working deck area showing pound board arrangement

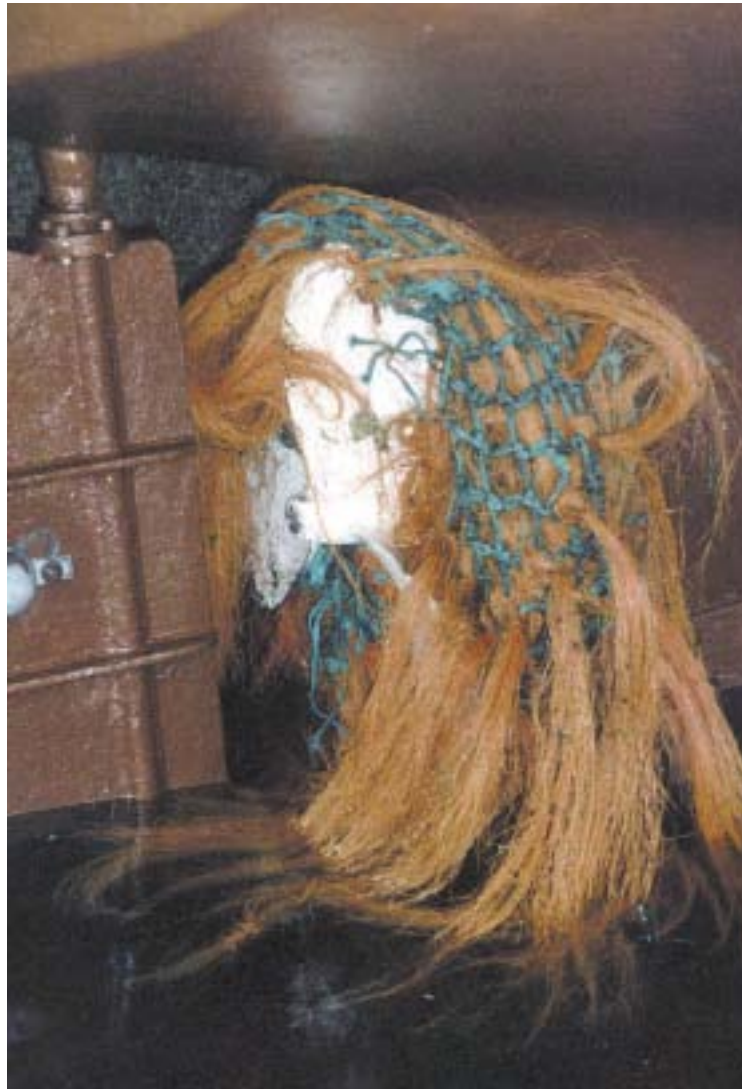
While trawling, a vessel's main engine suddenly stopped when her propeller was fouled by

discarded fishing gear from a beam trawler. The vessel had to be towed back into port; fortunately there was no damage to the main engine or gearbox.

Photograph of propeller fouled by discarded fishing gear

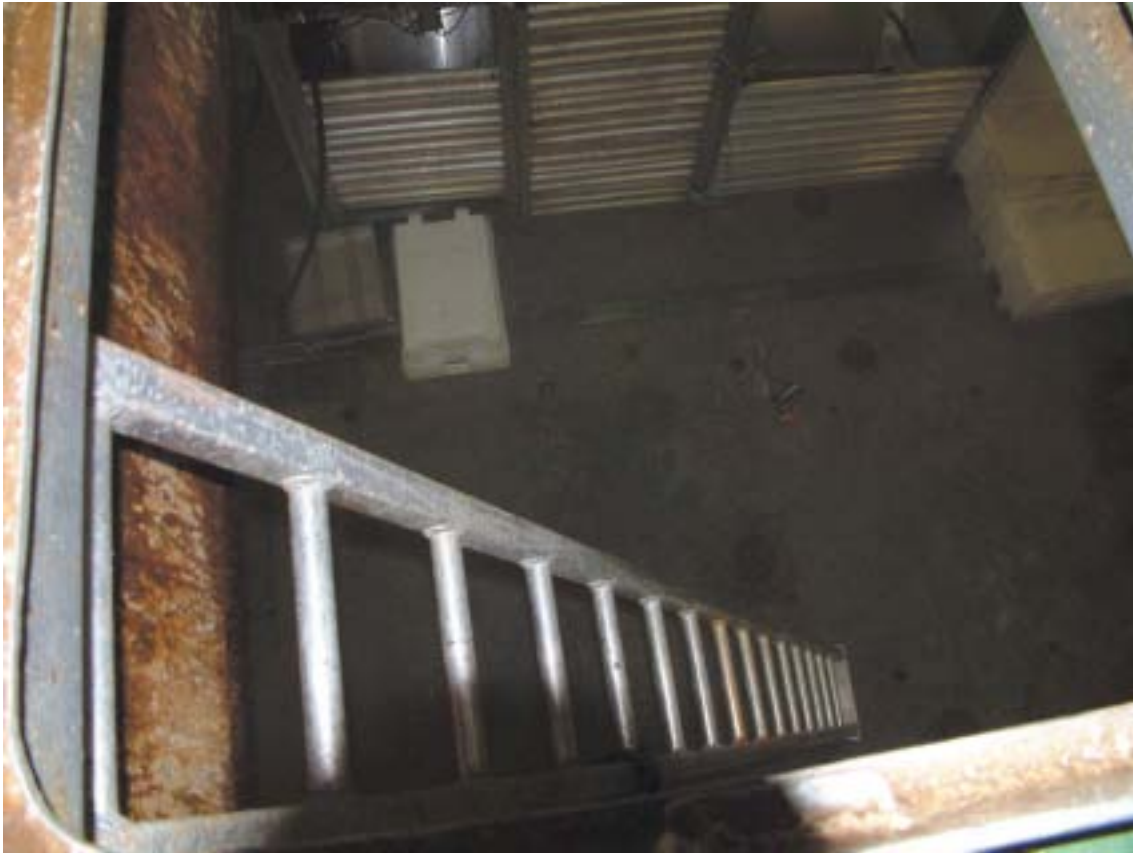
A 34m vessel was trawling when one of her crew fell down into the fish room through the open hatch from the deck above.

Views into and out of the fish hold indicating the distance the casualty fell

1. Whenever working close to open hatches, always ensure safety measures are in place, such as portable guard rails. If that is not possible, use a safety harness attached to a point which will prevent a person working close to an open hatch from falling down. It's also a good idea to wear a hard hat with a chinstrap, just in case.
2. Contrary to popular belief, the assessment of risk is not a complicated exercise. It requires all concerned in any operation to stand back, for a few minutes only, and consider the risks associated with that particular operation. If hazards are identified, often, simple control measures can be put in place to prevent accidents from happening.
3. The best people to carry out risk assessments are the skipper and his crew. It is they who know their vessel better than anyone else, and it is they, therefore, who are able to more readily identify risks.

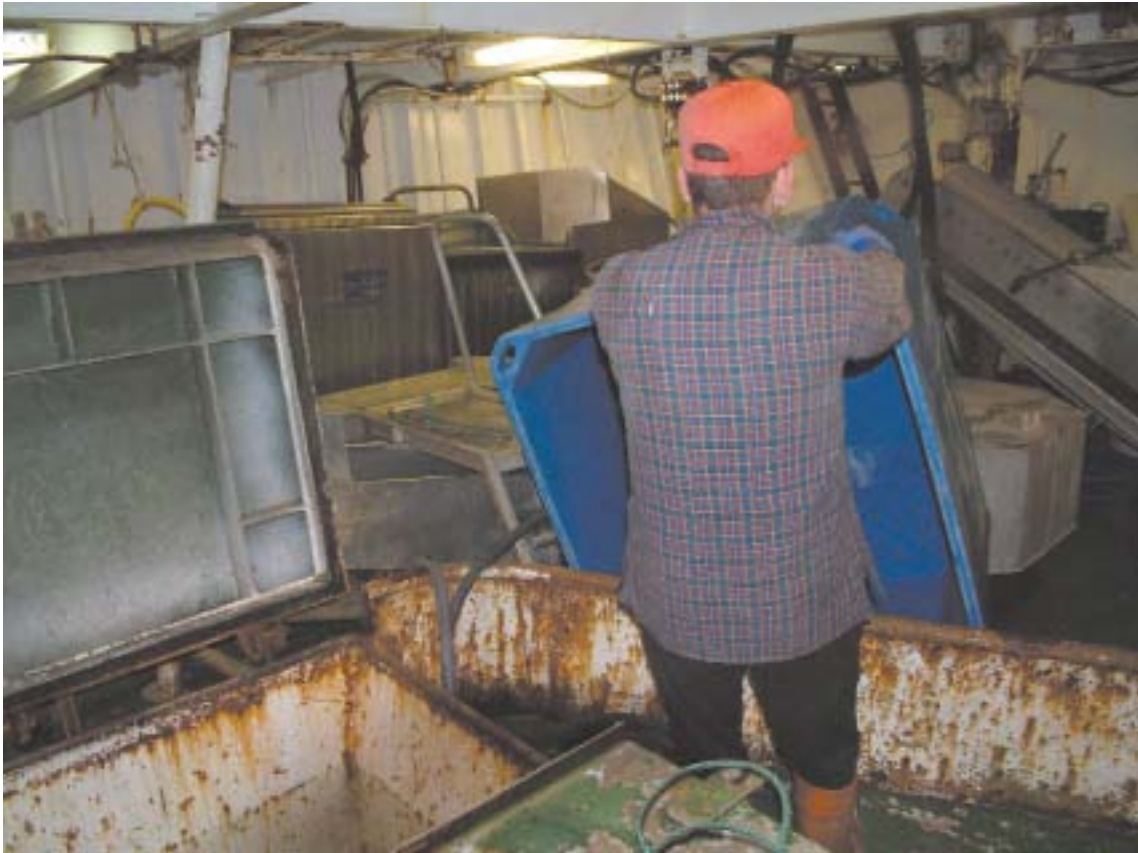
Bin being lifted into fish hold

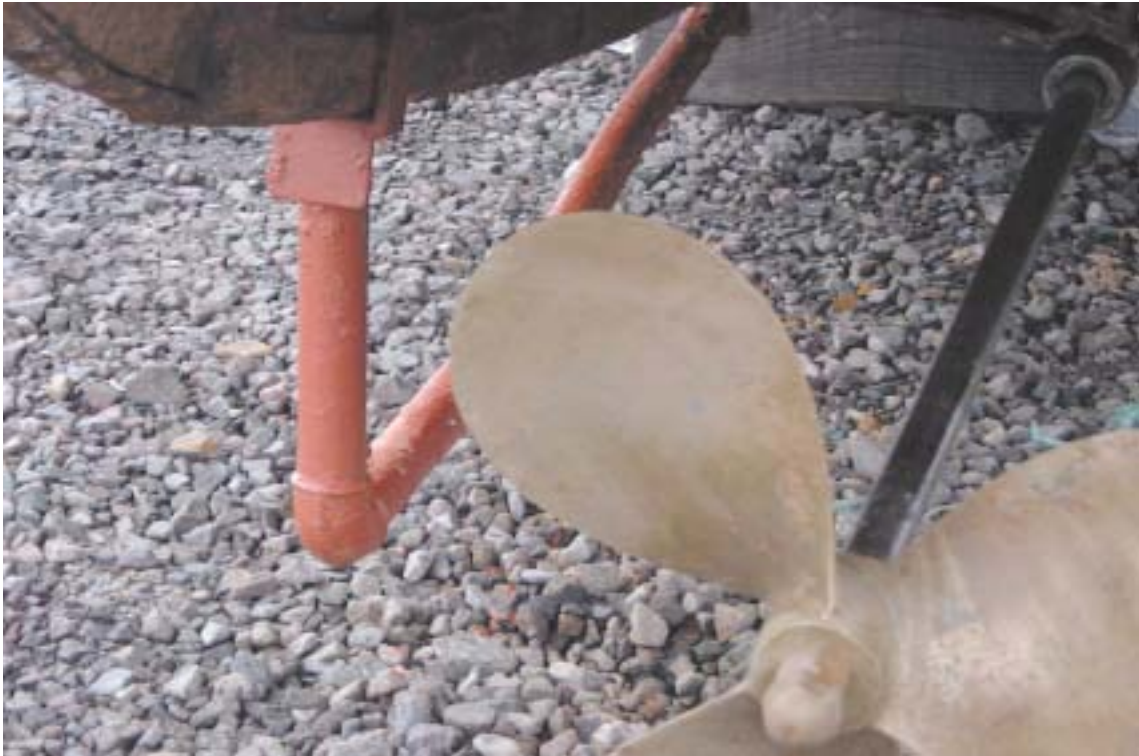
The local lifeboat arrived on the scene approximately 20 minutes later, and a portable salvage pump was put on board the fishing vessel. She was then towed back to port where she was lifted out of the water, and where a detailed inspection revealed that the propeller and the propeller inspection box had both been damaged. In addition, the splines on the propeller shaft, connecting it to the gearbox, had sheared.

View of propeller

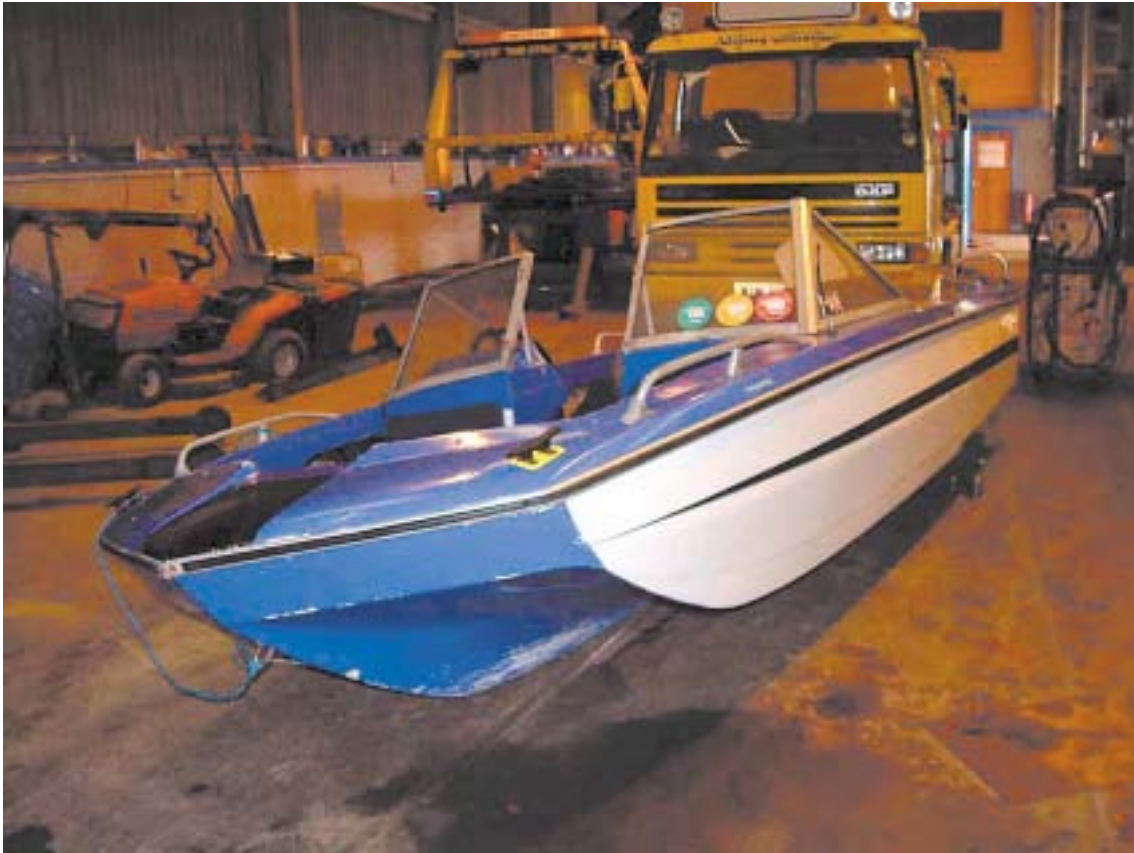
Photographs of the boat

1. The boat, which was nearly 30 years old, had had multiple owners and had been modified and poorly repaired such that it no longer met the original design criteria. Many boats like this are for sale on the second-hand market, and their condition is not regulated. A boat can inadvertently become a death trap when modifications are carried out inexpertly. Before buying a second-hand boat make sure you know:

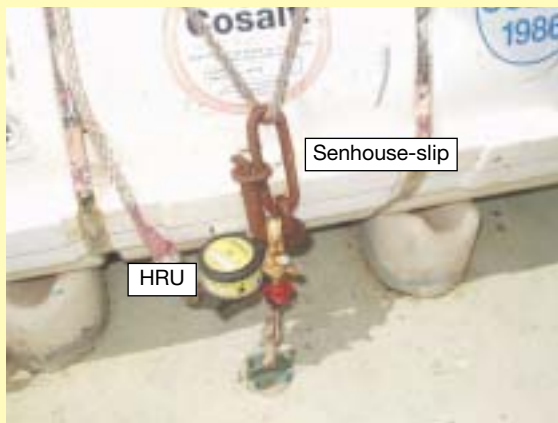
Typical senhouse-slip arrangement

The MAIB's preliminary examination into the circumstances leading to the loss of a crabber, identified a potentially serious problem with the manual release arrangements for liferafts fitted to fishing vessels.
