MAIB
MARINE ACCIDENT INVESTIGATION BRANCH

SAFETY DIGEST

Lessons from Marine Accident Reports

No 2/2003

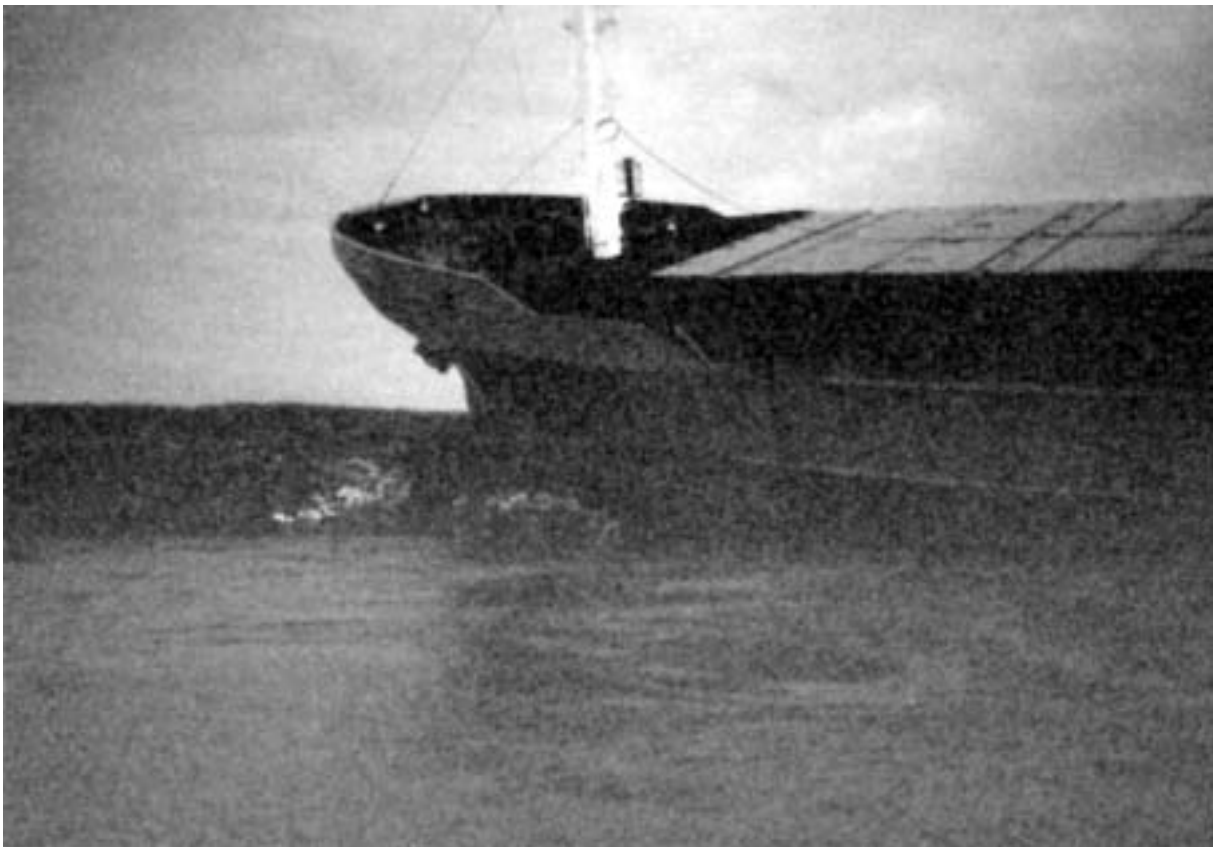
As the tide continued to ebb, the vessel eventually settled on the bottom with a 20° list. Later, as the tide flooded, water entered an open emergency escape hatch to the engine room.

Vessel following the grounding

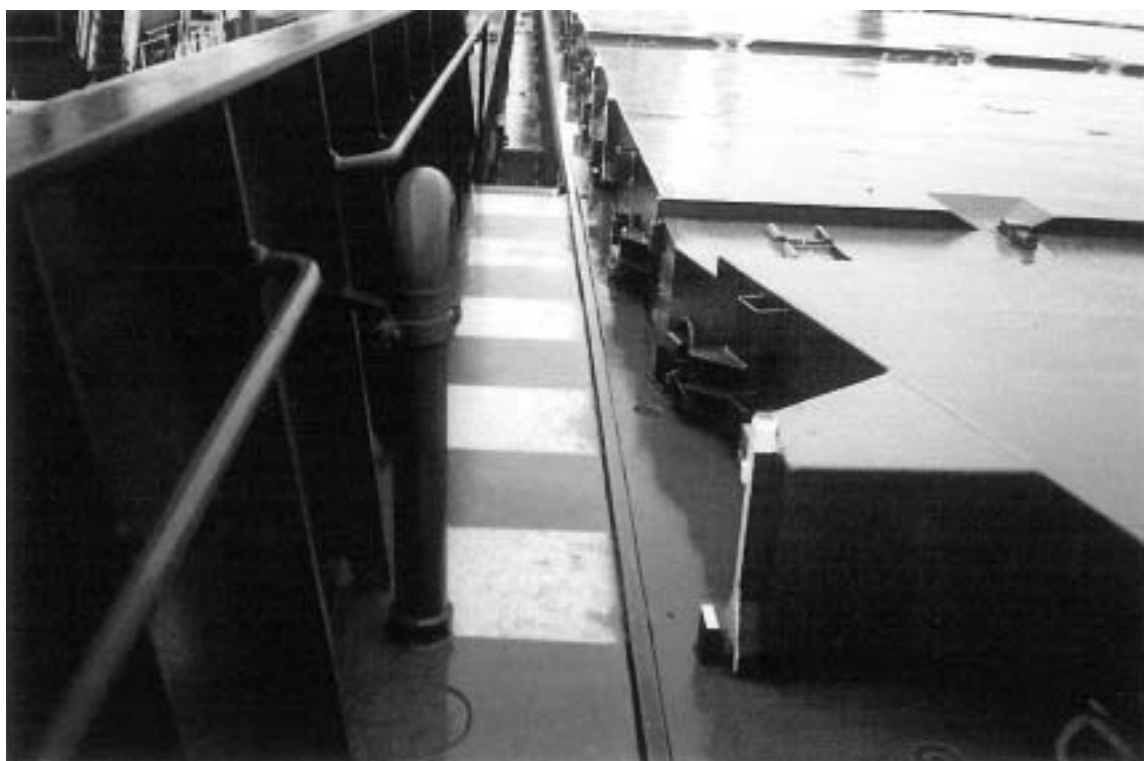
The chief officer had been standing in a position where there was a narrow gap between the gantry rails and the ship's side. The space was further restricted by a hand rail and an air pipe and, when the gantry crane was forward, by the access ladder to the crane (see **photographs**). In fact, in one position, the crane's access ladder came to within 6cm of the air pipe.

View showing gap between gantry crane ladder and vent pipe

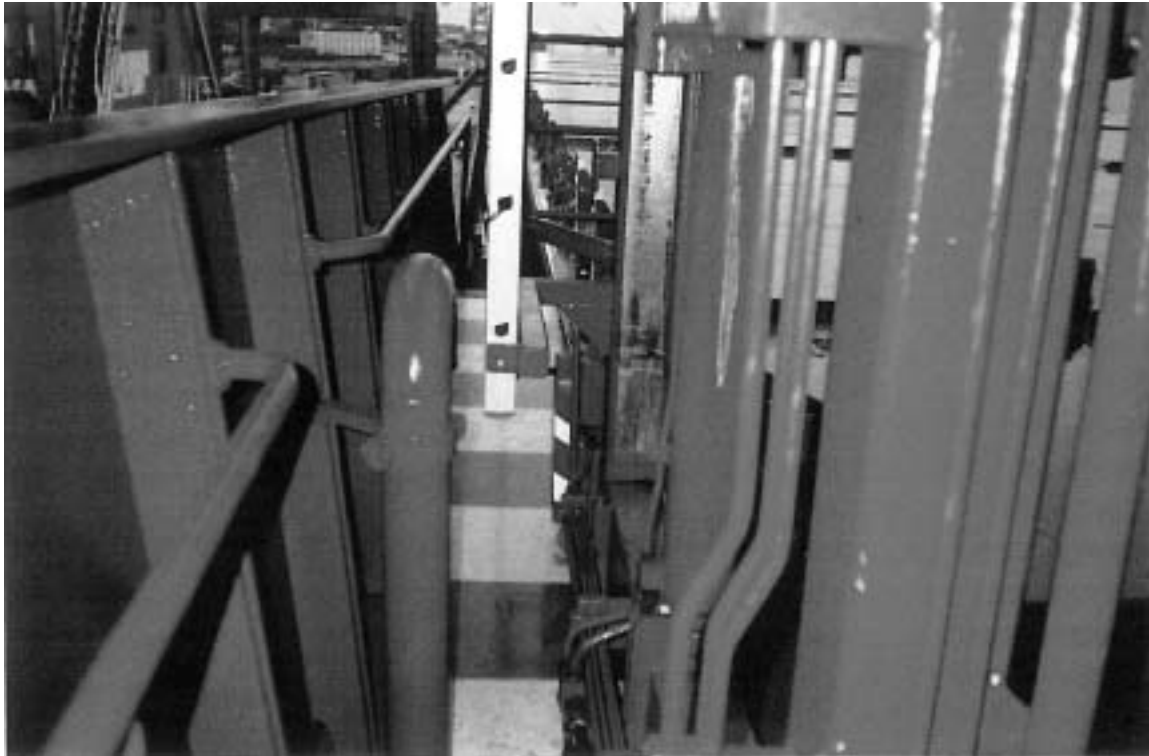
View of walkway from main deck to foc'stle head, showing air vent and hand rails

Suddenly, a cry was heard from the chief officer. The crane was stopped immediately. The chief officer's leg had become trapped and crushed between the crane and the air pipe. It was later diagnosed that he had suffered a fracture to his right femur.

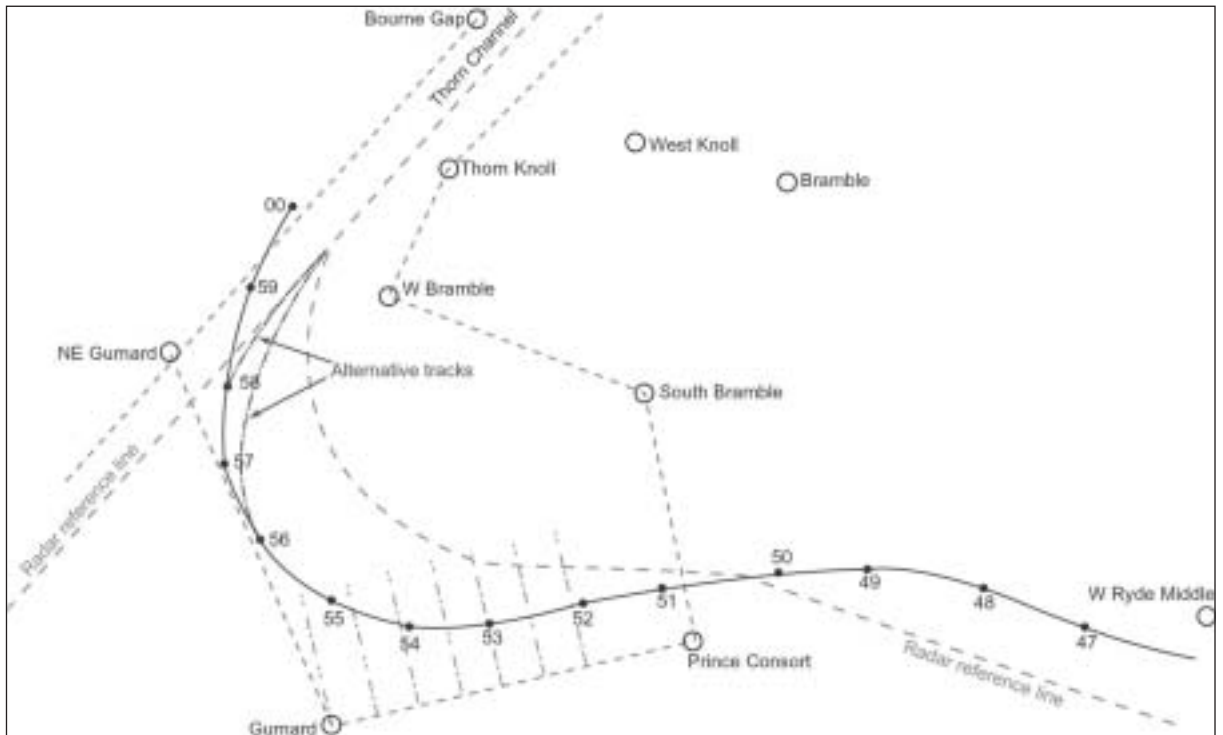
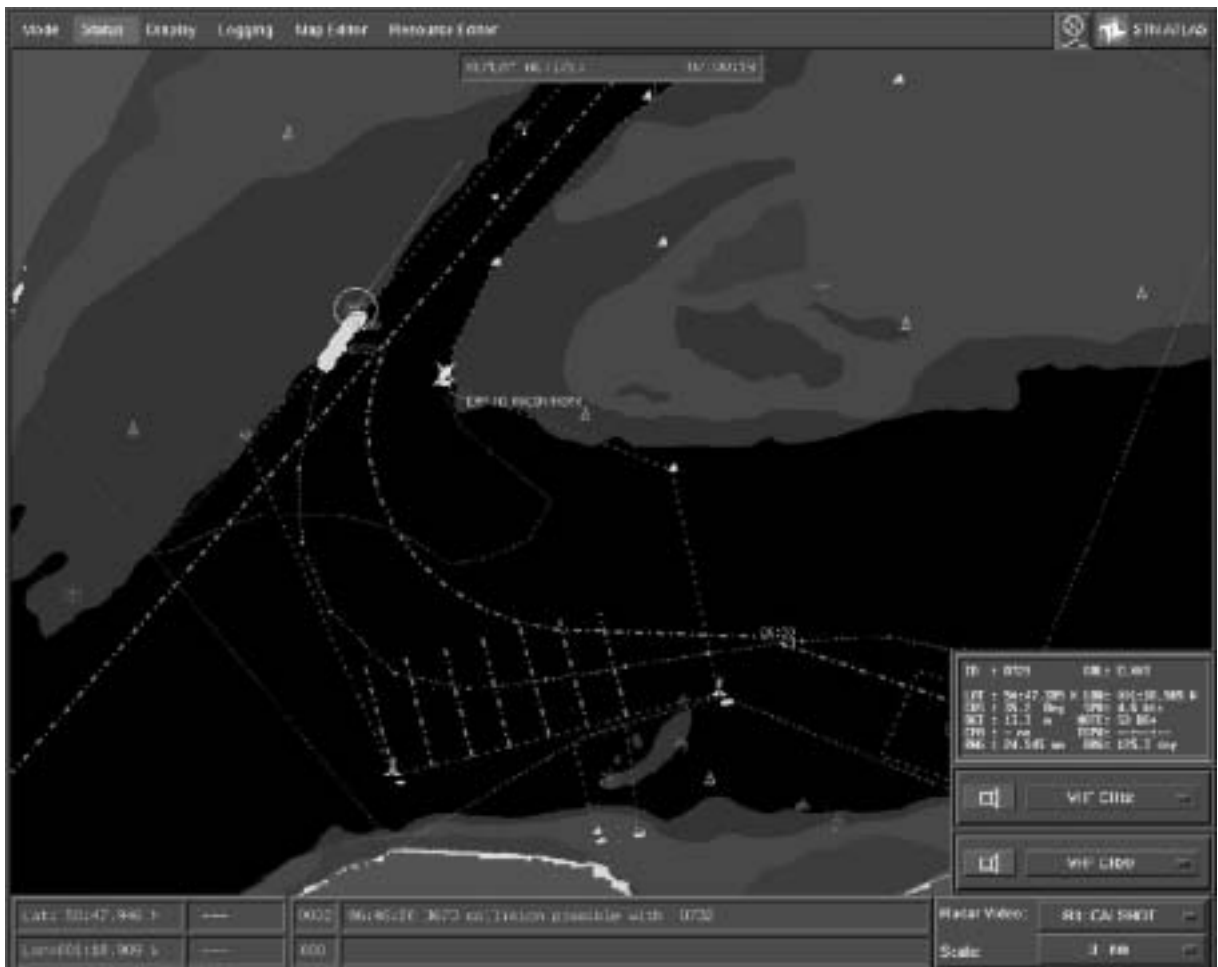
When the west Bramble and north-east Gurnard buoys appeared, the pilot realised the ship was outside the intended track for the turn. Despite further helm and engine orders, she grounded at about 0700.

Container ship grounding on edge of navigable channel

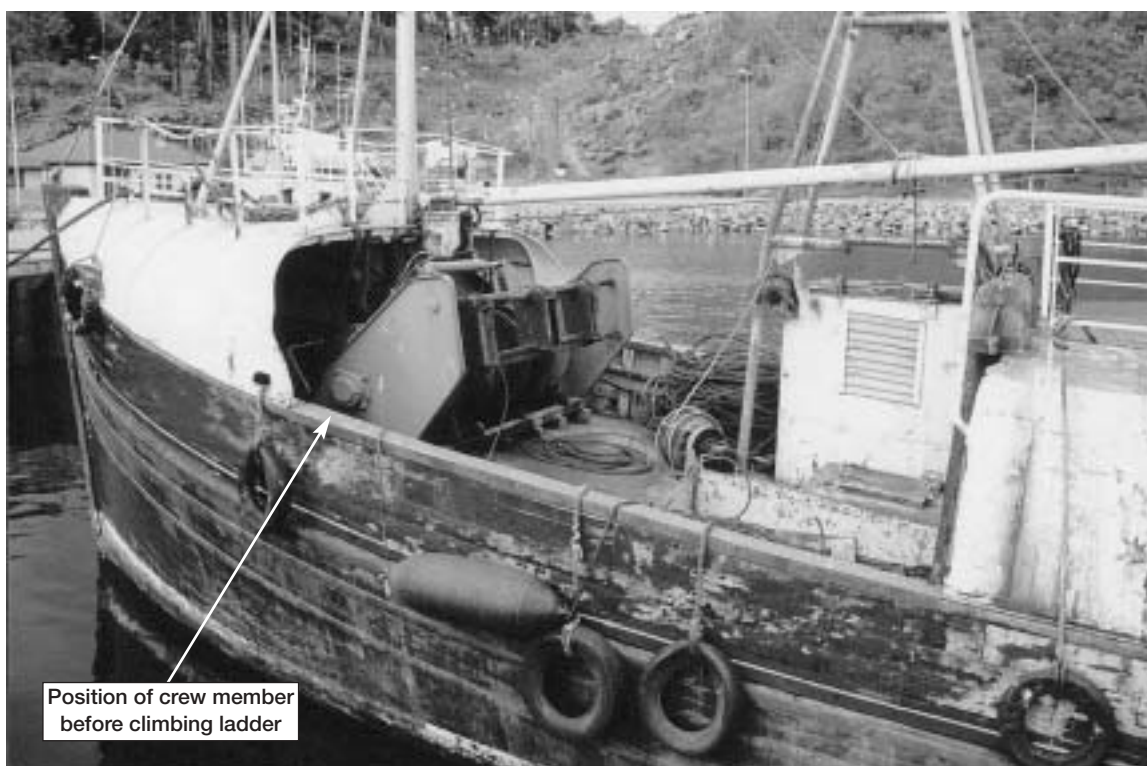
Vessel layout, showing significant freeboard height

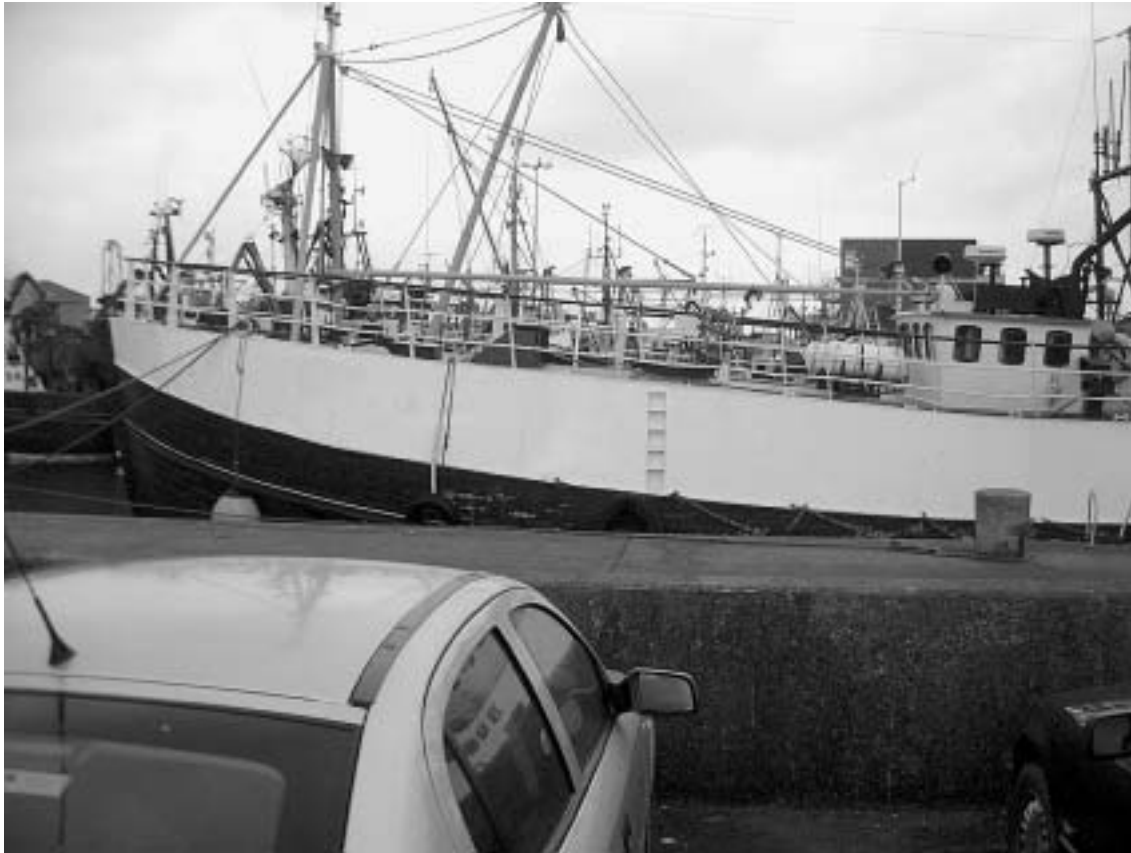
Note vessel's high bow

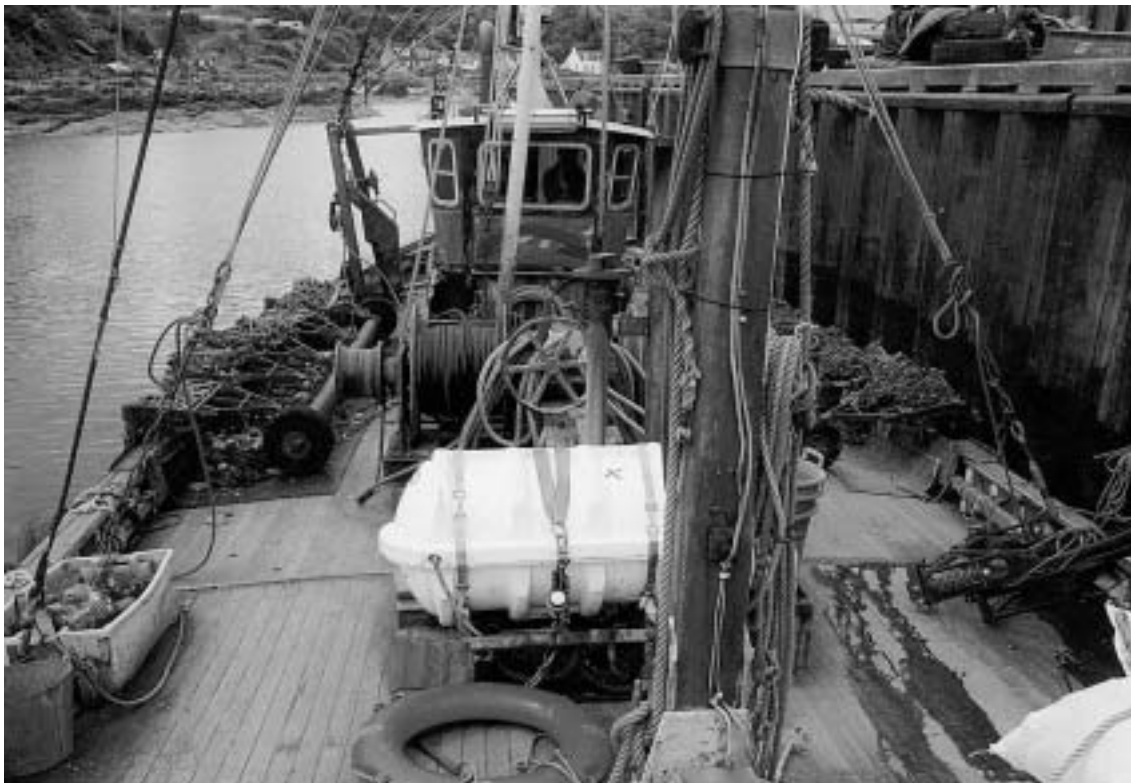
Fishing vessel's deck

The cause of the man overboard has not been determined with certainty, but the MAIB considers it likely that it happened while the crew member was leaning over the side to tighten bolts on the dredge gear. He had not been wearing a lifejacket or safety harness, and the bulwark height was very low, less than 37cms (see photograph). The vessel had been exempted from compliance with the minimum bulwark

height rules contained in the Fishing Vessel (Safety Provision) Rules 1975 owing to her age, and compliance would have entailed major modification.
