# Safety digest 1/2003

## **MARINE ACCIDENT INVESTIGATION BRANCH**

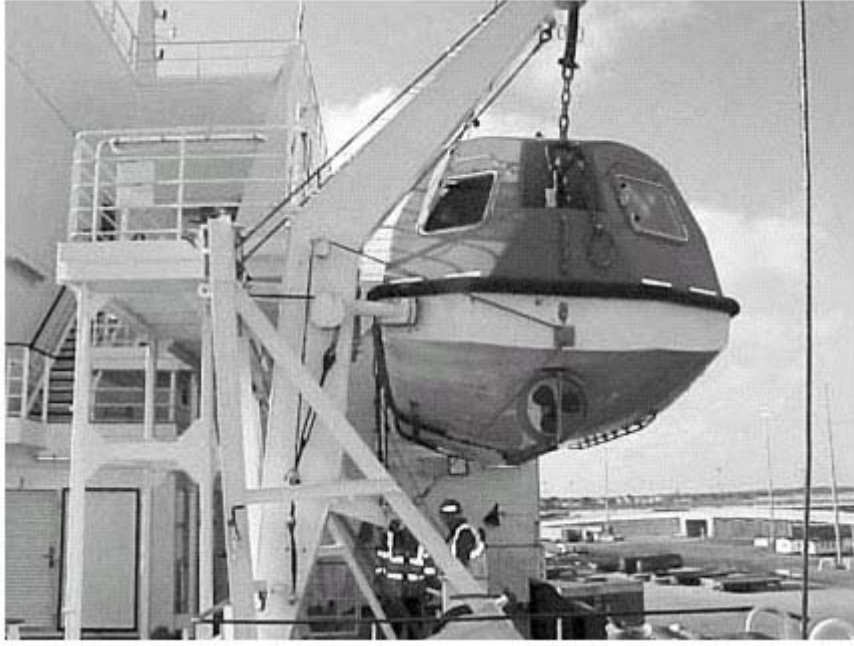
No 1 lifeboat, starboard side

As the davits moved outboard, both forward and aft auto release trip mechanisms operated, but only the forward gripe dropped free. With the aft gripe still hooked on, further lowering of the davits caused the lifeboat to twist on the davits. The davit brake was applied, and the aft gripe released by hand, causing the lifeboat to swing violently on the falls. The test was abandoned, and the lifeboat winched back into the stowed position so that the cause of the hang up could be investigated.

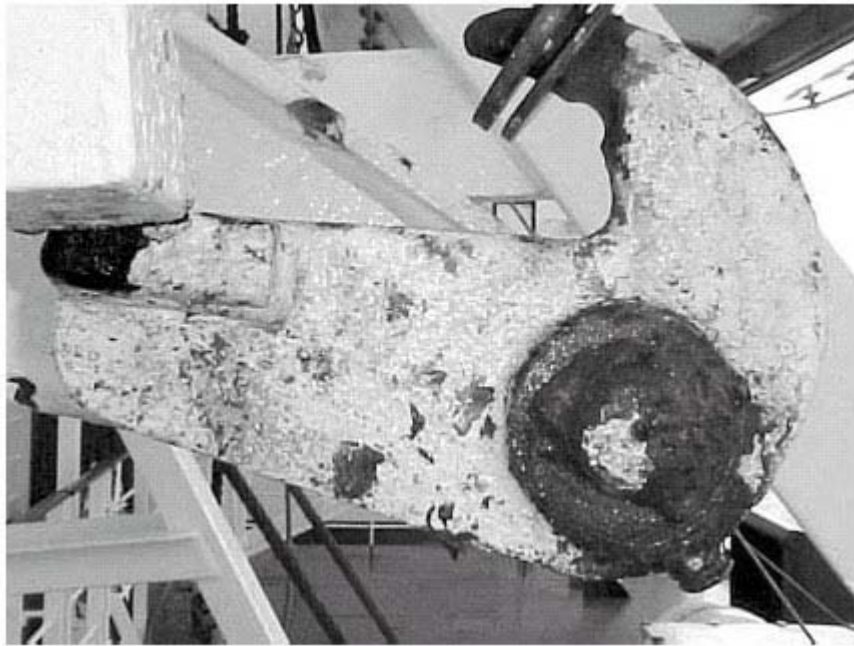
On examining the aft auto release trip mechanism, it was found that the hook, on which the gripe wire link was secured, had developed a very well defined groove where the link normally lay. The depth and contours of the groove were sufficient to hold this link in place, even when the operating arm had tripped. The wear on the hook had obviously taken some time to develop, and had probably been caused by a combination of corrosion, slight movements of the lifeboat in the davits, and vibration.

Worn hook on aft gripes

The company repaired the hook and fitted a new heel pad to ensure that the gripe wire link was correctly placed when the lifeboat was in the stowed position.

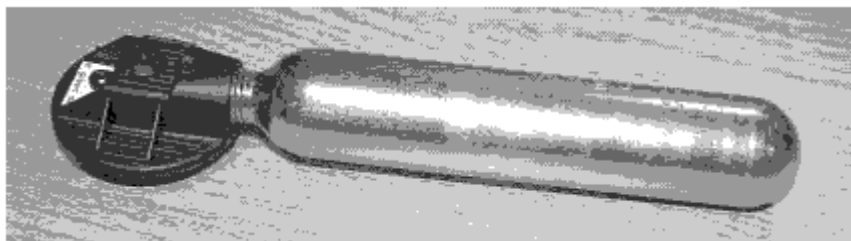
The tests revealed that the lifejackets which had failed to inflate, had probably done so because the gas cylinders had become detached from the Hammar release units.

Gas cylinder must be screwed into release unit back plate like this

**1. Fishermen and mariners who routinely wear inflatable lifejackets should ensure that the gas cylinders are firmly tightened into the release units. Owners of lifejackets fitted with Hammar release units are particularly urged to make this check, and should also carry out the safety checks listed in the booklet issued with every lifejacket:**

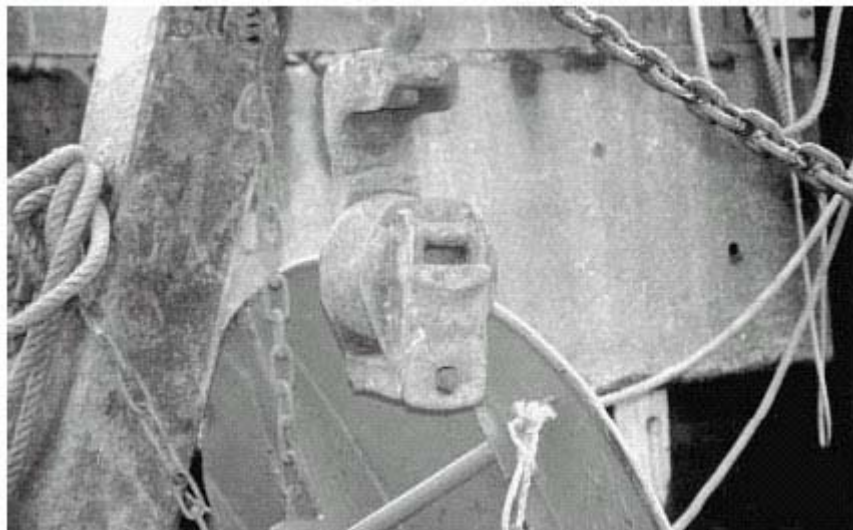
The snatch blocks being used on the aft gantry to lead the trawl wires over the stern, were being used in the open condition. Because of the general condition of the blocks, and the lack of any locking pins, they were unable to be used in the correct manner anyway.

Starboard snatch block

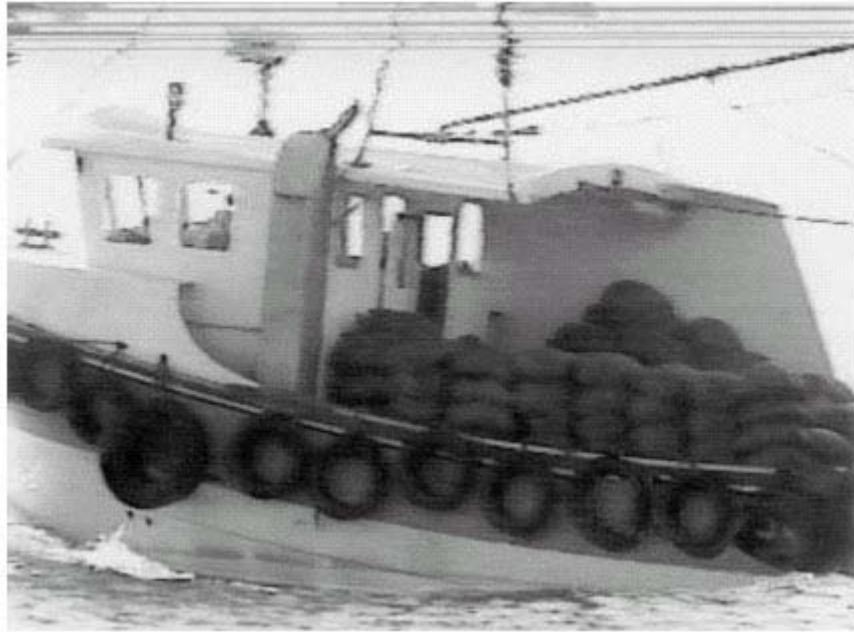
It was concluded that the capsizing was caused by the effect of undetected flooding, probably via the manual bilge discharge pipe, in combination with the heavy load of mussel bags on deck.

An example of mussel bag loading onboard the vessel

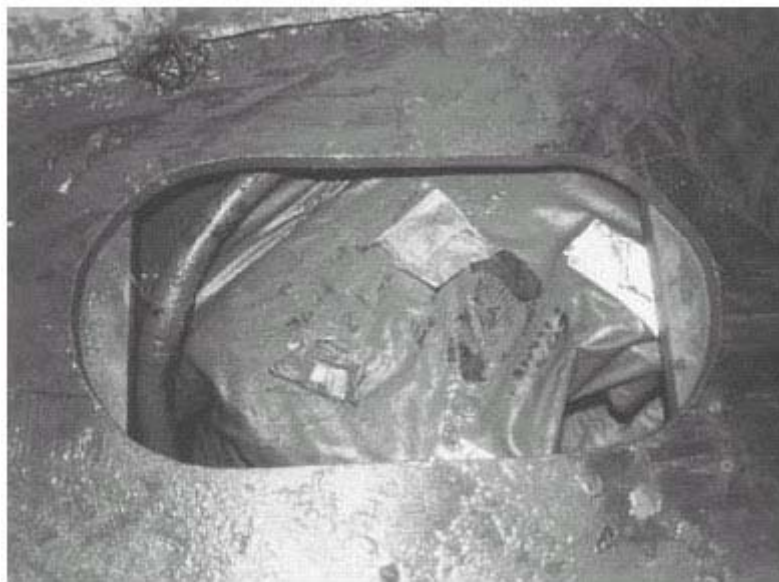
Stowage of lifejacket as found under cabin bunk
