Safety digest 1/2003

MARINE ACCIDENT INVESTIGATION BRANCH

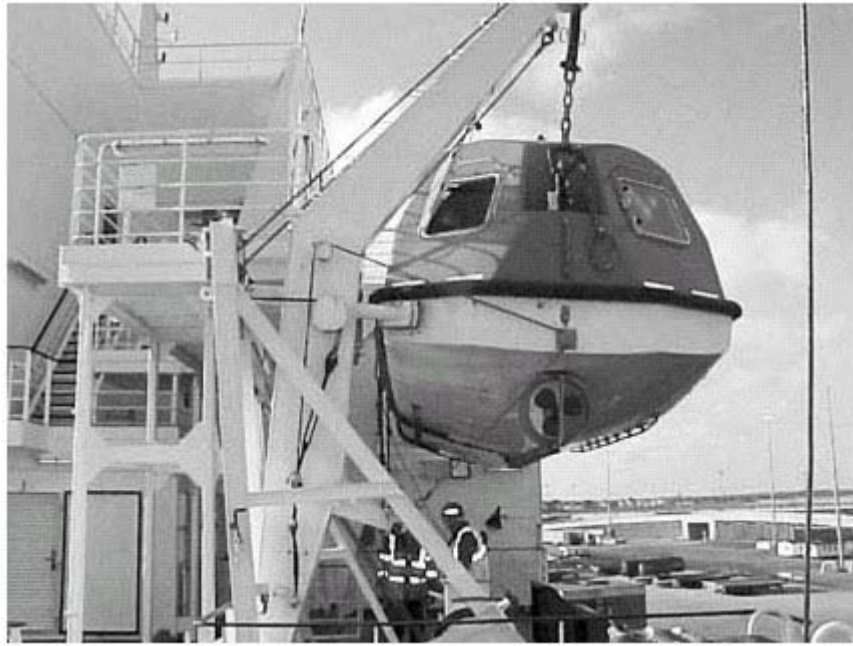
No 1 lifeboat, starboard side

As the davits moved outboard, both forward and aft auto release trip mechanisms operated, but only the forward gripe dropped free. With the aft gripe still hooked on, further lowering of the davits caused the lifeboat to twist on the davits. The davit brake was applied, and the aft gripe released by hand, causing the lifeboat to swing violently on the falls. The test was abandoned, and the lifeboat winched back into the stowed position so that the cause of the hang up could be investigated.

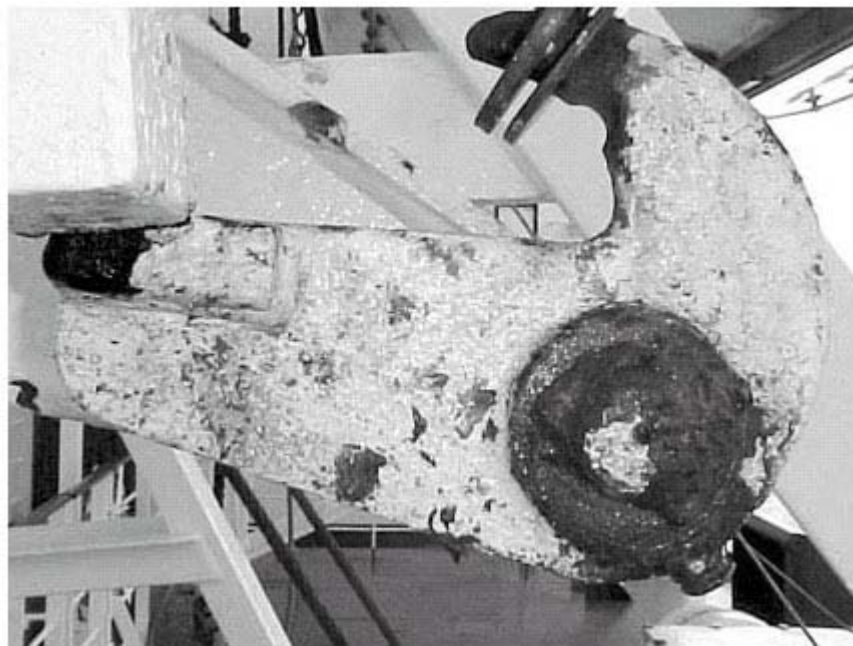
On examining the aft auto release trip mechanism, it was found that the hook, on which the gripe wire link was secured, had developed a very well defined groove where the link normally lay. The depth and contours of the groove were sufficient to hold this link in place, even when the operating arm had tripped. The wear on the hook had obviously taken some time to develop, and had probably been caused by a combination of corrosion, slight movements of the lifeboat in the davits, and vibration.

Worn hook on aft gripes

The company repaired the hook and fitted a new heel pad to ensure that the gripe wire link was correctly placed when the lifeboat was in the stowed position.

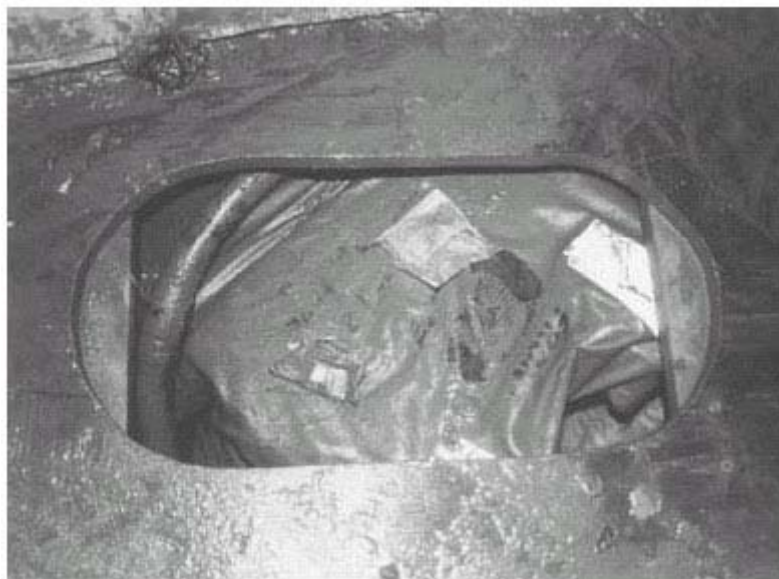
Stowage of lifejacket as found under cabin bunk
