Marine Accident Investigation Branch (MAIB) - Safety Digest 3/2002

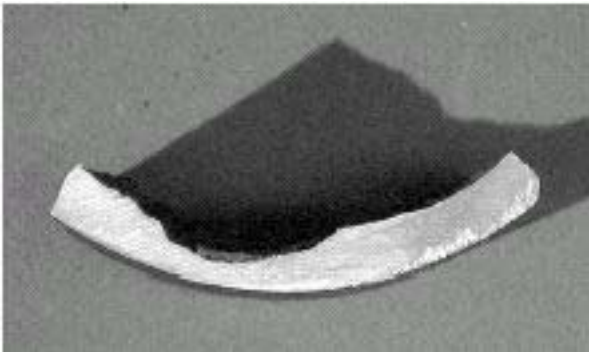
A boroscope inspection of all accessible screen tubes followed, and identified other tubes suffering from on-load corrosion. All had localised scale build-up in line with the flame, together with tube wall wastage underneath the scale. Subsequently, No 3 boiler was chemically cleaned, and all screen tubes were scanned for thickness. No 2 boiler was similarly treated. The screen tubes on No 1 boiler had been renewed recently, so were in good condition.

The internal surface of the tubes had severe gouging and wastage on the fireside half where as the sheltered half was unaffected. The wastage was in the area of the ruptured section and its immediate vicinity.

Checks at five points on the tube samples showed undulating thickness ranging from 2 to 4mm on the fireside whereas the unaffected sheltered side showed a uniform thickness of about 6 mm. The thickness of the rupture lips at the window opening and open fissure areas was about 1 to 2 mm. Further study showed that apart from slight signs of decarbonisation at the inter granular cracked areas, the base material of the tubes was unalloyed carbon steel. Thick lumpy deposits of oxide scale (magnetite) ranging from about 0.2 to 0.6 mm was found on the internal surface of the fireside half. Copper deposits were also found on the outer layer of the inner surface deposits. pH tests on the scale /deposits showed acidic levels in the range of 3 to 4 confirming that the corrosion was acidic corrosion.

Wall thinning in way of lumps of bore scale

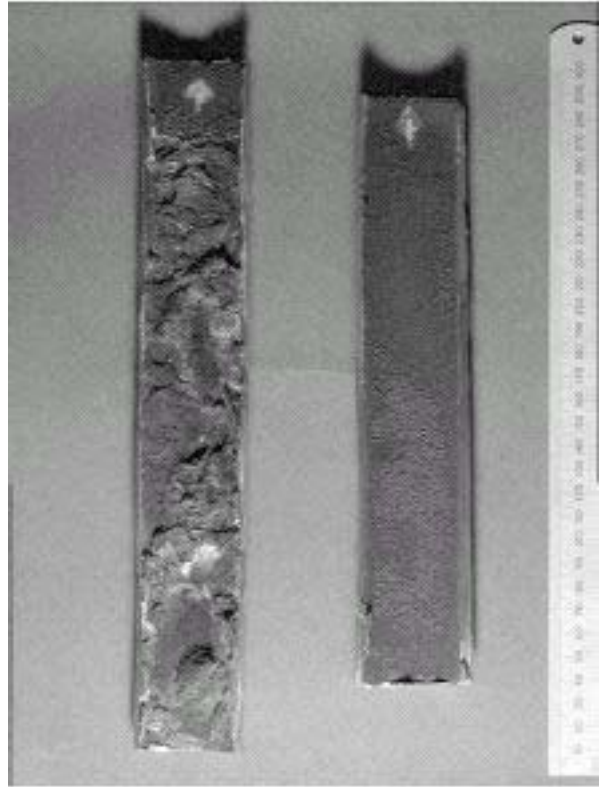
Inner surfaces of tube strips

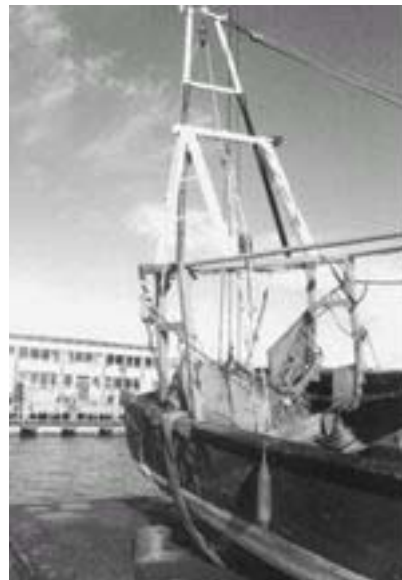
The situation seemed to stabilise with the vessel listed to starboard, and with freeing ports on the aft starboard side underwater. As the crewmember cut the net to release the unwanted load, the vessel encountered the wash from a passing vessel. She rolled, took water over the starboard bulwark and capsized rapidly. Within minutes, she inverted and foundered.

The gantry and A frame
