Marine Accident Investigation Branch (MAIB) - Safety Digest 1/2001

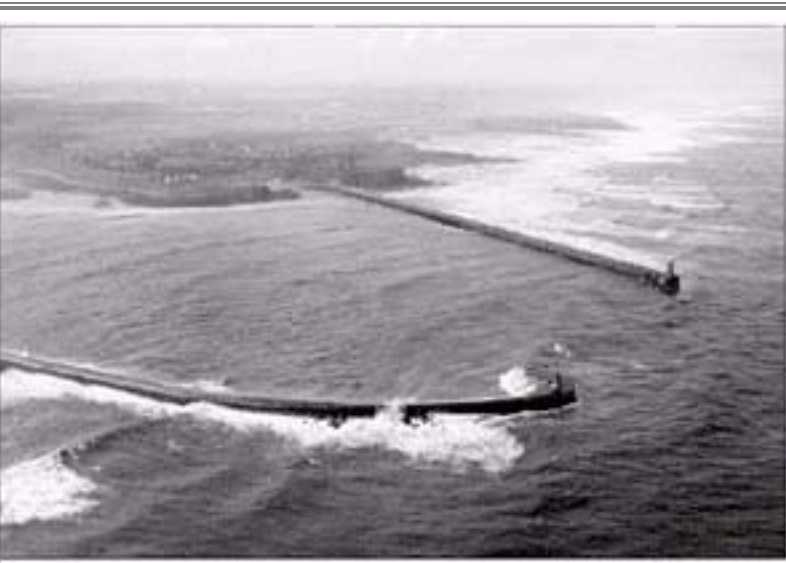
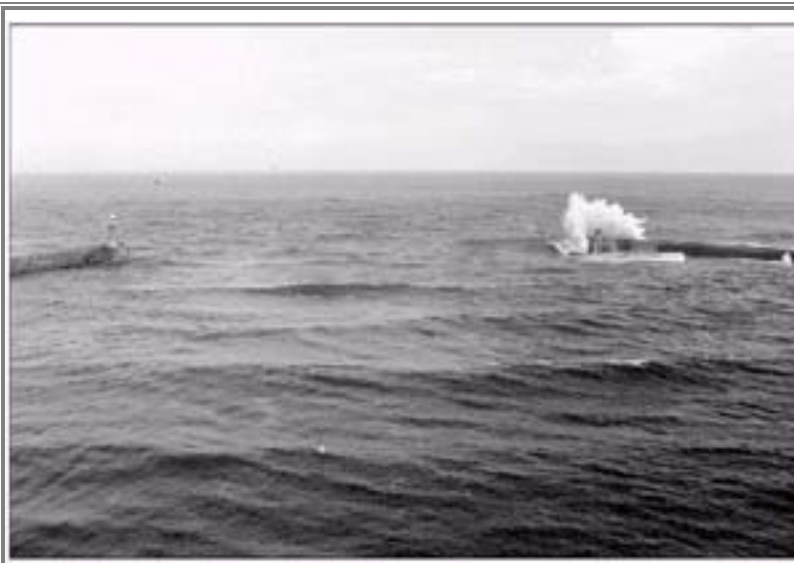
Entrance to the River Tyne after the *Signature* accident. The height of the waves had substantially reduced by the time these photographs had been taken [courtesy of the Northumbria police]
