# Marine Accident Investigation Branch (MAIB) - Safety Digest 3/2000

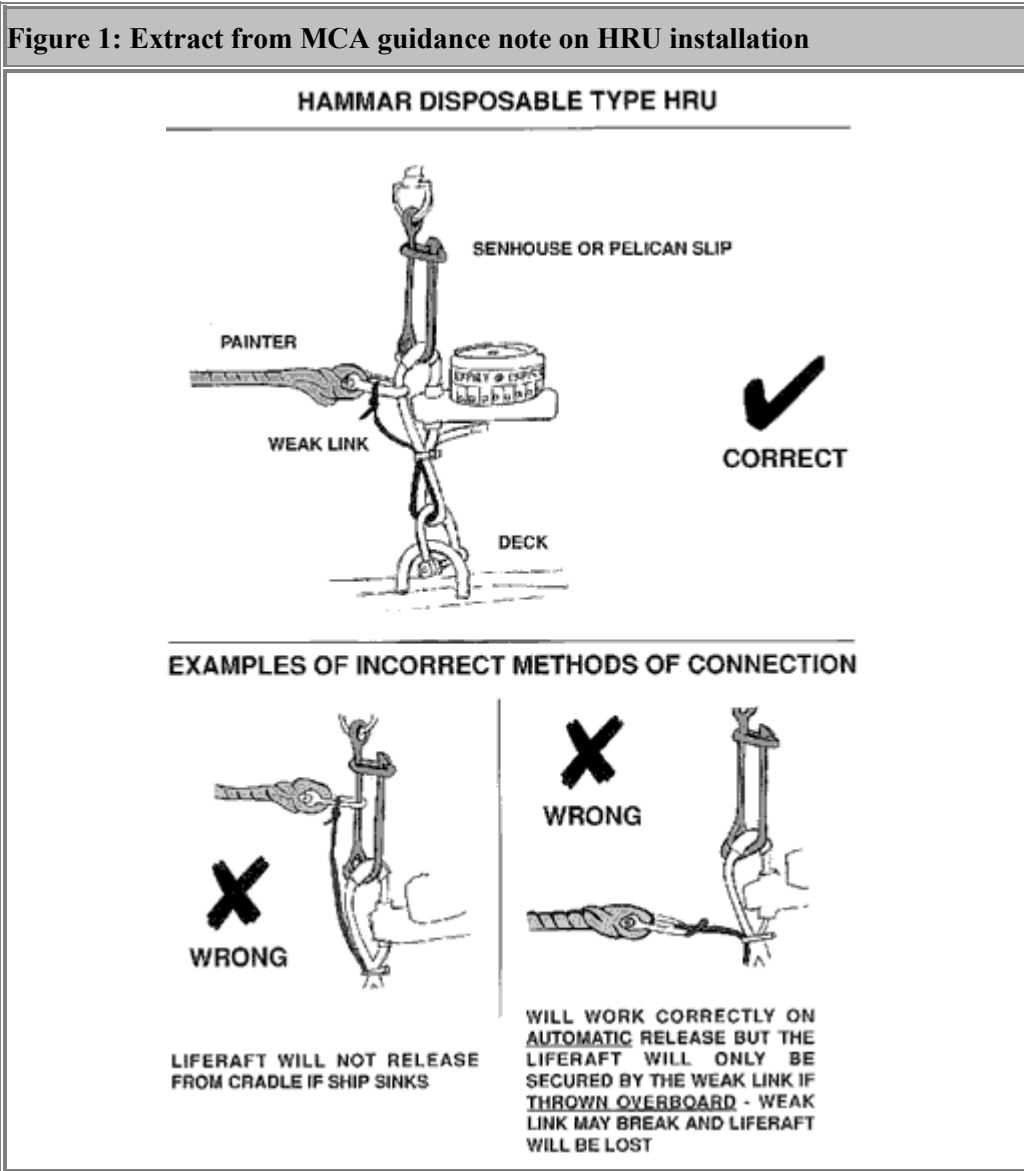
**Footnote**

Although manufacturers of HRU's provide diagrams that show correct installation, the MAIB is aware that many people have difficulty following them. Some may be unaware that the MCA produces a useful guidance note on the subject. An extract is reproduced here. Read it.
