# Marine Accident Investigation Branch (MAIB) - Safety Digest 01/00

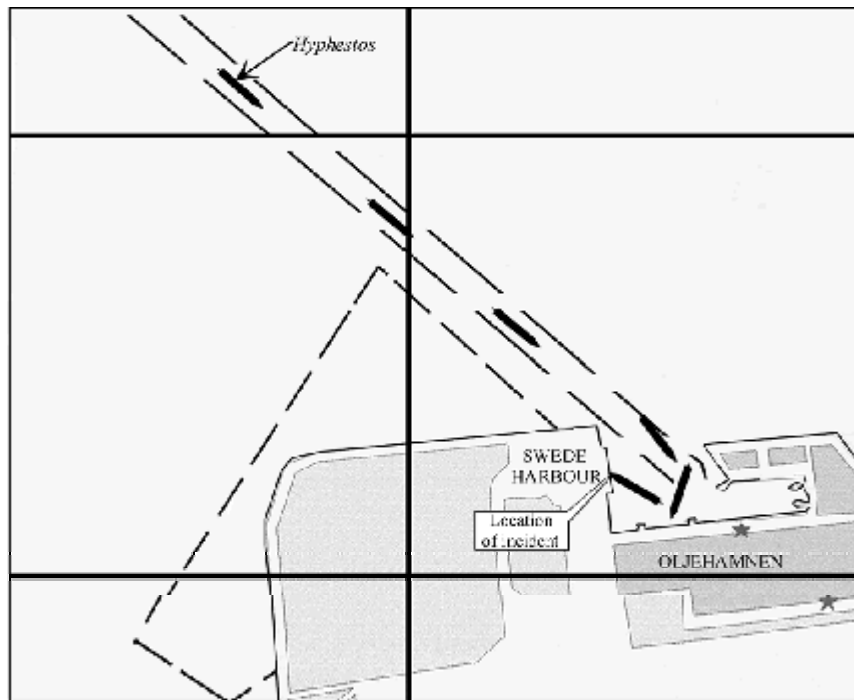
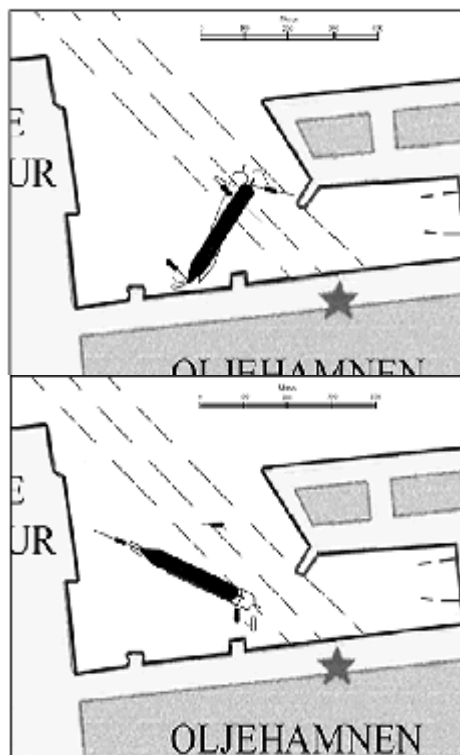
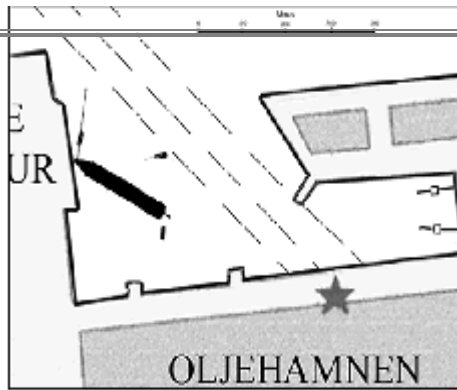
**Illustration of events leading to impact with the jetty**

Once *Hyphestos* had stopped off the berth, the swing was started with the head tug pulling the bow to starboard, and the tractor tug aft pulling the stern to port. A third tug pushed on the starboard quarter. Towards the end of the manoeuvre, the stern tug found herself very close to a buoy marking the fairway, and in danger of damaging her towing cable. Her skipper informed the pilot of the problem, and was told to slacken the cable and follow along. He was told to await further orders.

There was substantial damage to ship, jetty fender and cranes. Nobody was injured.

First point of turn complete  
Head tug pulling bow to starboard

Head tug pulling *Hyphestos* ahead with slow ahead rung on

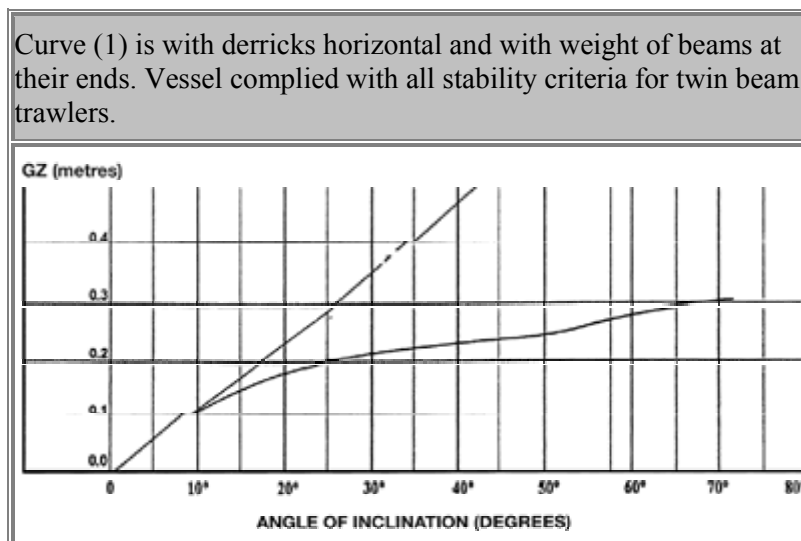
The wreck was surveyed using remotely operated vehicles (ROVs). She was found with her derricks partly topped, her beams at the derrick ends, and a large quantity of shells and sand in the cod end of one net. The other cod end was badly damaged. It was concluded that she had hauled her nets to the surface with a large amount of sand and shells in each cod end. Both derricks were then topped, but the unusually large weights in her nets acting on the derrick ends, seriously reduced her stability. In this state she was unable to resist even small heeling forces and she rolled to port, was unable to recover due to lack of stability, and sank by the stern.

As she went down by the stern, her liferafts, which had been stowed on the aft shelter, floated free. Unfortunately they floated forward and became fouled on the derricks and netting, resulting in neither being able to float to the surface. The emergency position indicating radio beacon (EPIRB) probably suffered a similar fate, because it too had been stowed on the shelter, quite close to the liferafts.

**1. Skippers and crews will know that it is more difficult to accurately assess the weight of any debris while the gear is still on the bottom. This is particularly so if the winchs capacity is large. With little idea of the weights in the nets, it is impossible to assess the effect on the vessels stability of bringing gear to the surface, and handling these weights at the derricks heads.**

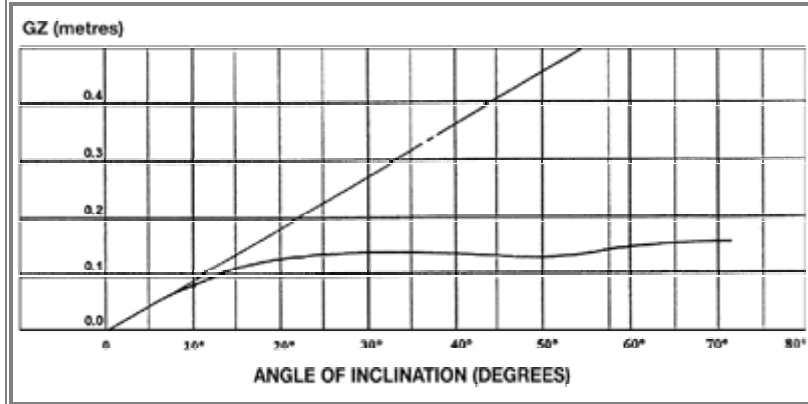
Curve (2) is with derricks 30° above the horizontal with weight of beams at their ends. Vessel did not satisfy four of the six criteria for twin beam trawlers, or the lesser standards of non-beam trawlers.

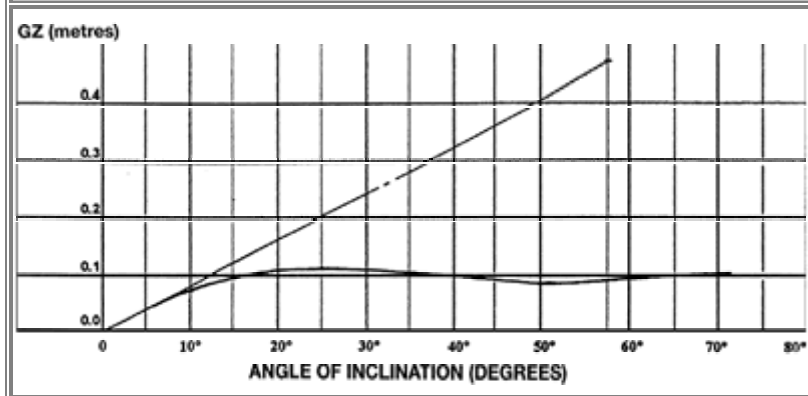
Curve (3) is with derricks 45° above the horizontal with weight of beams at their ends. Vessel did not satisfy four of the six criteria for twin beam trawlers, or the lesser standards of non-beam trawlers.
