# Marine Accident Investigation Branch (MAIB) - Safety Digest 02/1999

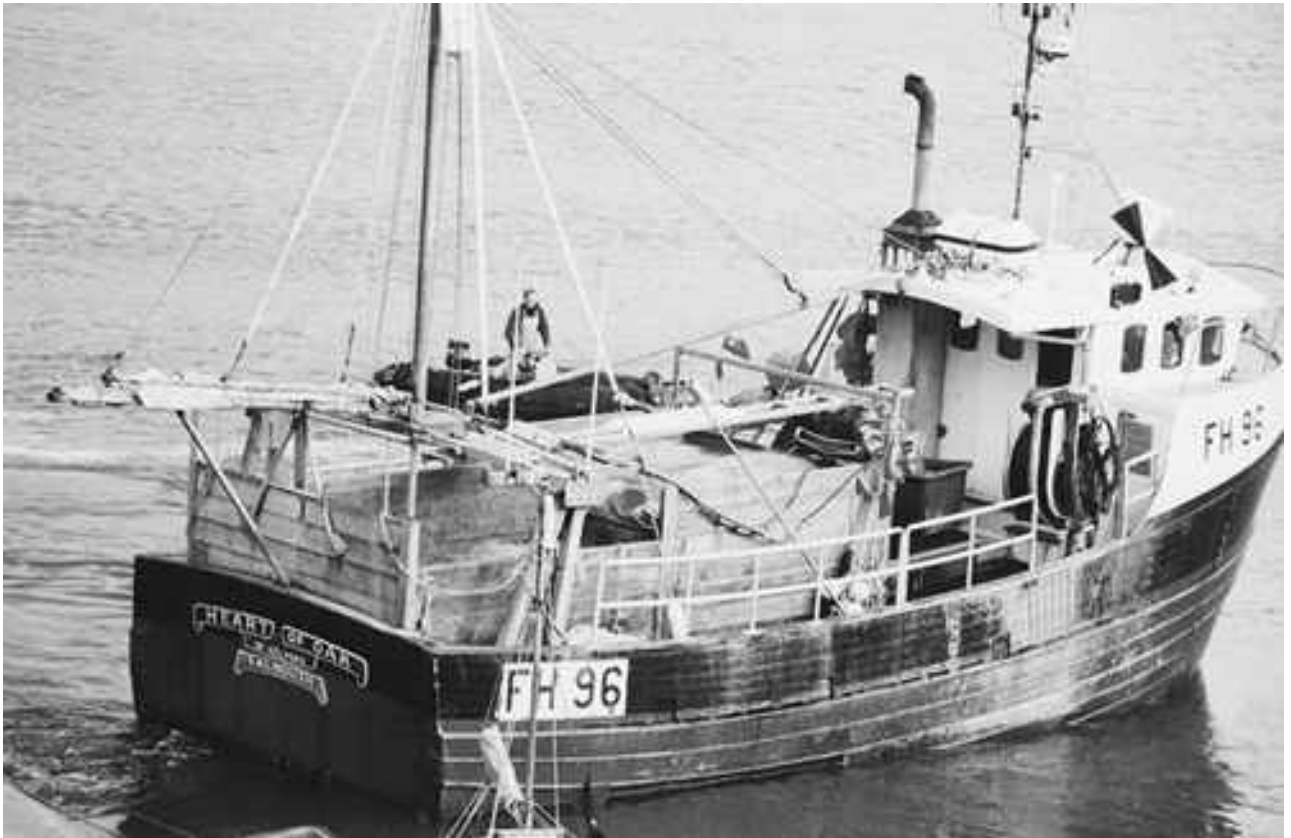
**Heart of Oak of Helford**

While making way in the heavy swell the vessel started to roll heavily and the partially full net bin slid from where it was stowed, starboard of amidships, to where the deckhand was working. He raised himself up to try and fend it off but was caught by the bin and lost his balance. He fell overboard.

Since this unfortunate accident, the owners of the vessel have fitted aluminium rails round the working deck and the crew now wear single chamber self-inflating lifejackets at all times when working on deck.
