Marine Accident Investigation Branch (MAIB) - Safety Digest 01/1998

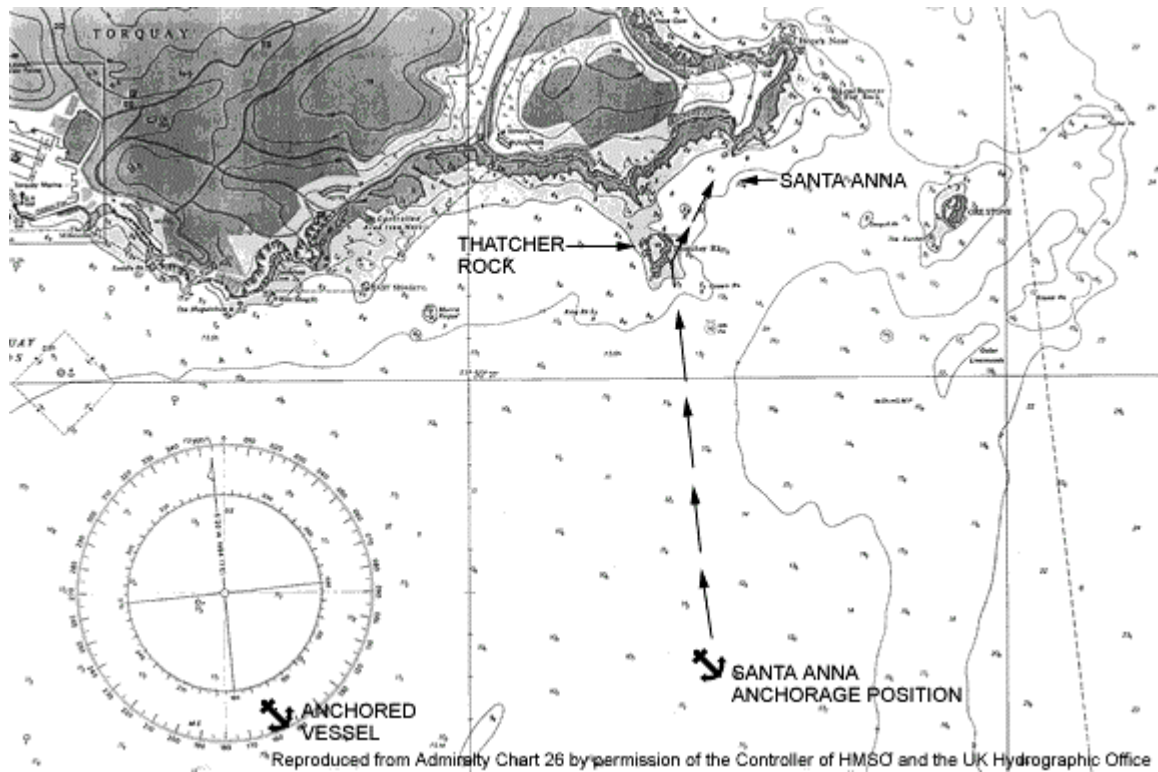
There was no pollution and there were no injuries. SANTA ANNA did however, suffer extensive bottom damage.

1. This incident demonstrates, yet again, the power of the wind and sea.
2. Even the most sheltered anchorage has its limitations in strong winds and this incident demonstrates the effect of south-westerly Force 9 winds on a ship at anchor in Torbay which "affords good anchorage, sheltered from W winds" .

3. When the weather deteriorated beyond that forecast, the Master should have appreciated that additional measures were necessary to ensure the safety of his ship; he was obviously aware from his precautions that his ship could drag in the strong winds. Those mariners who have experienced dragging an anchor will need no reminding that the rate of drift downwind can be frighteningly fast. In this incident it was assessed as two knots. The Master would have been well advised to have had both engines running ready for immediate use and perhaps propelling at slow speed at the height of the storm. He should have considered paying out more cable, letting go the second anchor or leaving the anchorage to ride out the storm at sea.
