Marine Accident Investigation Branch (MAIB) - Safety Digest 01/1998

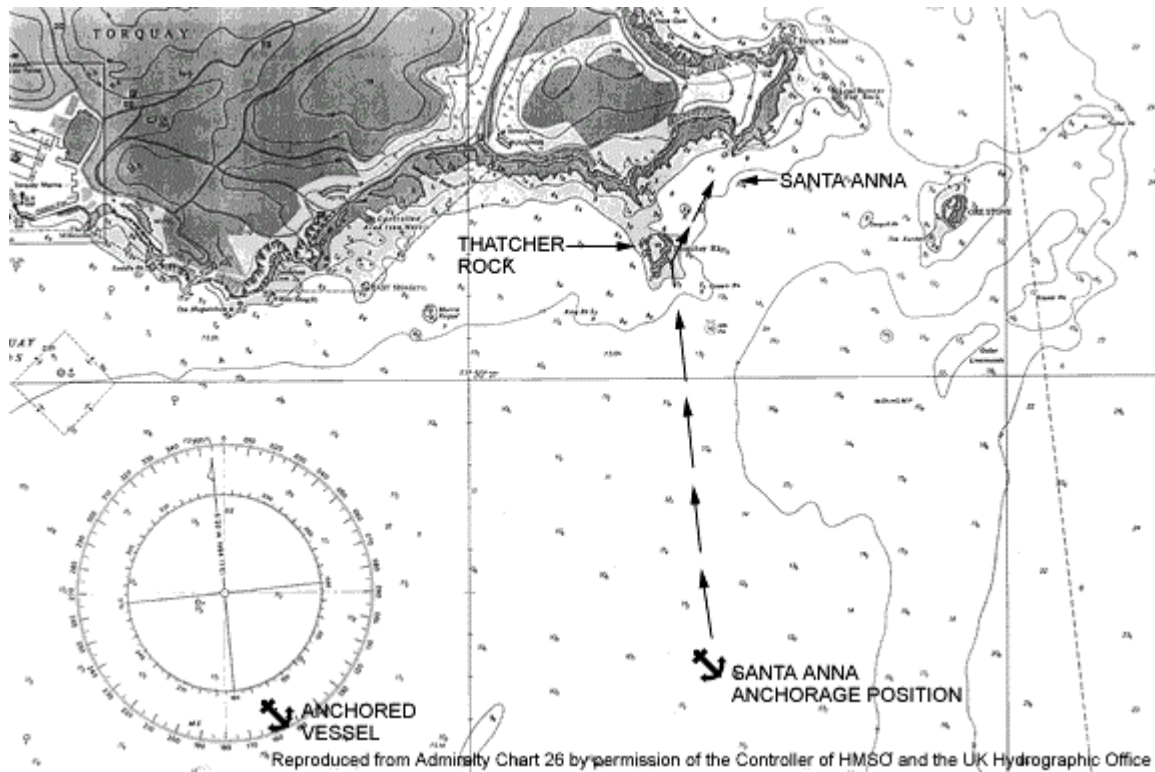
There was no pollution and there were no injuries. SANTA ANNA did however, suffer extensive bottom damage.

1. This incident demonstrates, yet again, the power of the wind and sea.
2. Even the most sheltered anchorage has its limitations in strong winds and this incident demonstrates the effect of south-westerly Force 9 winds on a ship at anchor in Torbay which "affords good anchorage, sheltered from W winds" .

3. When the weather deteriorated beyond that forecast, the Master should have appreciated that additional measures were necessary to ensure the safety of his ship; he was obviously aware from his precautions that his ship could drag in the strong winds. Those mariners who have experienced dragging an anchor will need no reminding that the rate of drift downwind can be frighteningly fast. In this incident it was assessed as two knots. The Master would have been well advised to have had both engines running ready for immediate use and perhaps propelling at slow speed at the height of the storm. He should have considered paying out more cable, letting go the second anchor or leaving the anchorage to ride out the storm at sea.

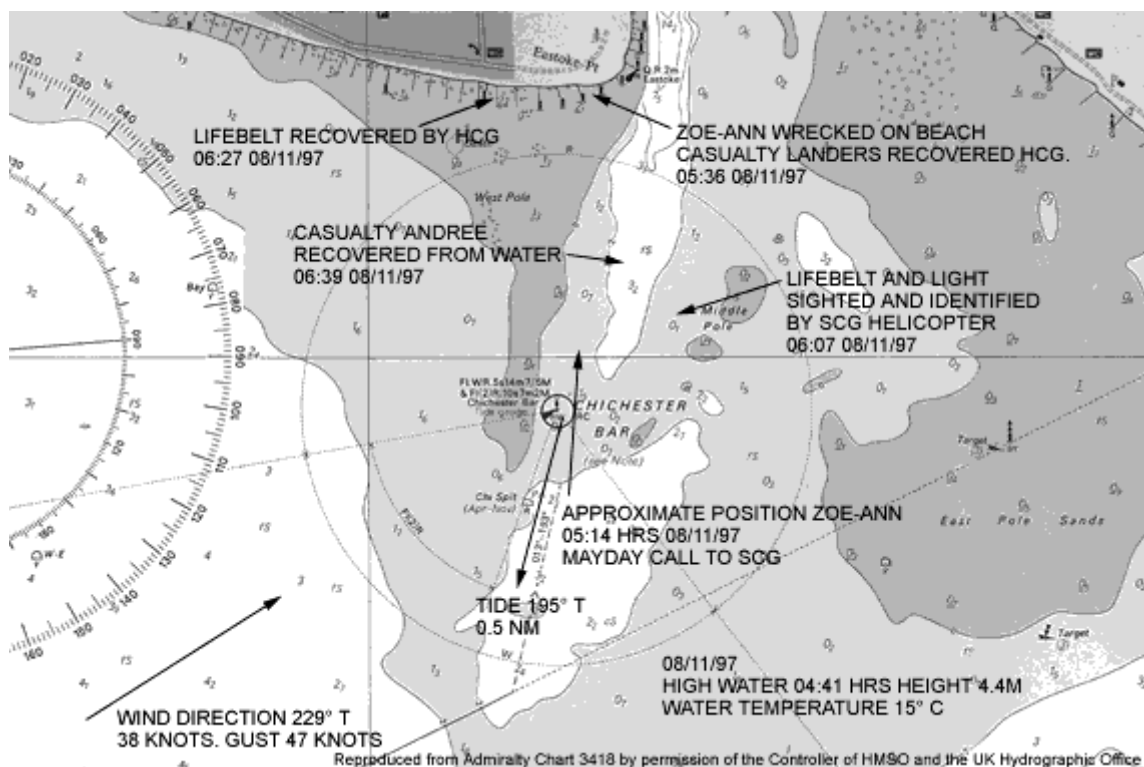
Two to three boat lengths north of Chichester Bar beacon, the boat was struck on the port quarter by a large wave estimated to be 6 metres high. The yacht was knocked down to almost 90°, and the Owner thrown overboard. The Yachtmaster threw a dan-buoy towards him and tried, unsuccessfully, to start the engine. The Owner could not be recovered. A MAYDAY call was made at 0514 and the emergency services were alerted. The yacht ran aground on a groyne at Eastoke Point at the entrance to Chichester Harbour and the Yachtmaster was able to scramble ashore. The Owner's body was found an hour later. He could not be revived.

When the yacht was examined later, five lifejackets and harnesses were found stowed on board.

1. The most significant feature of this incident was the lack of clarity as to who was in charge. Only one person can be the Skipper. He must take full responsibility for the safety of vessel and crew and must have authority over all those on board, regardless of status.
