Marine Accident Investigation Branch (MAIB) - Safety Digest 01/1997

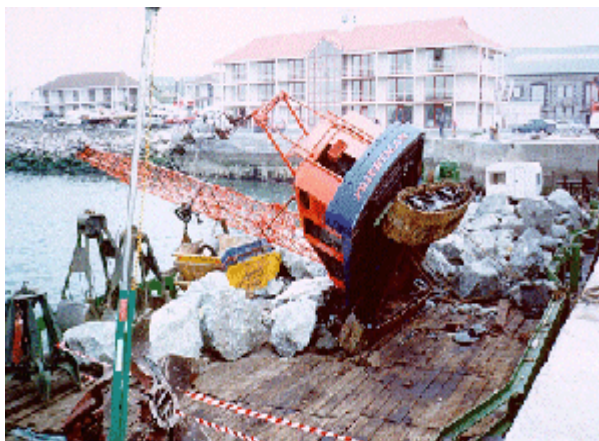
At about this time, the crane driver selected a piece of limestone rock, estimated to weigh between 3.5 and 4.0 tonne. As the rock was lifted and came free, it swung away from the jib, effectively increasing the lift radius and overloading the crane. To counter the overloading and overturning moment, the crane driver started to luff-up or raise the jib. At that moment, the barge moved under the influence of the sea swell rapidly adding to the overturning moment. With the situation becoming critical, the driver tried to drop the rock back on to the deck. Unfortunately the foot brake jammed, preventing him from releasing the load. He considered releasing the brakes by hand but realised that the sudden uncontrolled release would cause the counter weight to pull the jib and grapple rapidly back, leading to possible damage to the driver's cab itself. With the crane now unbalanced and on the verge of toppling, the driver jumped out of the cab. In doing so he broke his left arm. The crane toppled over and ended up with the jib resting over the side, slightly crushing the hand rail.

1. Although the crane was chained down during the transit voyage, it was not chained down whilst working. It was considered that to secure the crane whilst working would not only prevent the operator sensing any degree of unbalance but also restrict his ability to manoeuvre the crane. Auto-indication of overloading is mandatory but rectification lies in the hands of the crane driver.
2. The use of a crawler crane for the cargo operation was brought about by the lack of an alternative loading arrangement during the initial stages of the contract. The incident itself was brought about by a combination of the failure of the crane braking system and the rolling effect of the sea swell.

1. The Merchant Shipping (Hatches and Lifting Plant) Regulations 1988, SI No 1639, require that the employer (and Master, although in this case the barge did not have one) shall ensure that no lifting plant is used unless it has been thoroughly examined by a competent person within the preceding 12 month period. In this case, the employer - the crane driver - was provided with a certificate stating that the crane had been thoroughly inspected in June, some two months earlier.
2. The cause of the brake failure was not immediately apparent but as the mobile crawler crane had been sold with a current examination certificate, the Health and Safety Executive (HSE) were to pursue the matter under their Regulations.
