Marine Accident Investigation Branch (MAIB) - Safety Digest 02/1997

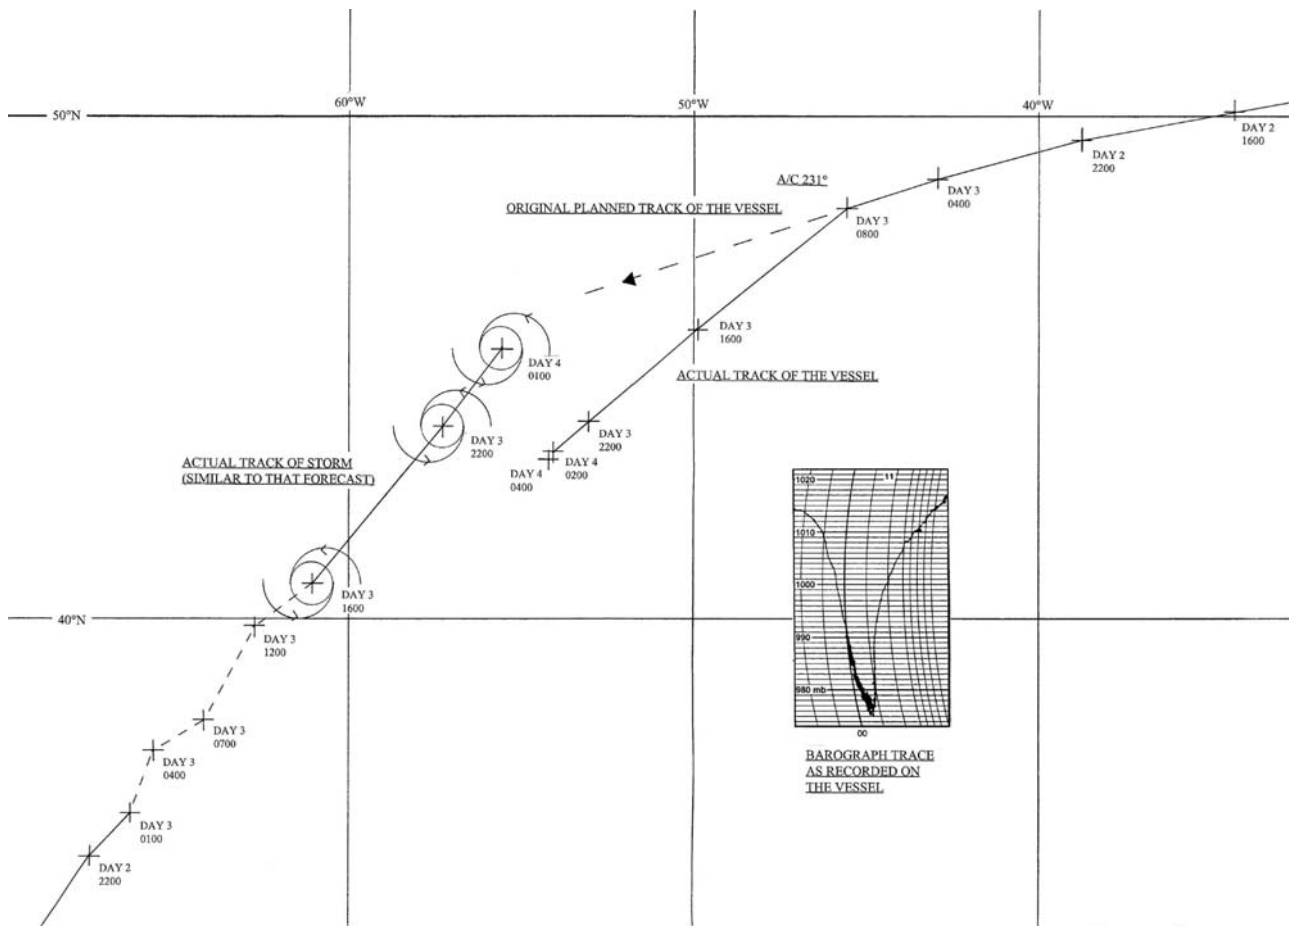
A large passenger ship left a European port in September for an Atlantic crossing. During the passage it became clear that the intended track of the vessel and the predicted track of a hurricane were convergent. Weather forecasts predicted hurricane force winds out to 130 miles and storm force winds out to 275 miles from the storm centre in the south-east quadrant. The hurricane was travelling at about 30 - 35 knots to the north-east. See Figure1.

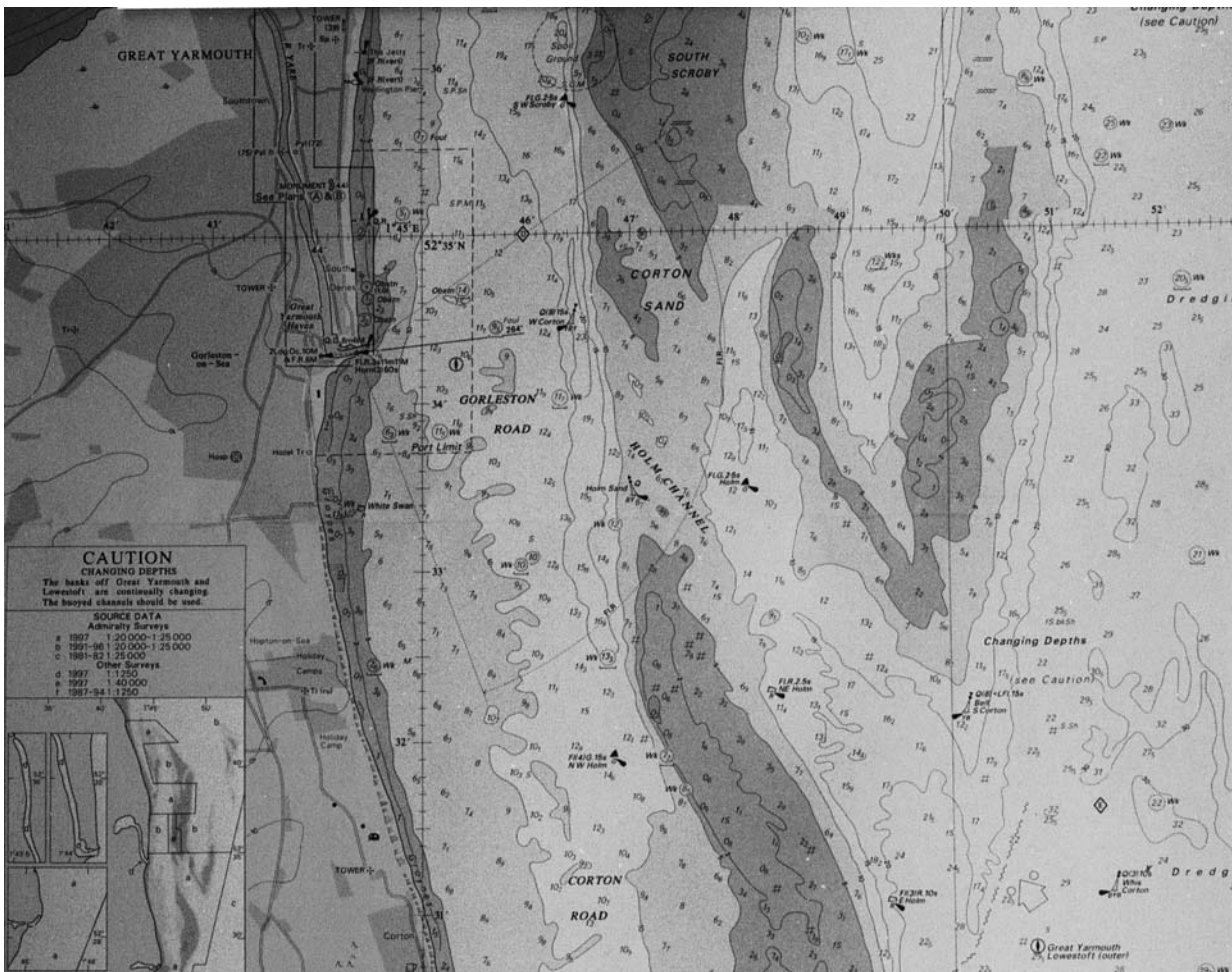
Reproduced from Admiralty Chart 1536 by permission of the Controller of HMSO and the Hydrographic Office.

A general cargo vessel of 1,960 GT loaded with potash was approaching Great Yarmouth from the south-east via Holm Channel (see chart extract). The Master had the con and was the only person on the bridge. The vessel was being steered by auto-pilot. The wind was westerly Force 2 with good visibility and there was a southerly tidal stream of about one knot. The time was about 0530 and it was dark.

Shortly afterwards the Master realised that both the auto-pilot and gyro compass had failed and attempted to prevent the vessel from running aground on Holm Sand by changing over to hand steering and applying full starboard helm. His action was too late to prevent the vessel from grounding. The vessel remained aground for a day but was not seriously damaged.

1. The good seaman knows that when navigating in shoal waters, and especially in a narrow channel, a vessel should be in manual steering with a dedicated helmsman. This Master did not comply and found himself unable to take sufficiently early corrective action when something went wrong. The steering failed, the Master was slow to notice it and the vessel grounded. This accident highlights the real risks arising from one man bridge operation in confined waters. The lesson is to

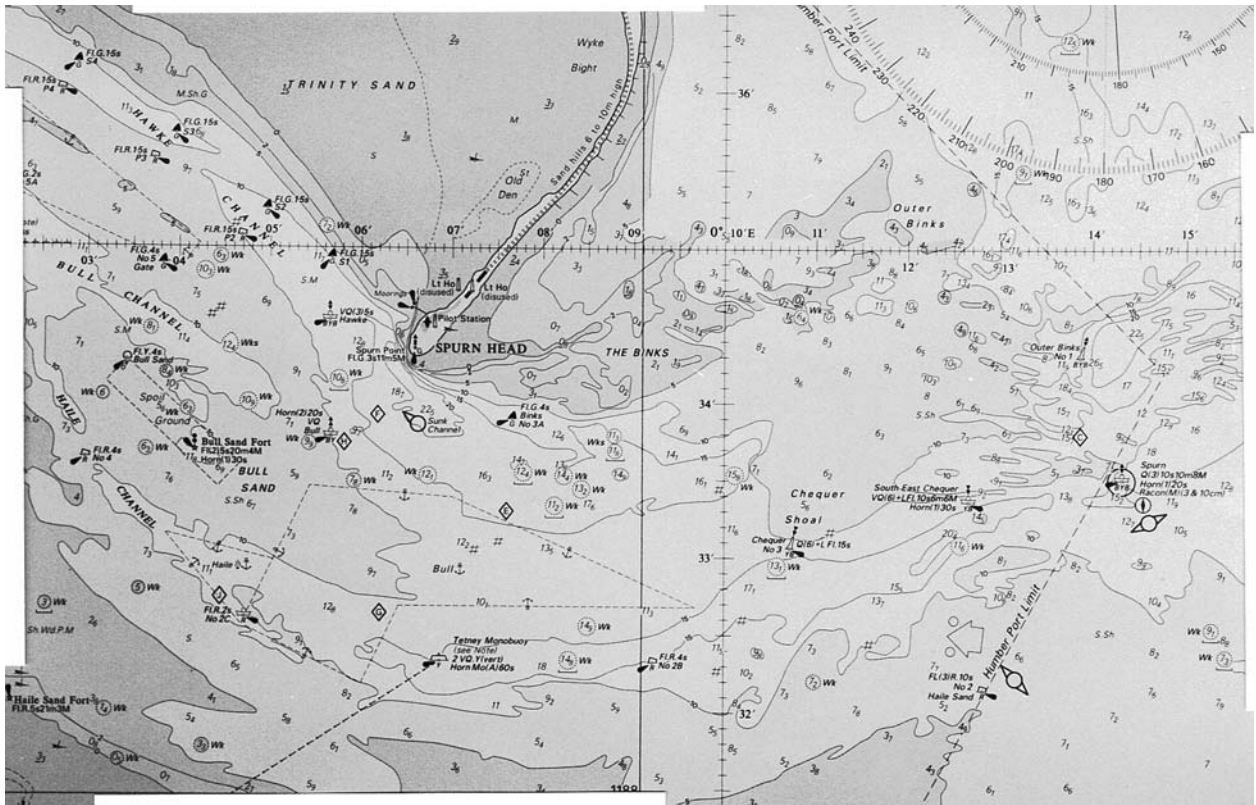
Reproduced from Admiralty Chart 109 by permission of the Controller of HMSO and the Hydrographic Office.

The cargo vessel was slightly to the north and the fishing vessel was slightly to the south of the channel between the north-east extremity of Bull Anchorage and the Chequer Shoal (see chart extract). When the range had closed to one mile, the Master of the cargo vessel noticed the fishing vessel's echo on his radar and assumed that he would pass starboard to starboard. The Skipper of the fishing vessel on the other hand, having also detected the cargo vessel on his radar at short range, altered course to starboard to pass port to port. Despite the poor visibility both vessels were proceeding at their full service speeds.

The two vessels collided. Both vessels were damaged but were able to continue under their own power. There was no pollution and nobody was injured.

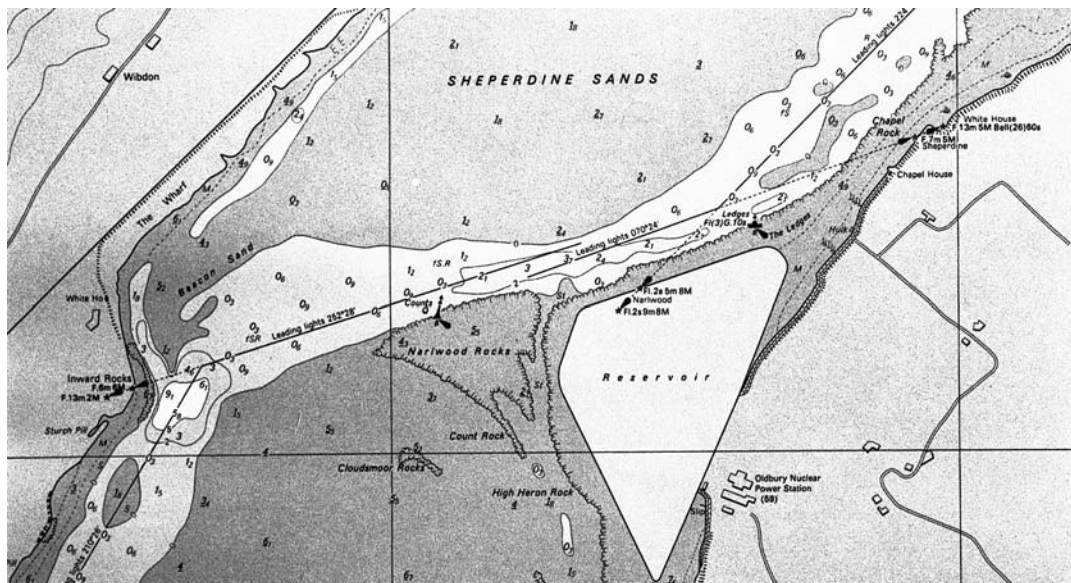
Reproduced from Admiralty Chart 1166 by permission of the Controller of HMSO and the Hydrographical Office.

A UK registered sail training vessel was outbound in the River Severn on passage from Sharpness to Barry at the time of the incident. She was carrying twelve crew and twenty trainees. The weather was favourable with good visibility and the tide was ebbing. A pilot was on board and the vessel was making a speed of about 7 knots under power (the sails had not been set).
