Marine Accident Investigation Branch (MAIB) - Safety Digest 02/1996

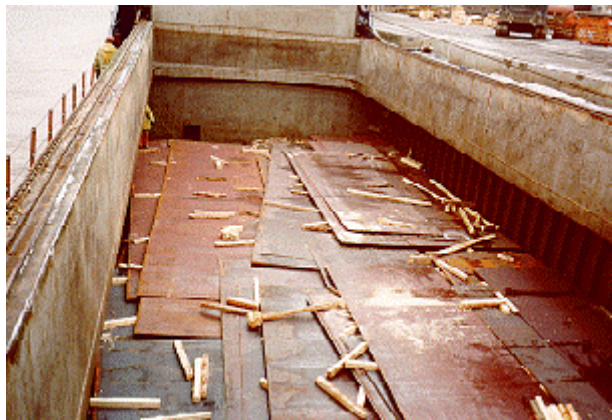
Shift of Inadequately Secured Cargo

1. The steel plate was distributed equally between the two holds and secured with timber wedges/shores.
2. Friction would have been effectively reduced between the steel plates and the dunnage because it is likely that both would have been covered by ice to some extent, given the freezing conditions in which the cargo was loaded.
3. The original loading plan required that the steel plate cargo would be overlaid by steel pilings but this did not occur.

4. Vessels which are carrying steel cargoes can be very stiff and roll violently in a seaway and consequently any weaknesses in securing the stow will be quickly revealed. The fact that the steel pilings were not carried would exacerbate this tendency.

1. Movement of the cargo could have been avoided if it had been securely lashed in place with wire ropes set taut. This was indeed done before the vessel resumed her voyage with the overload of steel pilings.

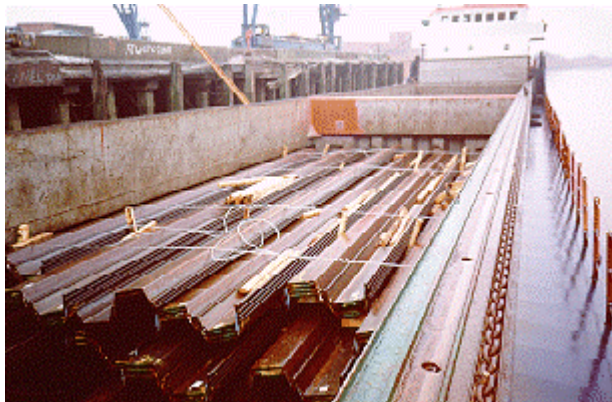
Cargo Securely Lashed in Place

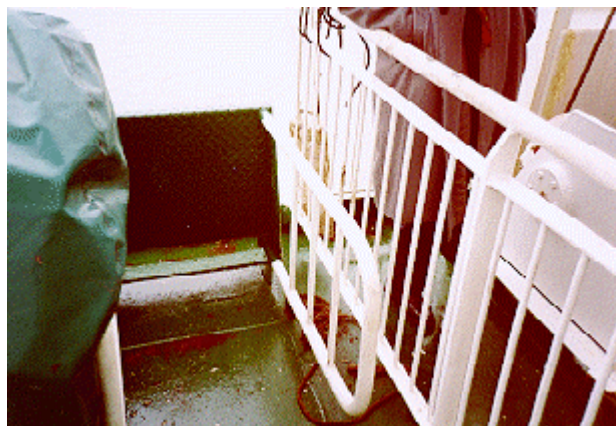
Boarding Bridge in "Closed" Position

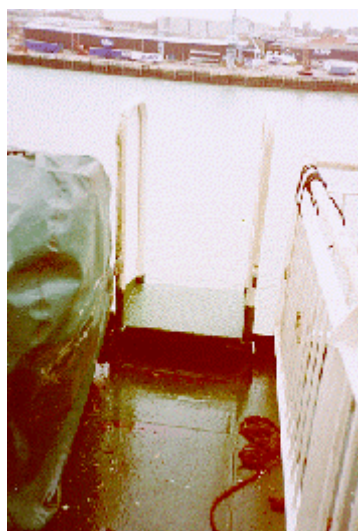
Boarding Bridge in "Open" Position
