Marine Accident Investigation Branch (MAIB) - Safety Digest 2/1995

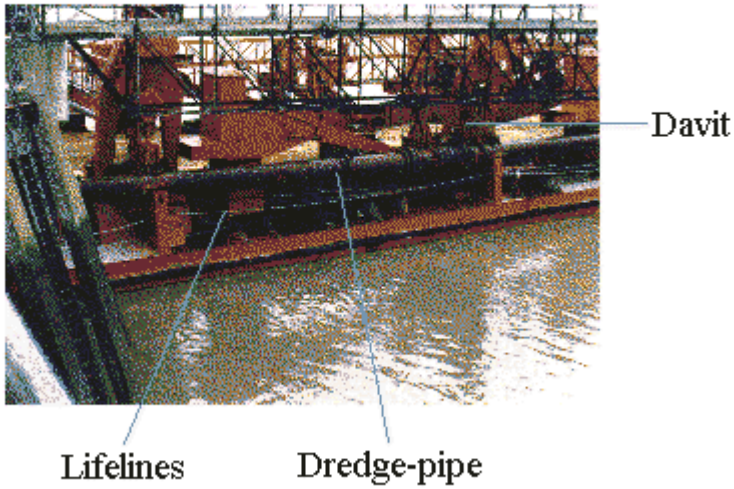
3. When in the loaded condition, the vessel's freeboard in way of the davits was very small with the result that in any kind of seaway, waves were likely to come inboard. Two safety harnesses were carried on board the vessel but neither were in use on the day of the incident.

1. Taking into account the evidence found, there seems no doubt that the Assistant Engineer was lost overboard whilst negotiating his way forward to his place of work. Access was difficult with limited space. Lifelines were in place although slack and the advice contained within the "Code of Safe Working Practices for Merchant Seamen" Chapter 15 regarding safety when working outboard was not heeded.
2. Subsequent to this incident, the company has issued instructions that when emergency work is required on the open deck whilst at sea, two men will work together and both will wear life-jackets and safety harnesses.

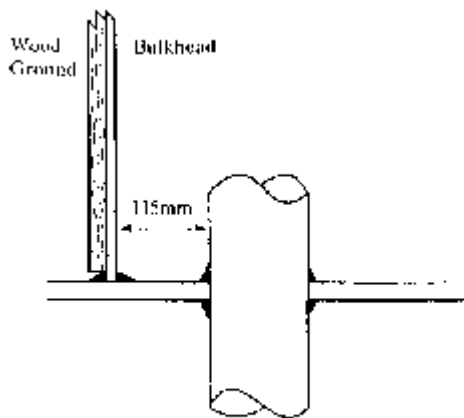
INCORRECT

1. On investigation, the fire was found to have started behind the galley bulkhead amongst the bulkhead groundings. The cause of the fire was the excessive heat generated by high exhaust temperatures being transmitted directly from the engine exhaust pipe to the steel structure via welds. A heat barrier had not been fitted between the exhaust pipe and the support structure. The steel bulkhead onto which the wooden grounds had been secured was about 115 mm from the exhaust pipe.
2. The cause of the high exhaust temperatures was probably due to a restriction round the propeller or propeller shaft. Such a restriction, possibly from fishing gear or a rope, would have caused overloading of the engine and exhaust temperature rises.

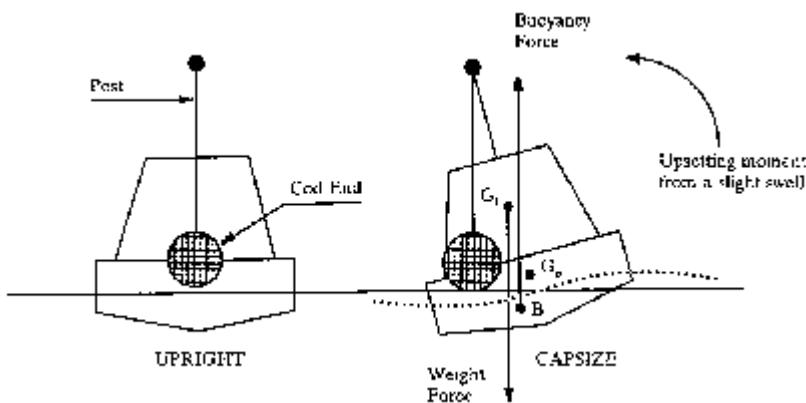
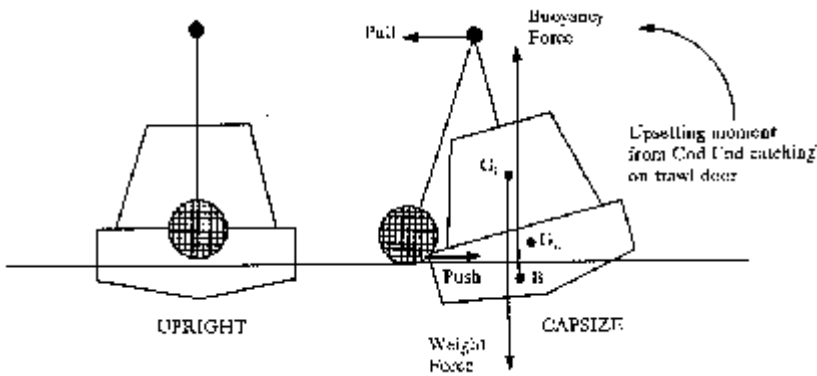
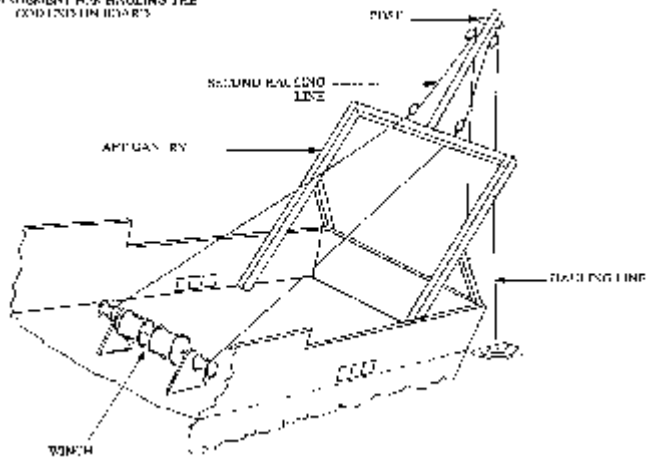
ARRANGEMENT FOR HAULING TEE
CONDITIONS IN BOARD'S

1. As this vessel was under 12 metres in length there was no statutory requirement for its stability to be established. Stability characteristics had never been determined.
2. The primary factor leading to the capsizing and loss of this vessel is almost certainly that the weight of the cod end, when lifted clear of the water, and suspended from the top of the post on the stern gantry, raised the effective centre of gravity to such an extent that the vessel's transverse stability was reduced to near zero.
3. With her stability reduced to near zero a small upsetting moment such as a roll in the slight swell would have been sufficient to cause the vessel to capsize. Alternatively the cod end could have caught on the port side trawl door and acted like a weight on the gunwale of the vessel (see Figure 2).
4. Neither crewman was wearing any form of buoyancy aid. The Skipper was a non-swimmer.

1. This accident could have been avoided if the vessel's stability characteristics had been assessed by a suitably qualified person and advice been given on any operational limitations required.
2. The Department of Transport publishes advice to fishermen regarding the stability of small fishing vessels and on the dangers of suspended loads.
3. Attention is drawn to Merchant Shipping Notice No M.989 "The Safety of Small Fishing Vessels" and the Department of Transport safety leaflet "Fishing is a Dangerous Business. Make it Your Business to Make it Safer".
4. Fishermen who understand the dangers of recovering a cod end heavy with sand will not attempt to lift it clear of the water. Instead they will tow it at speed behind the vessel for some time to wash the sand out of it and reduce its weight before attempting to lift it above the water surface.

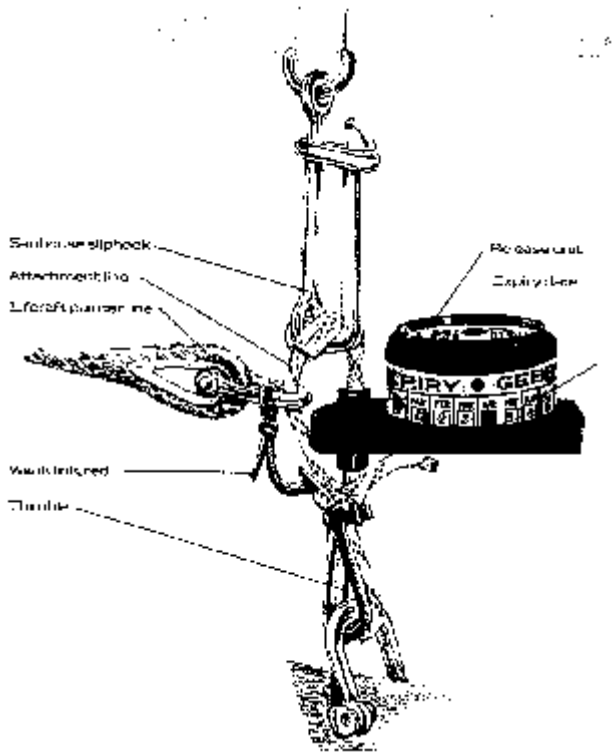
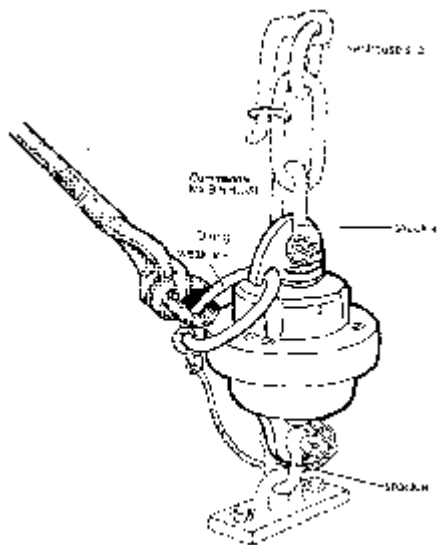
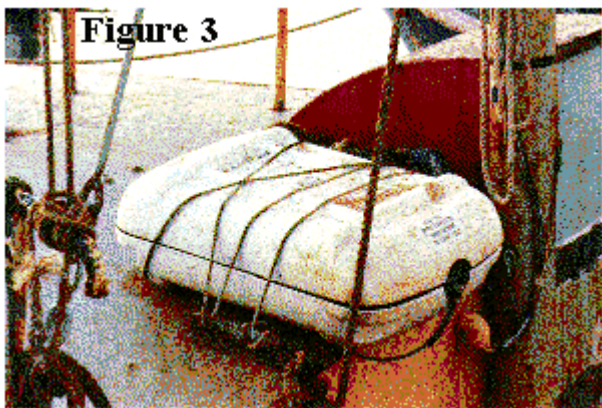
It is clear that incorrect re-installation was the most probable cause of the liferaft's failure to float free. This was an error of a type which is worryingly common. At the time of the relevant mandatory survey a vessel's life-saving equipment will be closely inspected. However, liferafts, and probably their hydrostatic release units, are likely to require overhaul or renewal before the next survey is performed. It is generally after these servicing periods that the errors of incorrect installation are likely to be made. It is thus vitally important that Masters, Skippers and Owners ensure that liferafts are correctly installed so that the equipment will operate as the manufacturer intended.

Two commonly encountered hydrostatic release units are shown in Figures 1, 2 and 3. These arrangements show a weak link to which the liferaft's painter should be attached. It must be remembered that these weak links are carefully designed components, which are intended to break under a load which is sufficient to cause the liferaft to inflate, yet not so large as to cause damage to the liferaft or prevent it floating to the surface.

Advice on the stowage of liferafts is contained in Merchant Shipping Notice No M.1400.

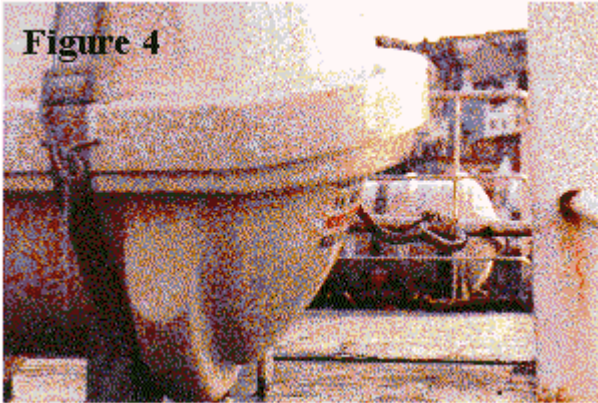
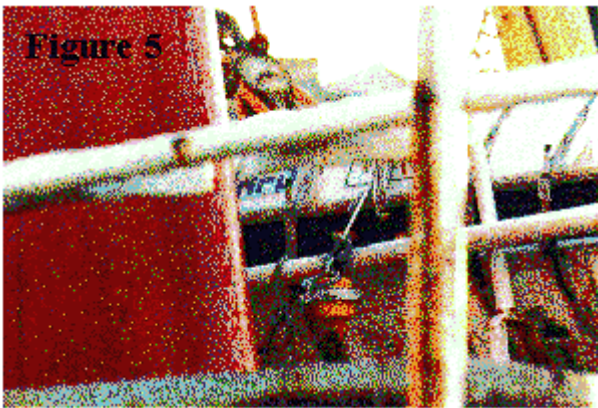
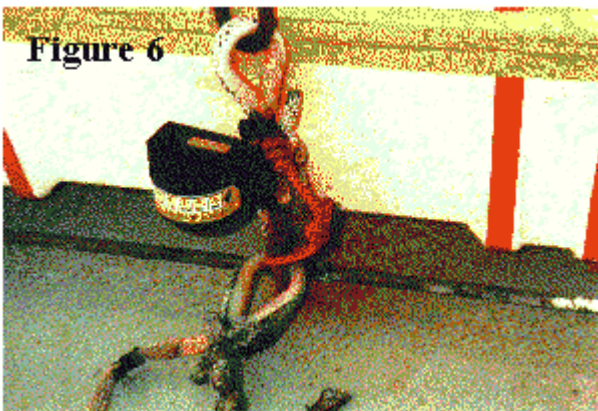
An independent sighting of 23 inflatable liferaft containers, on various types of small vessels, revealed that only two containers were correctly installed. Some of the more common errors of installation are shown in Figures 4, 5 and 6.
