Marine Accident Investigation Branch (MAIB) - Safety Digest - Fishing 2002

Contents

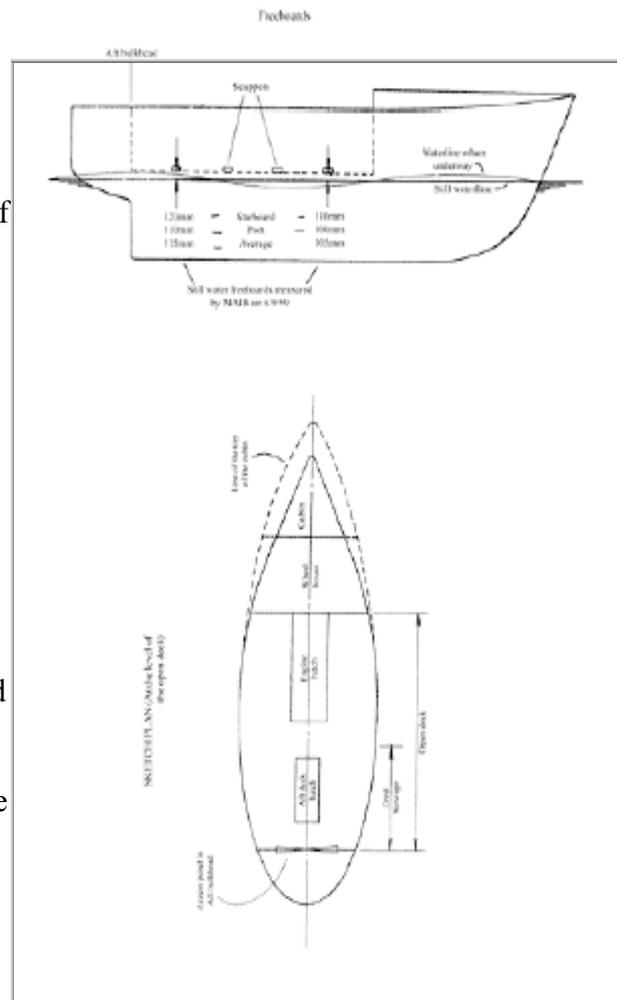
Donna M's freeboard was very low at the aft end. Her skipper assumed the previous owner had carried a similar load of 50 pots, and that the low freeboard was normal. He was unaware that by carrying this many pots he had reduced the freeboard to an unsafe level.

This floodwater then built up to such an extent that it penetrated the wiring to the electric bilge pump. The wiring was in poor condition, and the effect was that it disabled the bilge pump.

It is possible the crew were unaware that the pump was disabled to start with and, when they switched it on, might have assumed there was no water in the bilges. They must have realised something was wrong eventually because they tried to rig the deck wash pump to pump out the bilges. Before this could be achieved, however, sufficient water had flooded into the vessel and *Donna M* capsized.

The two-man father and son crew were both lost; neither was wearing a lifejacket.

1. Skippers should ensure that their vessels have adequate freeboard when loaded. There are no statutory requirements regarding freeboard for fishing vessels under 12m, but the formula in the Workboat Code published by the MCA is a good guide.
2. A relatively high percentage of accidents occur in vessels that have just changed owners. New owners or skippers should, so far as possible, do their best to establish how the previous users operated the vessel, paying particular regard to stability considerations and weights embarked.
3. Lifejackets should be worn. Comfortable self-inflating lifejackets, suitable for constant use, are readily available. Further guidance is shown in MGN 155(F), provided free by the MCA.
4. Bilge pumping systems should be regularly inspected to ensure they are reliable. Further guidance is shown in MGN 49(F), provided free by the MCA.

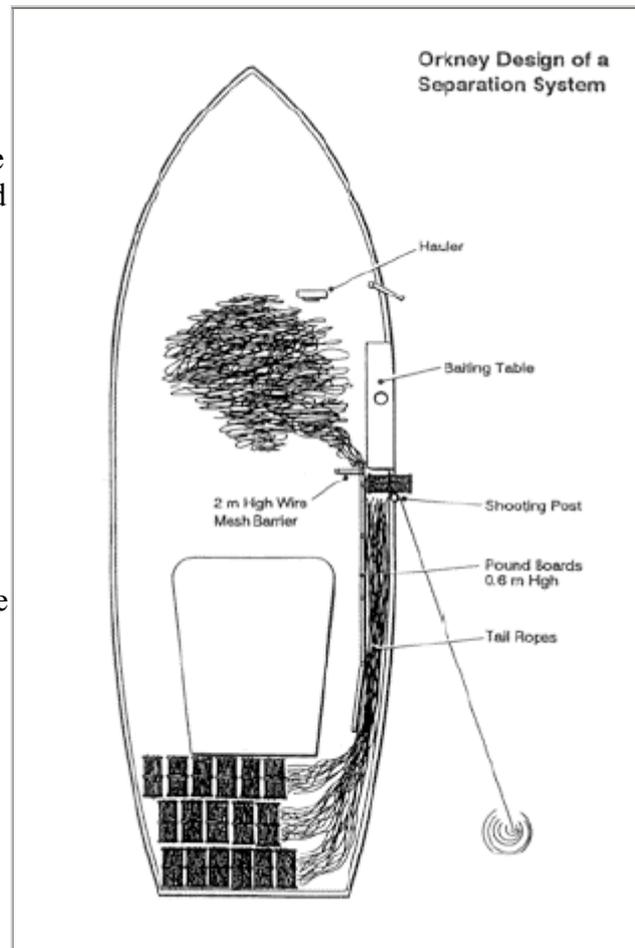
The 11.19m potting vessel *Dunan Star* was shooting for dog whelks 1.5 miles southwest of the Isle of Arran, when one of the two people on board became entangled in the back rope of a fleet of pots and was dragged over the side. He was not wearing a lifejacket.

Once again the skipper heaved on the hauler until the crewman reappeared, but by now the boat had drifted through the effects of the wind and tide and the victim was being pulled away from the boat. He also had some of the back rope around his chest and arms. The skipper, who could not reach the bight of rope around the crewman's leg, cut some of the rope around his chest in an effort to relieve the strain on his upper body. Having done so, however, the skipper was left holding the rope that led to the hauler. The deckhand was dragged underwater once again. He was not seen alive again.

The skipper contacted the coastguard immediately. A helicopter and lifeboat were tasked, and a short time later, with the help of the lifeboat crew the body of the deckhand was recovered. He was still entangled in the fleet of pots.

1. This is a horrific situation that no fisherman would ever wish to be in. The majority of potting vessel crews are well aware of the hazards involved when shooting pots, and take care to avoid them. Too often, however, accidents happen. By far the most common occurs when shooting pots, and involves somebody getting caught in a bight of back rope. Pay particular attention to keeping your feet out of the bights of back rope.

3. There is no means of telling whether a lifejacket would have helped save a life in this situation. What can be said with confidence is that his chances of survival, however slim, would have increased had he been wearing one. Always wear a working-type lifejacket when on deck. You never know when you might depend on it.

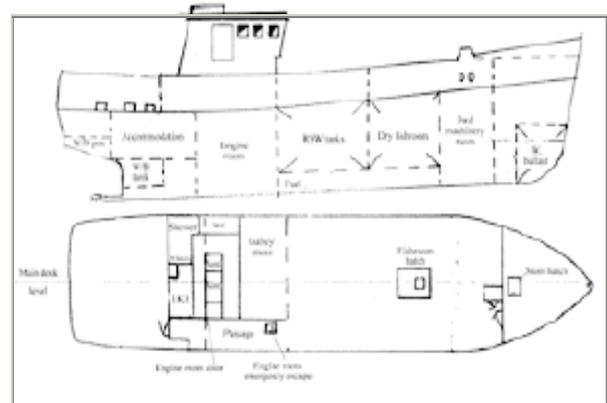
One crewman was ashore, the skipper was resting and the engineer was, among other things, pumping out the engine room bilges using a portable petrol-driven pump within the engine room. Its engine exhausted directly into it. Hoses on the pump led into the bilge for suction, and up through the engine room emergency escape hatch, for discharge. This pump was being used because the vessel's own power-driven bilge pumps were defective.

The pump had been running for well over an hour, without ventilation fans or any other machinery running, when the crewman returned from ashore. He went looking for the engineer 20 minutes later, and found him in the engine room, unconscious and slumped over the portable pump which was still running.

The engineer was found to have been poisoned by carbon monoxide.

1. Portable pumps may be very useful; particularly in an emergency. This is shown by the number of incidents where these pumps are supplied by the coastguard to vessels having flooding problems. However, they should always be used with their engine exhausting into a well-ventilated area.
2. Petrol gives off highly flammable fumes that are heavier than air. Therefore, using a petrol engine within an engine room runs the risk of explosive fumes accumulating in the bilges; particularly if ventilation is poor.
3. Carbon monoxide gas can be produced by any system which burns a fuel such as petrol or diesel. As it has no smell, it is a notoriously difficult gas to detect without instrumentation, and yet it is extremely poisonous. In this incident, even trained fire officers were unable to detect the presence of the gas without a meter.

4. Portable engine-driven pumps must be seen as for use in emergency conditions only. They should not be seen as a replacement for the vessel's own power pumps.
