Marine Accident Investigation Branch (MAIB) - Safety Digest - Fishing 2000

This *Safety Digest* draws the attention of the fishing community to some of the lessons arising from investigations into recent accidents. It contains facts which have been determined up to the time of issue.

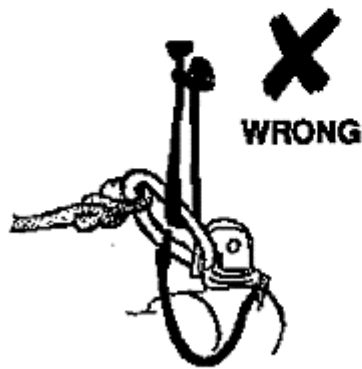
EXAMPLES OF INCORRECT METHODS OF CONNECTION

LIFERAFT WILL NOT RELEASE FROM CRADLE IF THE SHIP SINKS

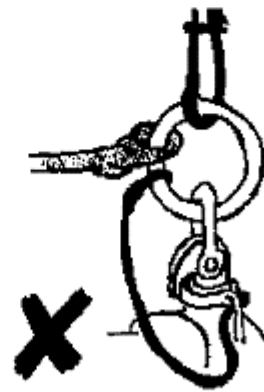
LIFERAFT WILL NOT RELEASE FROM CRADLE IF THE SHIP SINKS

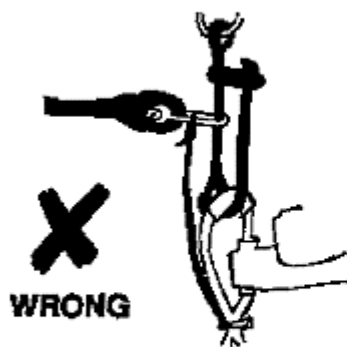
EXAMPLES OF INCORRECT METHODS OF CONNECTION

LIFERAFT WILL NOT RELEASE FROM CRADLE IF SHIP SINKS

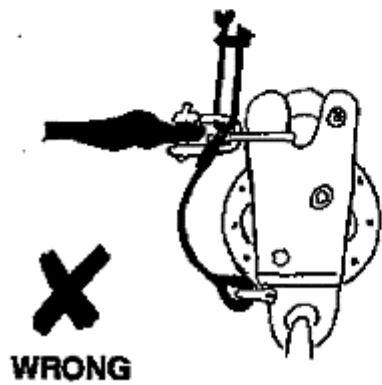
EXAMPLES OF INCORRECT METHODS OF CONNECTION

LIFERAFT WILL NOT RELEASE FROM CRADLE IF SHIP SINKS
