Marine Accident Investigation Branch (MAIB) - Safety Digest - Fishing 2000

This *Safety Digest* draws the attention of the fishing community to some of the lessons arising from investigations into recent accidents. It contains facts which have been determined up to the time of issue.

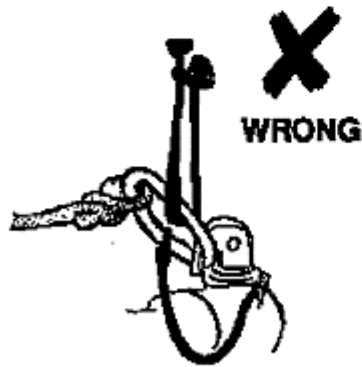
LIFERAFT WILL NOT RELEASE FROM CRADLE IF THE SHIP SINKS

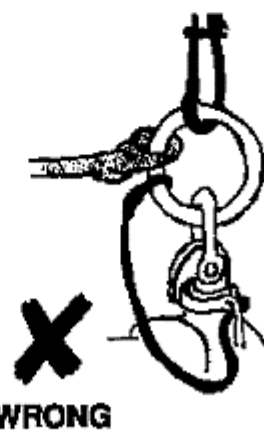
LIFERAFT WILL NOT RELEASE FROM CRADLE IF THE SHIP SINKS

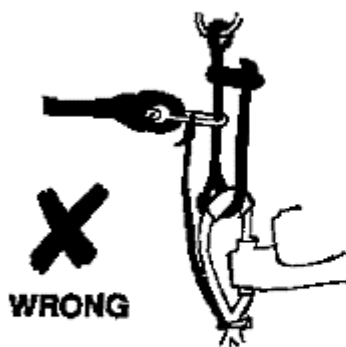
LIFERAFT WILL NOT RELEASE FROM CRADLE IF SHIP SINKS

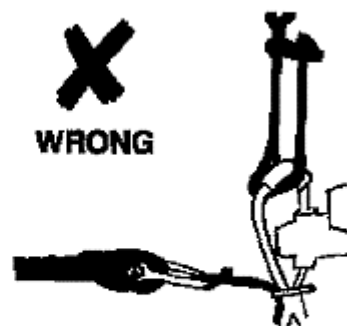
WILL WORK CORRECTLY ON AUTOMATIC RELEASE BUT THE LIFERAFT WILL ONLY BE SECURED BY THE WEAK LINK IF THROWN OVERBOARD - WEAK LINK MAY BREAK AND LIFERAFT WILL BE LOST

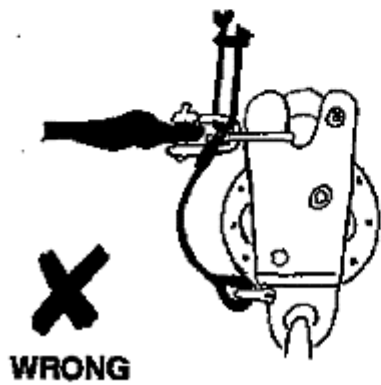
LIFERAFT WILL NOT RELEASE FROM CRADLE IF SHIP SINKS

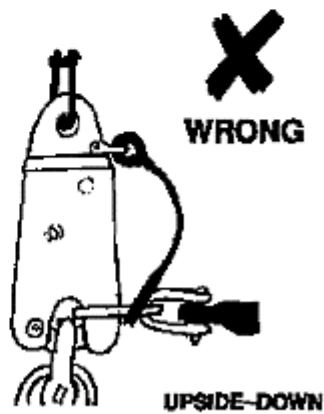
MAY FOUL WHEN AUTOMATICALLY RELEASED

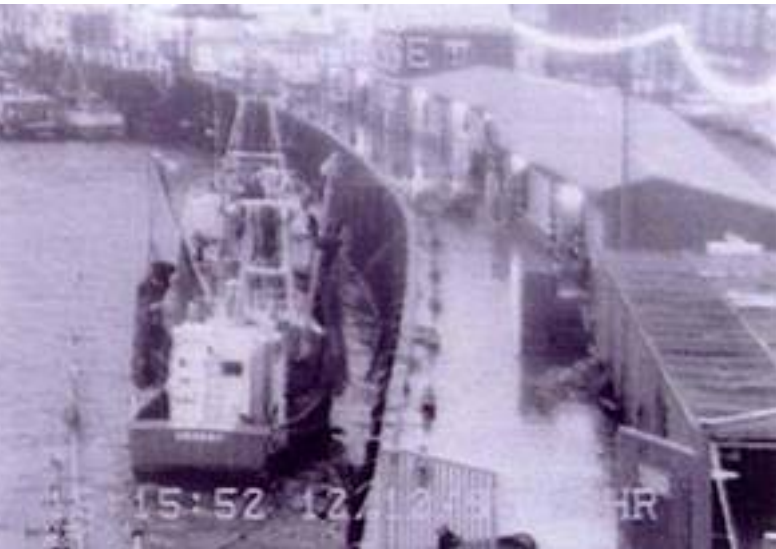
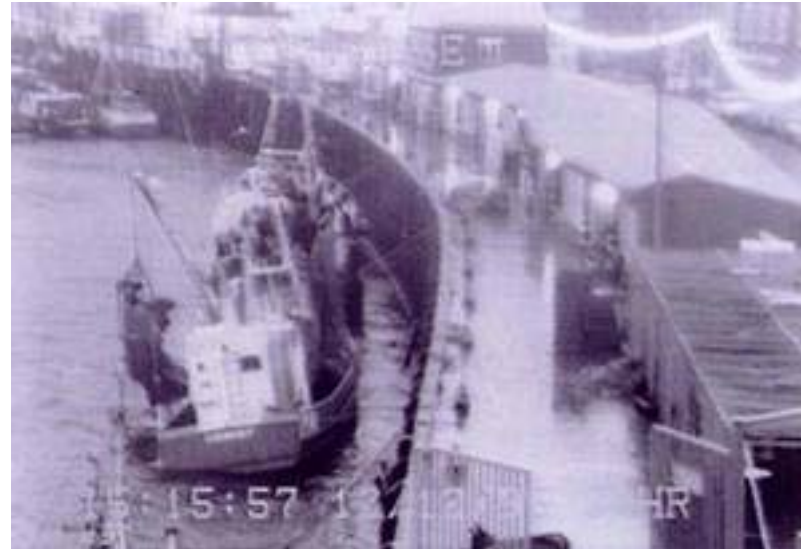
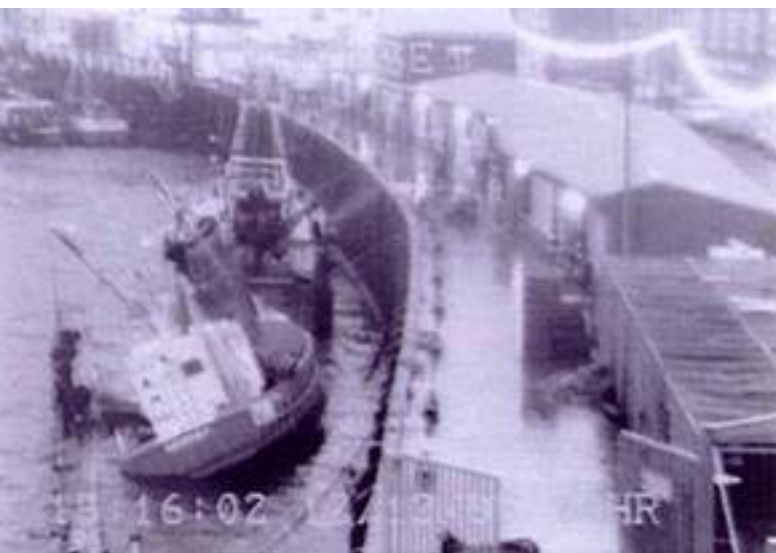
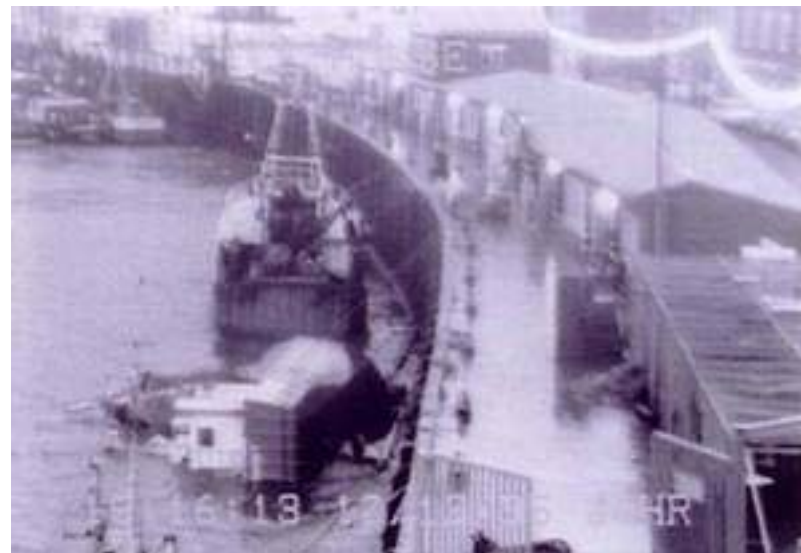
A newly built steel beam trawler, 11.98m long had had her stability calculated after she was launched, but before significant items of top weight were added. In port one day, the crew were changing the cod ends on her trawl gear. The vessel was lying starboard side to a dock wall, with the trawl gear on that side suspended from the top of the almost vertical derrick. (See photographs).

The skipper began hauling the port beam gear, using the port derrick, which was slightly lower than the starboard derrick. As the chain mat cleared the port bulwark rail the vessel heeled suddenly to port and capsized. All three of the crew managed to scramble to safety. None were seriously injured. The vessel was later recovered and her stability assessed and found to be significantly less than the minimum standard recommended by the MCA for less than 12m fishing vessels.
