MARINE ACCIDENT INVESTIGATION BRANCH

TIMBER DECK CARGO STUDY

Safety Study No 1/2003
August 2003

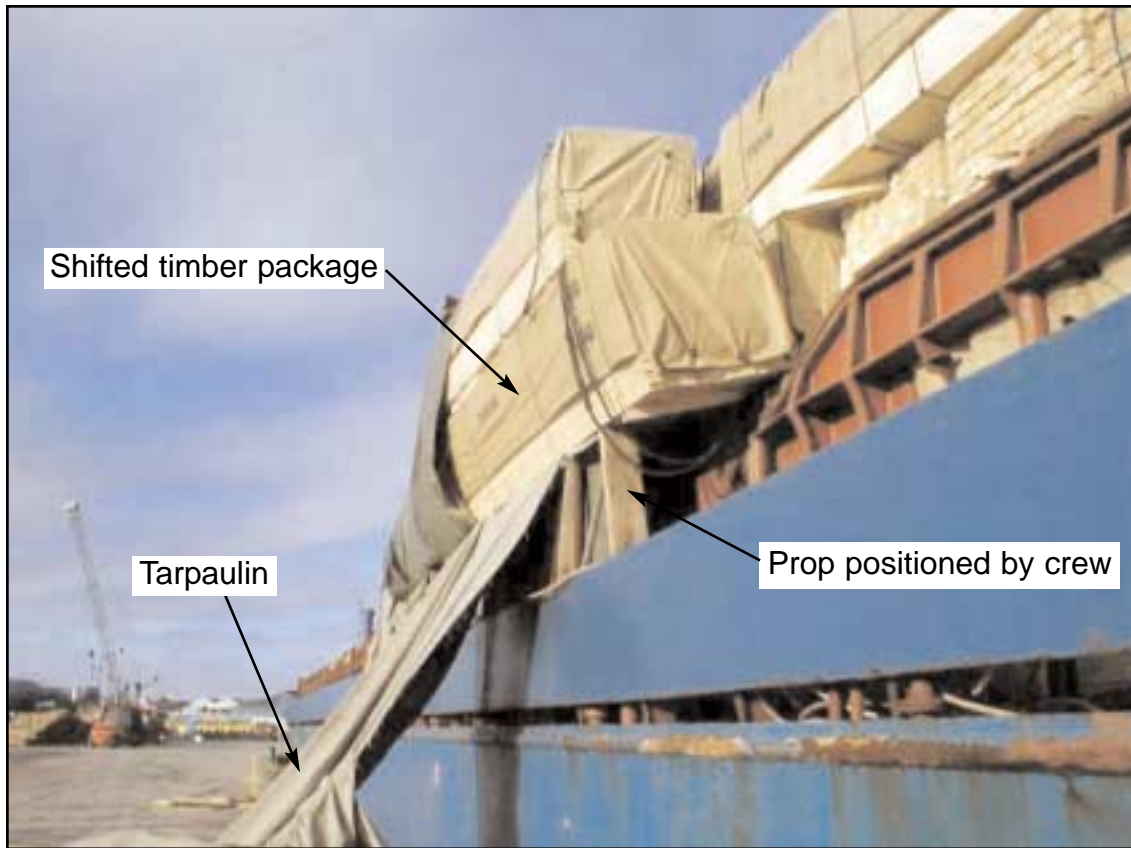
Figure 1

Looking forward on port side

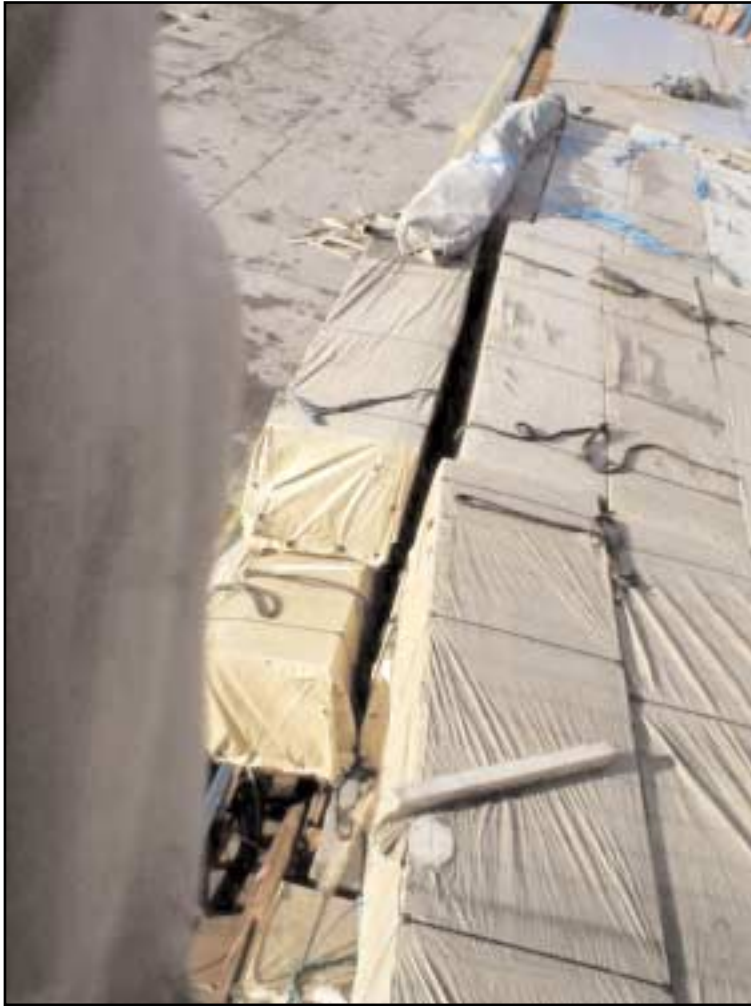
Figure 3

The vessel eventually reached a Scottish port and berthed port side to (**Figure 2**). In the early hours of the morning, the crew began preparing the cargo for unloading. All the lashings had been removed (**Figure 3**) and, while the tarpaulins were being taken off, a section of cargo at the aft end on the port side collapsed (**Figure 4**). While rolling up a tarpaulin at this position, a crew member fell over the side, along with the planks from the broken packages. He hit his head on the dockside, before falling into the water.

Looking onto deck cargo from wheelhouse

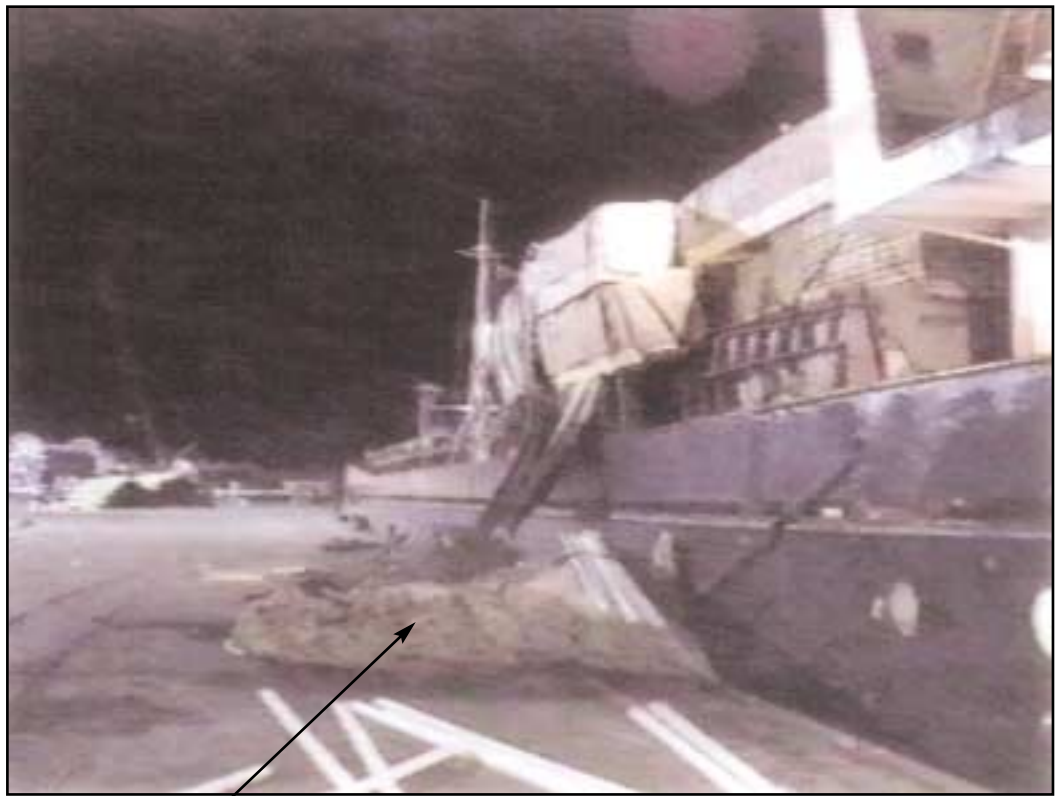
Figure 4

The packages of timber each consisted of a bundle of planks on square section timber bearers. Steel bands ran around the planks and the bearers to hold each of the packages together (**Figure 5**). The packages collapsed when the steel bands broke.

Collapsed timber packages

1. The friction between a timber deck cargo should be maximised, and steel-on-steel interfaces should be avoided if possible. A vessel's crew should always take a close interest in the loading of deck cargo, and should ensure that it is carried out satisfactorily. In this case, dunnage should have been positioned under the packages to create a higher friction wood-on-steel interface with plenty of contact area.

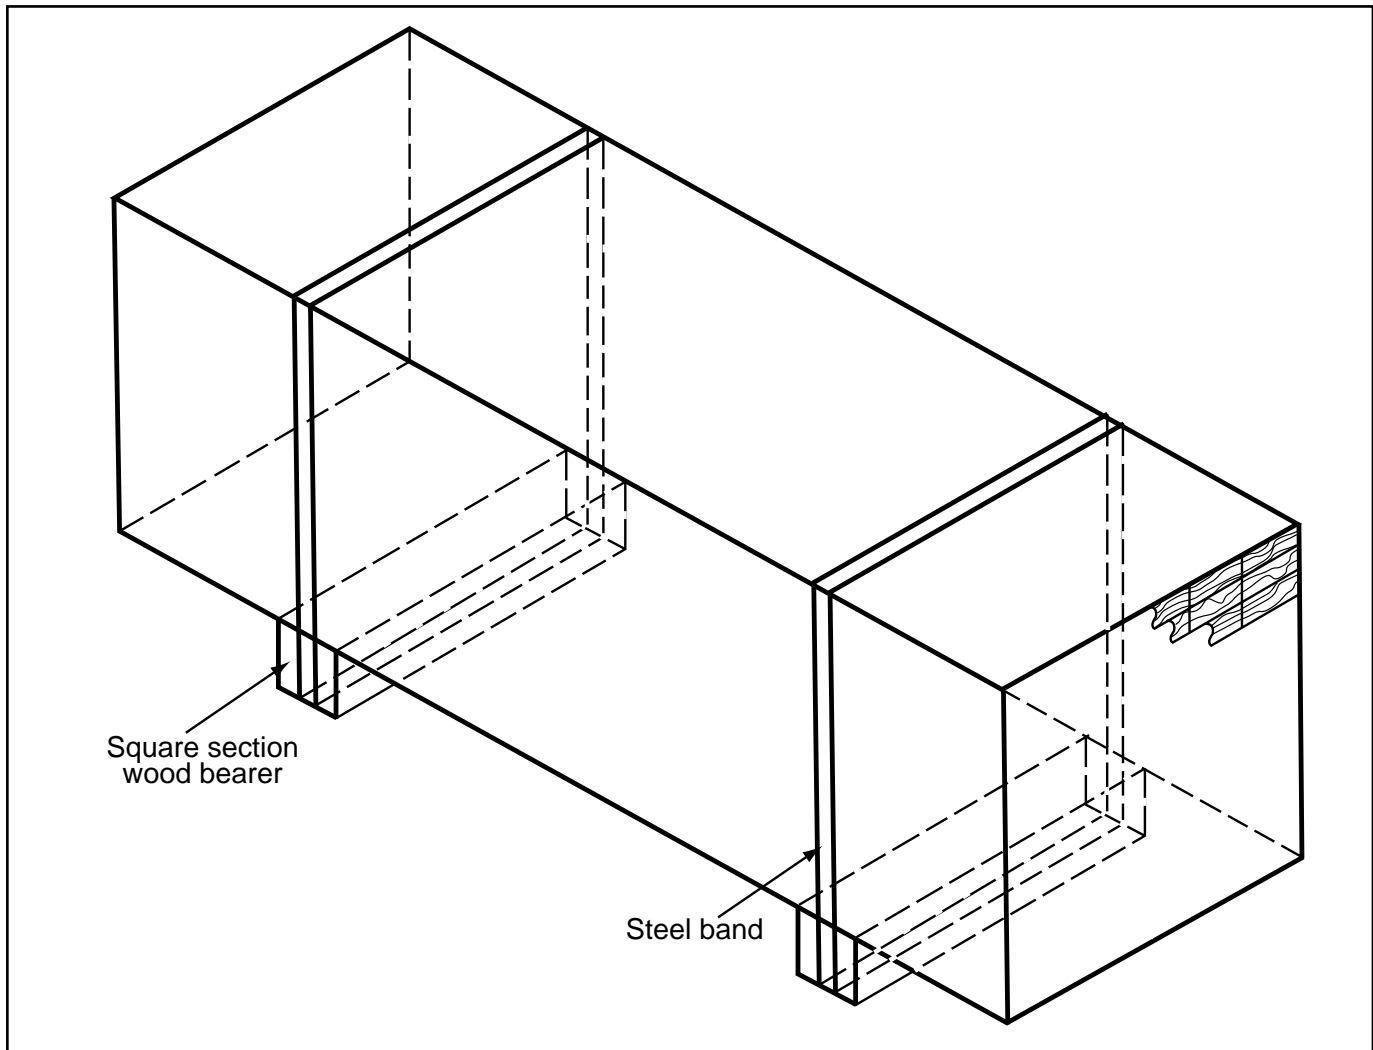
No dunnage was placed under the packages, so the weight was taken on the steel bands underneath the bearers. The poor friction between the deck cargo and the top of the hatch covers was a factor in this accident. There is very little friction between steel surfaces especially when wet.

Timber package

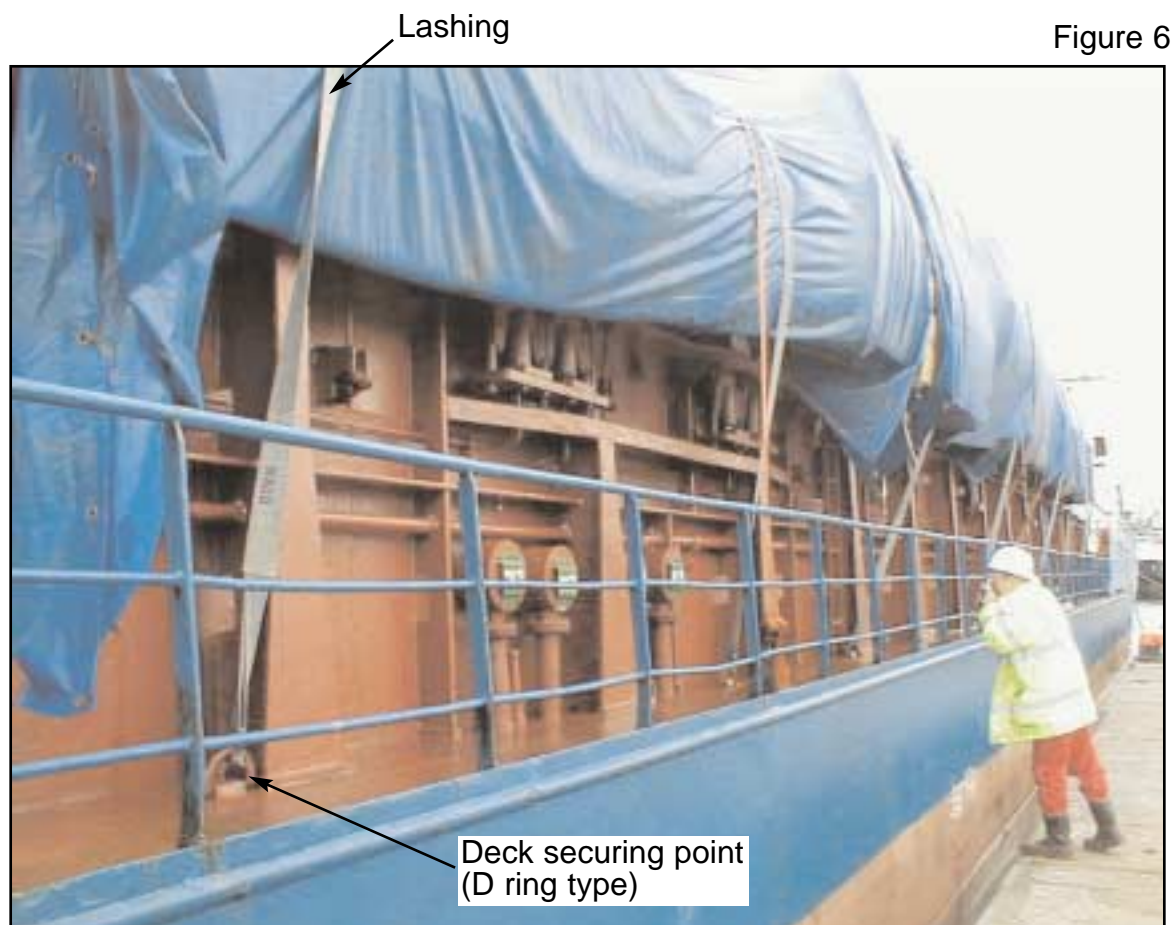
Looking aft on port side

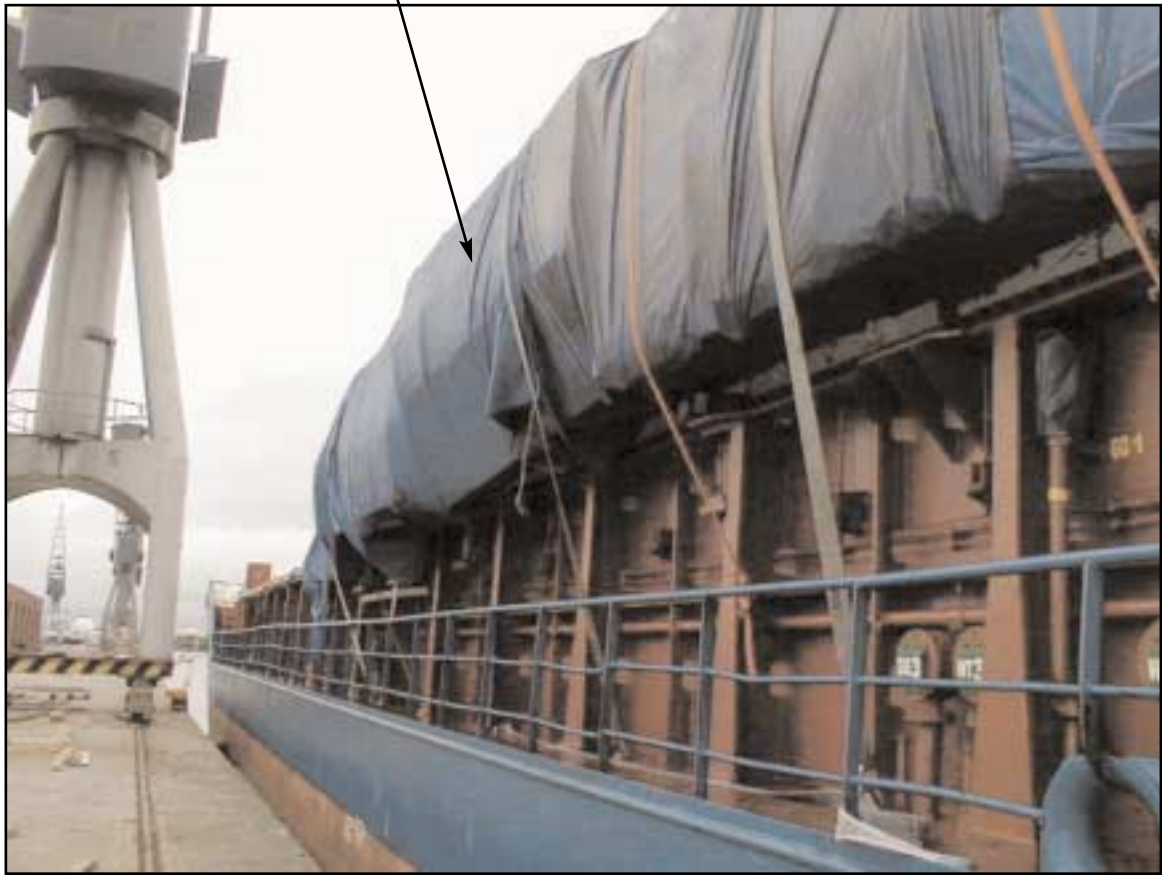
Figure 7

While on passage across the North Sea, heavy weather was encountered. A large wave struck the vessel's starboard side. This shifted the deck cargo and resulted in a port list of about 10°. The timber packages shifted such that they were overhanging the hatch cover on the port side (**Figure 7**) and were set in on the starboard side (**Figure 8**).

Deck cargo overhanging hatch cover on port side

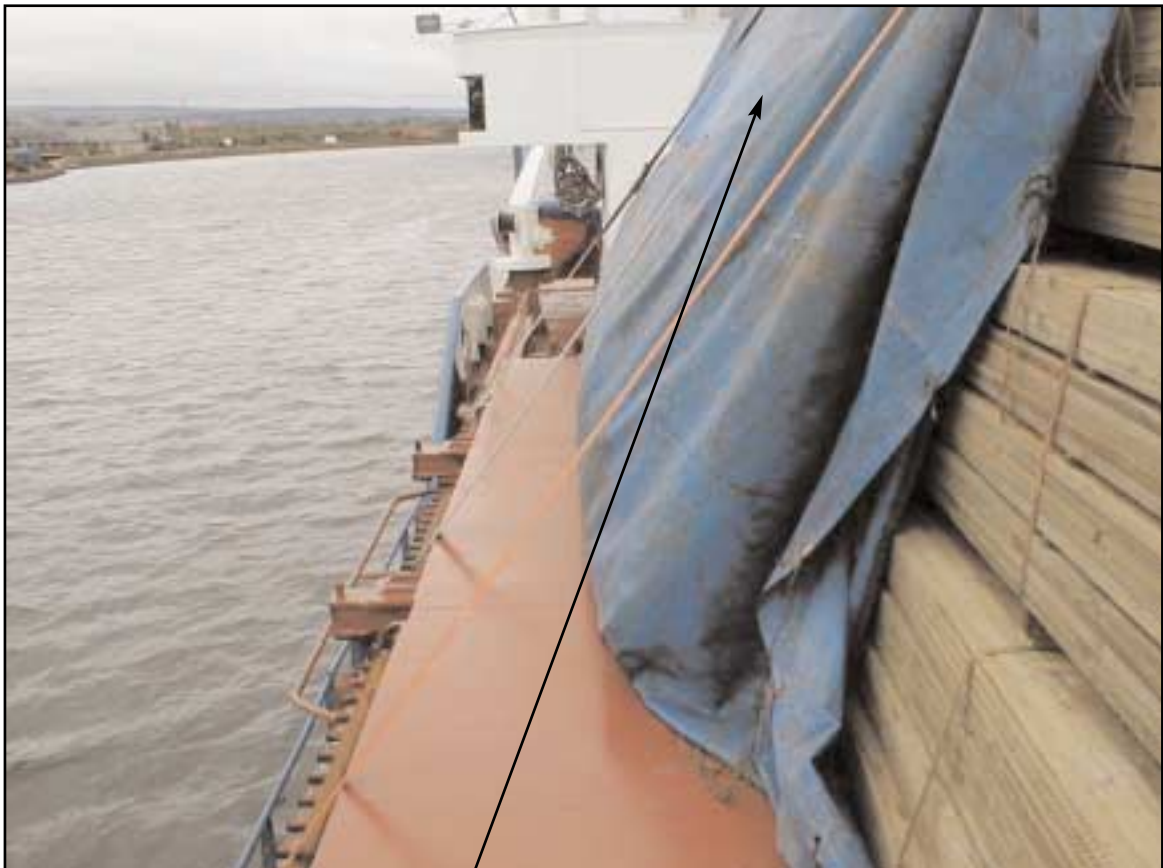
Figure 8

Cargo set in from hatch cover edge on starboard side

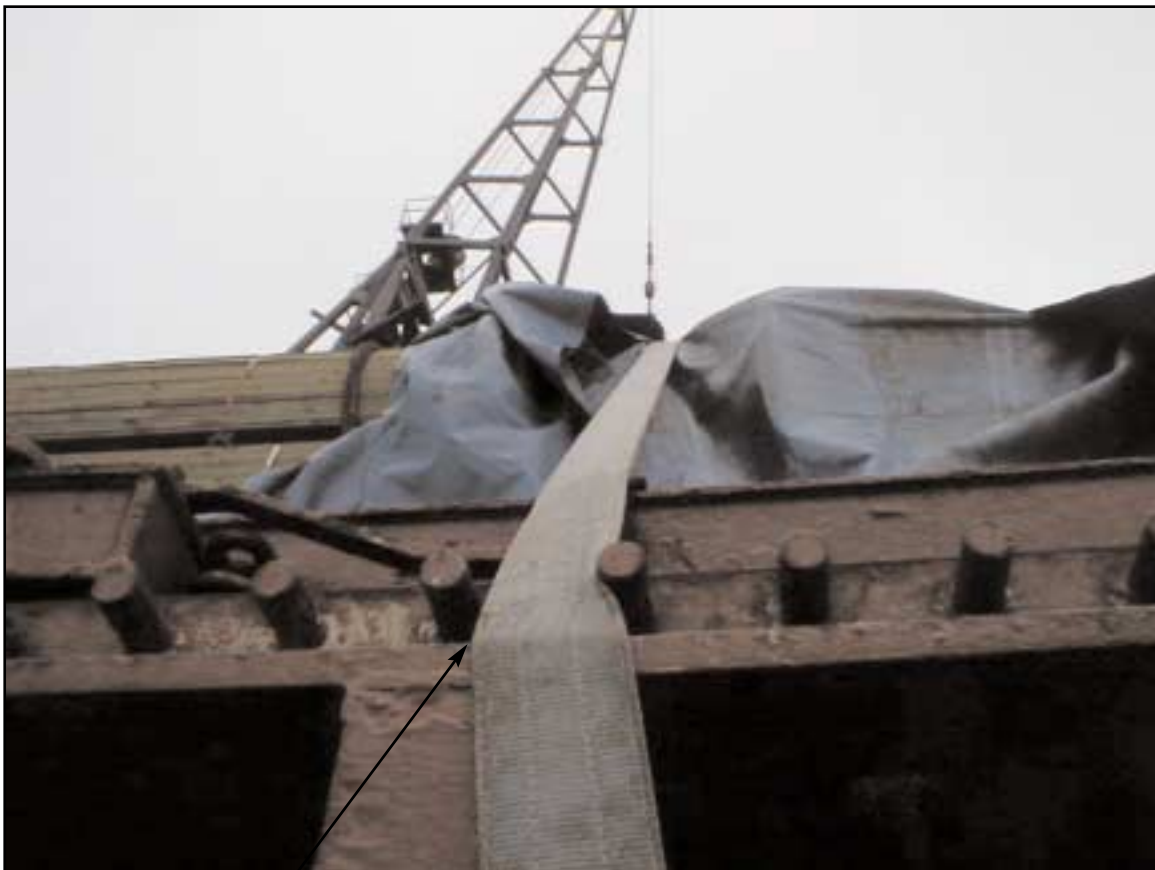
Figure 9

None of the deck cargo was lost overboard. After the cargo shift, the lashings were under greater tension and were rubbing against the relatively sharp edge of the hatch cover (**Figure 9**). As a result, by the time the vessel arrived in port, some of the lashings had parted (**Figure 10**).

Lashing bent over a relatively sharp hatch cover edge

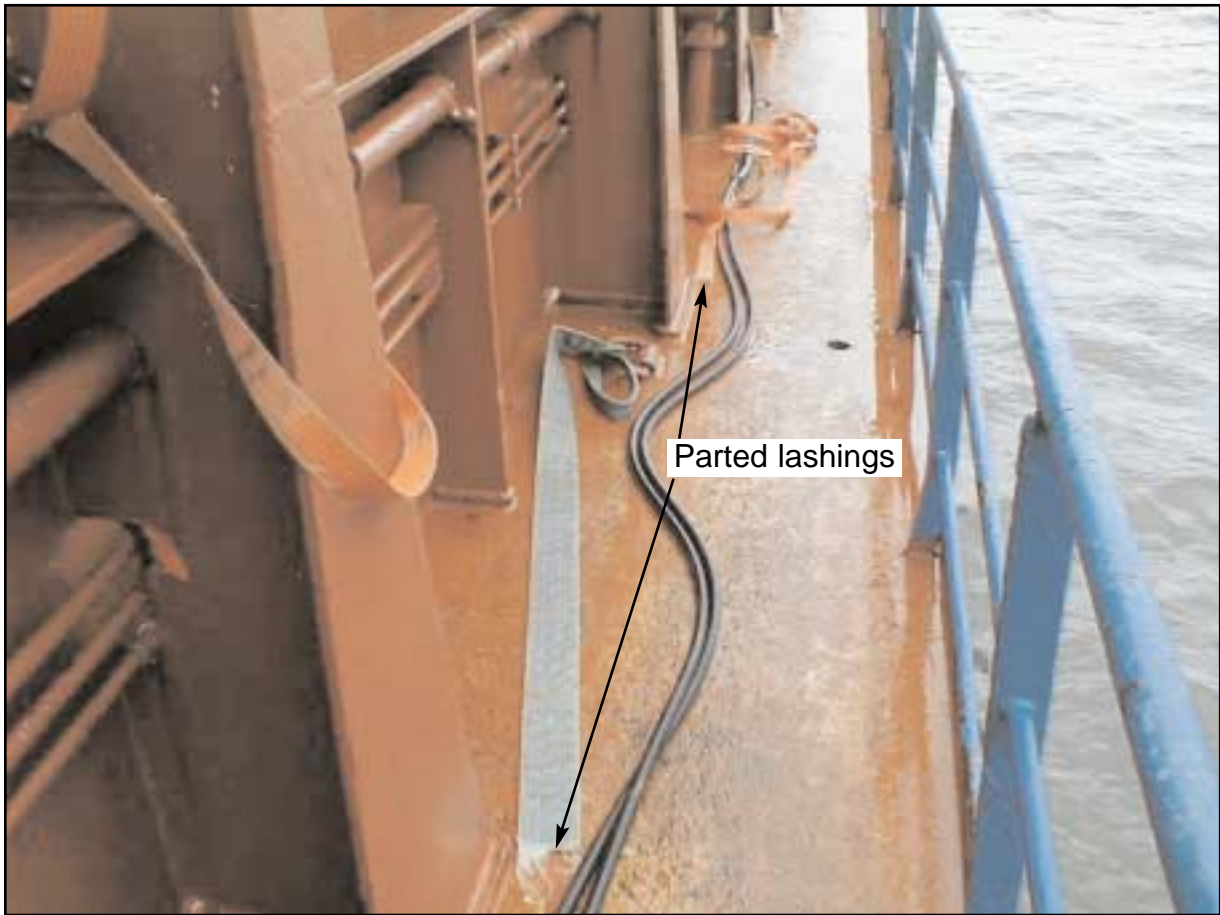
Figure 10

Flimsy lashing

- 3. Some vessels carry timber deck cargoes only rarely. These vessels should still carry adequate equipment and information. The lashings provided should be properly certificated, and the cargo securing manual should contain specific information for the vessel, so that the master is armed with the best advice to carry the cargo safely. Such advice should include the number of lashings which should be used, and the method of restricting sideways movement.**

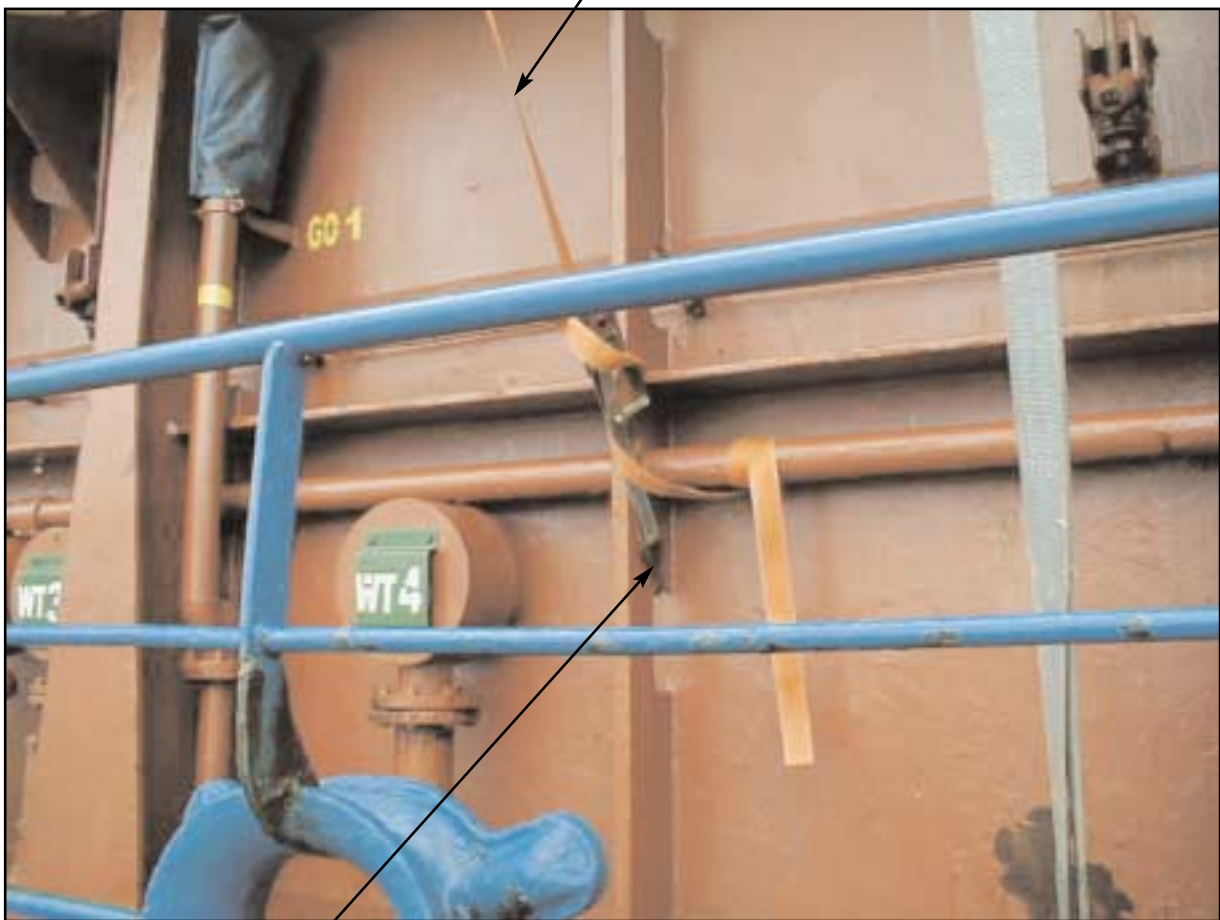
Figure 11

The vessel's cargo securing manual included a section on timber deck cargoes, which consisted of a copy of the IMO Code of Safe Practice for Ships Carrying Timber Deck Cargoes, 1991. There was no specific information for this vessel regarding carrying timber on the hatch cover. The lashings used were not certificated, as required by the IMO Code. Some were relatively flimsy, and were attached to the stiffeners on the hatch coamings (**Figure 11**).

Not a proper securing point

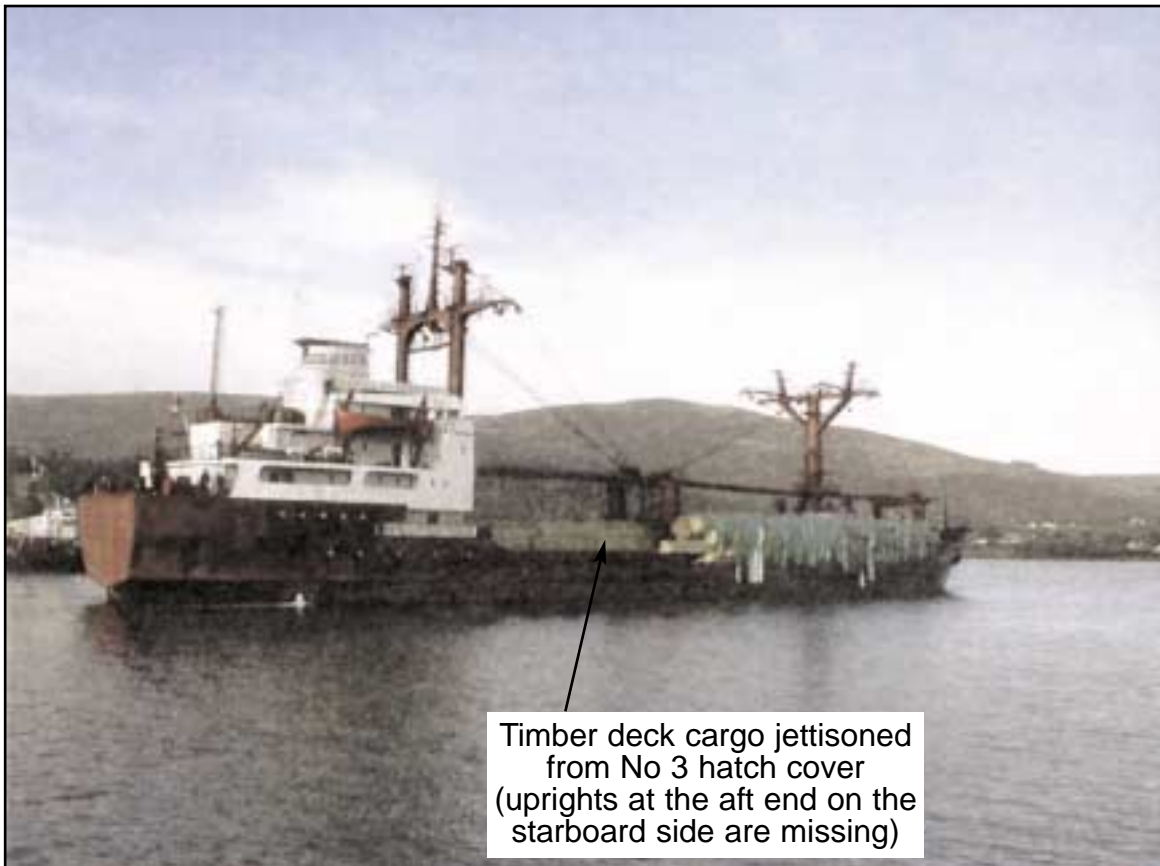
Figure 18

While on passage to Northern Ireland during the autumn, the vessel encountered heavy weather to the west of the Orkneys. A large wave hit the vessel on the port side and shifted the deck cargo on Nos. 2 & 3 hatch covers (**Figure 16**), causing a starboard list of about 35°. To save the vessel, the crew released the senhouse slips (**Figure 17**) in the lashings over No. 3 hatch. Most of the timber on this hatch cover then fell over the side, as the vessel rolled, and the uprights on the starboard side aft went over with it (**Figure 18**).

Timber deck cargo jettisoned from No 3 hatch cover (uprights at the aft end on the starboard side are missing)

- 3. The crew who went out on to the open deck in heavy weather to release the deck cargo on No. 3 hatch put their lives in danger. A remotely operated jettisoning system would have avoided this.**

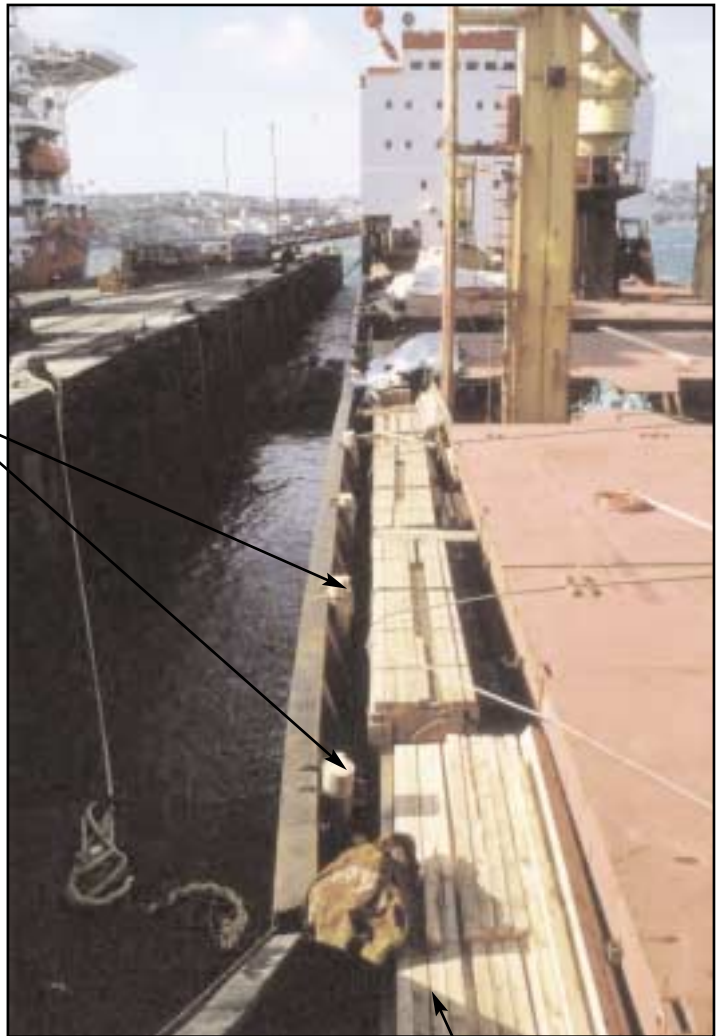
Figure 20

Although speed was reduced from 12 knots to 8 knots, large quantities of water were shipped on to the deck cargo. About 2 hours after darkness had fallen, loud bangs were heard from the cargo deck as two of the wooden uprights (**Figure 20**), used to help secure the stow, were broken. The master realised the deck cargo had started to shift, and altered course to port to close the French coast; the nearest place of safety. Speed was also increased to 12 knots. On the new course, the sea was about 35° on the starboard bow, and the vessel started to roll more heavily. About 20 minutes later, the vessel rolled heavily to port, which caused the deck cargo to shift about 0.5m across the deck and break all of the remaining uprights on the port side. The vessel immediately listed to between 10° and 15° to port.

Uprights
(cut off
during
salvage)

Looking aft on starboard side after salvage
(the deck cargo was stowed
similarly on the port side)

1. The use of uprights, by vessels carrying packaged timber deck cargoes, has decreased in recent years; indeed many modern vessels have no provision to have them fitted. When uprights are used, however, the support they provide is considerably increased when hog wires are also rigged.

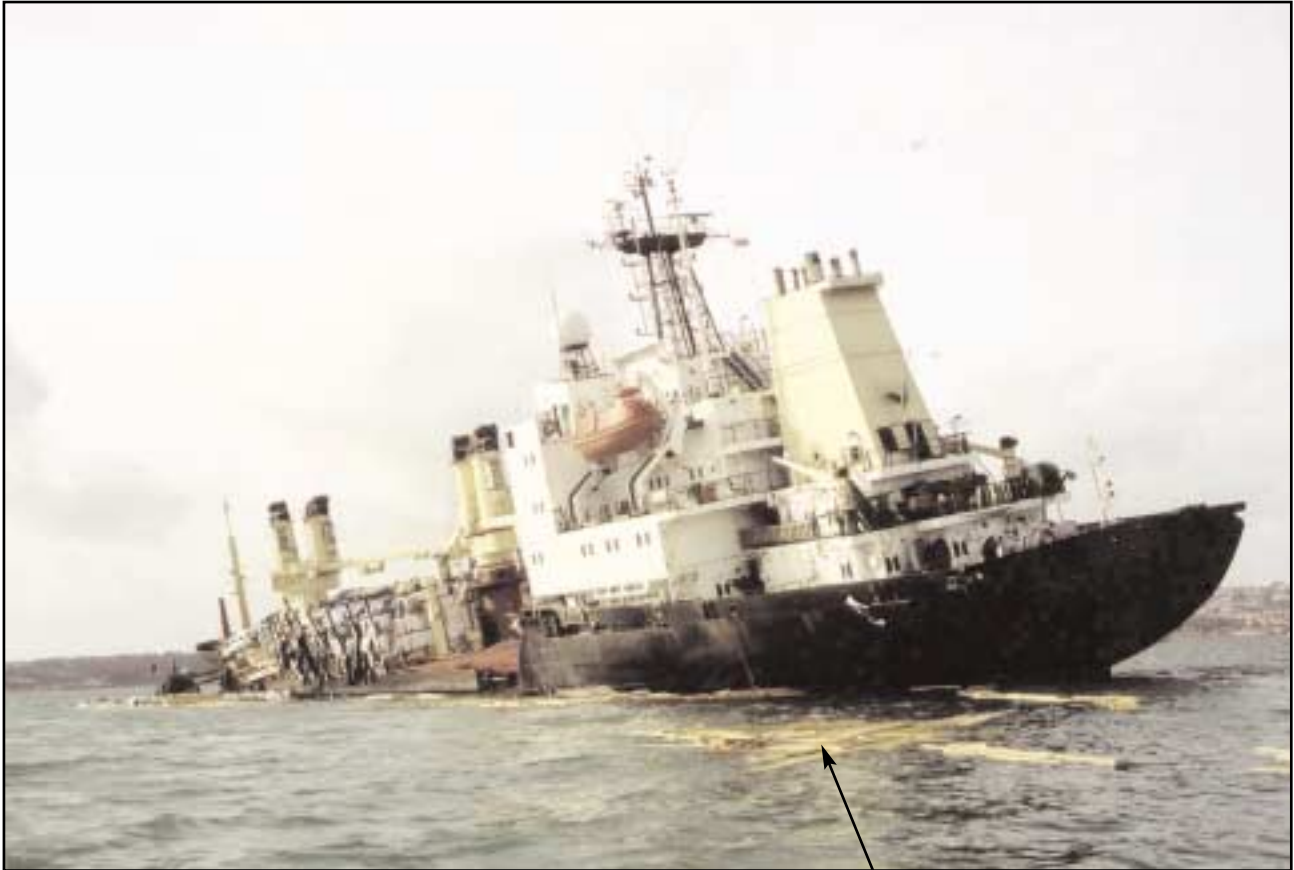
Figure 21

The master decided to jettison some cargo in an attempt to reduce the list. Some of the crew went out on to the open deck to try to achieve this. Conditions were hazardous, with no deck lights and gale force winds. Two of the lashings for the cargo on the hatch nearest to the superstructure were undone, and the other eleven were cut with an axe. This released about 1600m³ of timber, which reduced the list. About 30 minutes later, power was restored and the vessel subsequently reached Torbay. The ballast system would not work at this large angle of list, so more of the deck cargo was jettisoned in Torbay (**Figures 21 and 22**), until she was more or less upright.

Jettisoned timber packages

- 1. The crew who went out on to the open deck put themselves in a very dangerous situation to release some of the deck cargo. However, this action probably saved the vessel and was, therefore, justified. A remotely operated jettisoning system would have been a much safer way of dealing with the problem.**
- 2. If timber is carried on the hatch covers, there is a danger of it shifting in heavy weather, and causing a large angle of list. This means that downflooding of fuel tank vent pipes is possible unless they are in protected positions. If power is lost, and the vessel goes beam on to the weather with a shifted deck cargo, as was the case here, the crew is in great danger.**

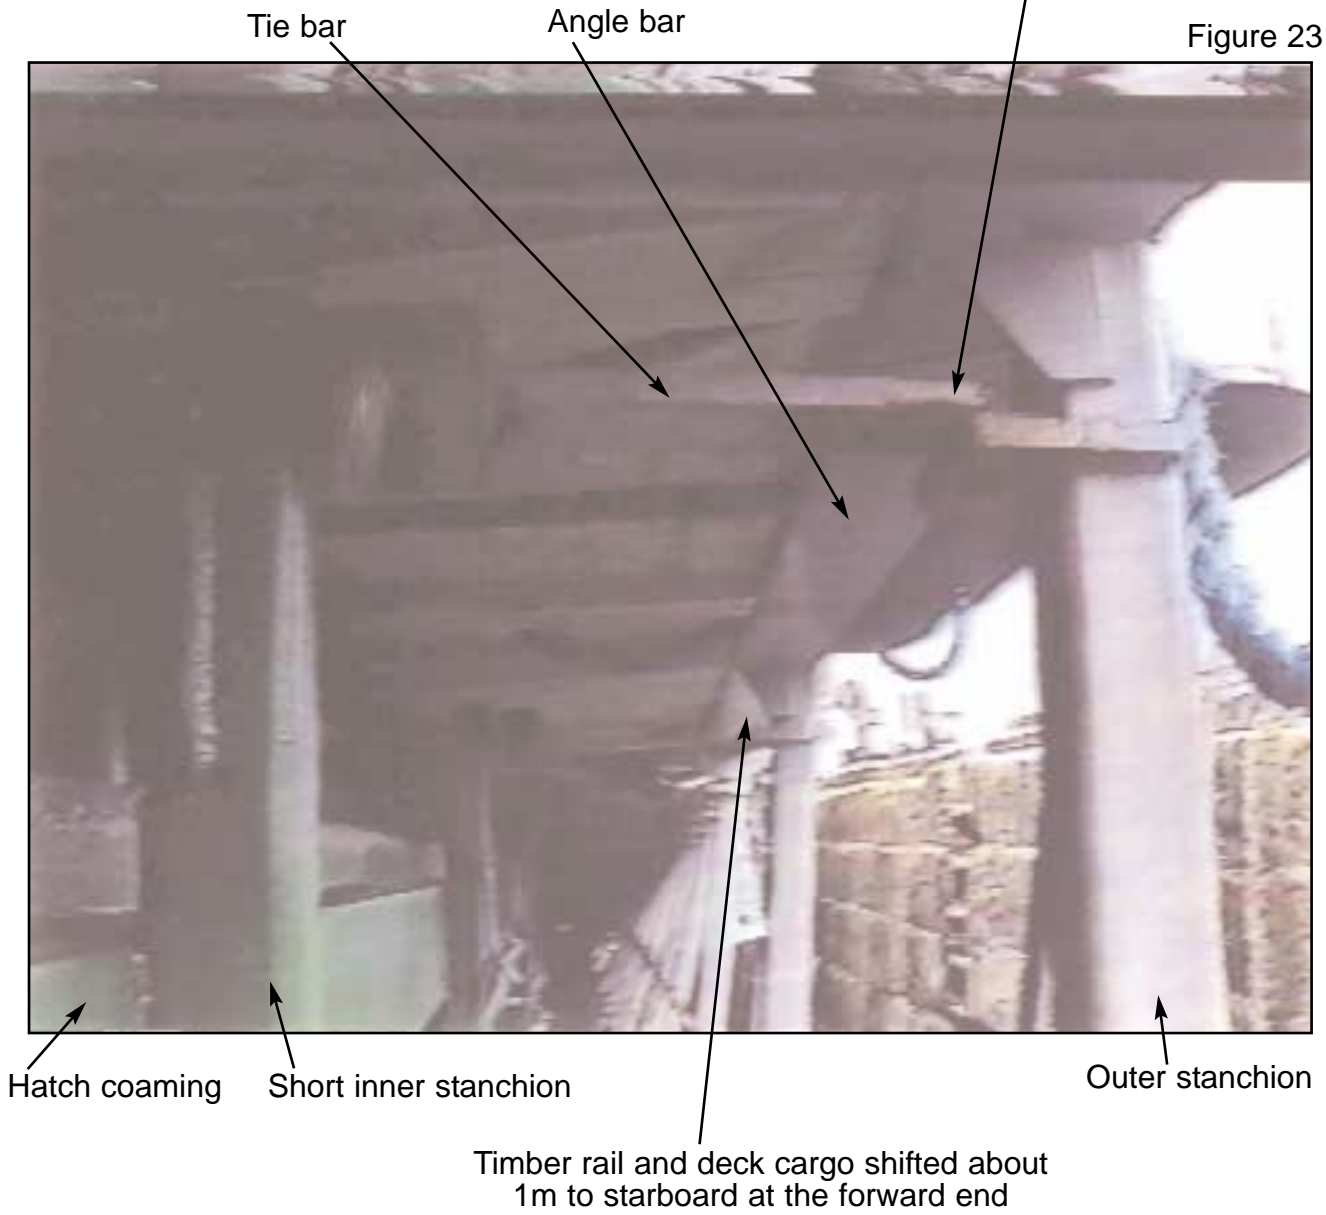
Figure 23

The main cause of the accident was found to be a failed starboard timber rail. The timber rail was a steel framework, consisting of outer stanchions along the main deck edge, and short inner stanchions attached to the sides of the hatch coamings. The stanchions were connected with tie bars (**Figure 23**). A horizontal angle bar was welded to the tops of the outer stanchions, to tie the framework together and stop the cargo shifting outboard.

When the wave hit, the cargo probably moved slightly, and the tie bars failed, allowing the deck cargo to move further. There were no structural calculations for the timber rails, and the strength of those frameworks was not properly verified.

Missing bolt was connecting the tie bar to the outer stanchions (sheared off due to excessive load)

Looking forward at main deck level on the starboard side

1. If timber rails are fitted, they should have adequate strength. Detailed structural calculations should have been made to ensure they were strong enough, and this should have been verified by a classification society.
2. The friction between timber deck cargoes and the hatch covers should be maximised. In particular, steel on steel interfaces should be avoided, as the friction is very poor. Wood against steel is much better. Painting the tops of the hatch covers with high friction paint is good practice, especially if deck cargoes are to be carried.

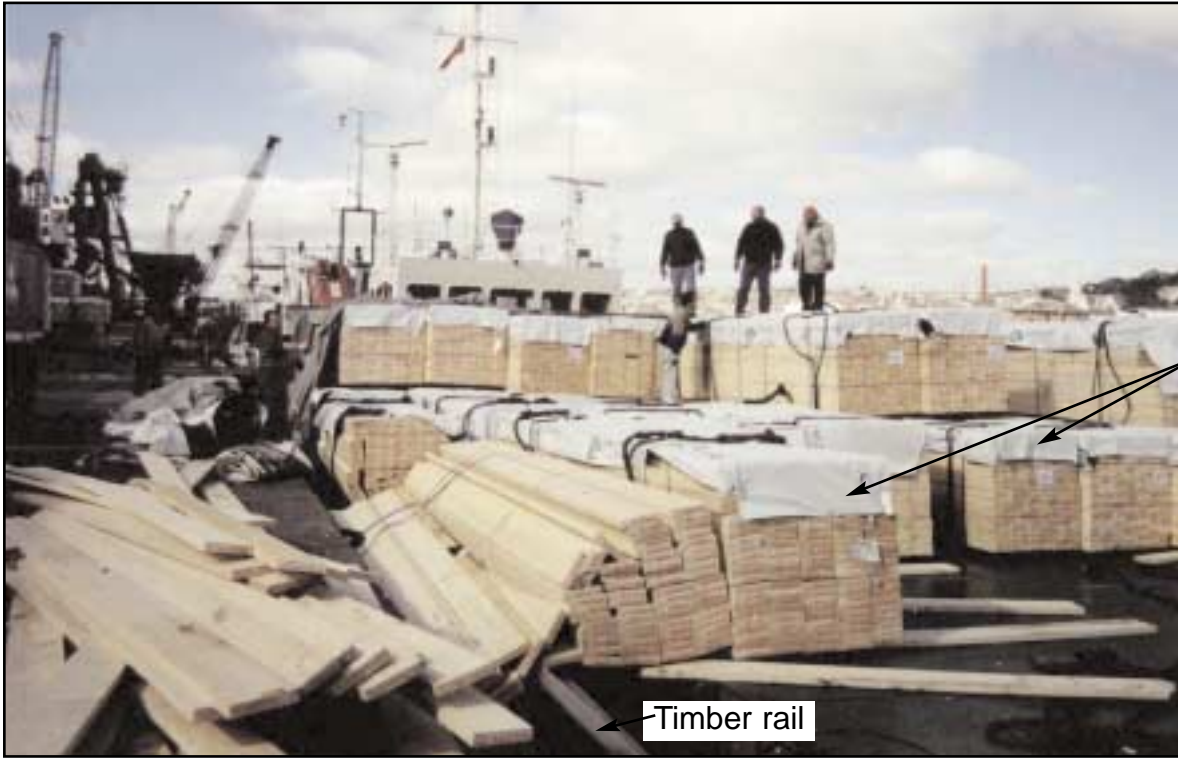
Figure 25

A waterproof covering was fitted over the upper part of each package (**Figure 25**). These plastic sheets did not have a high friction coating, and became slippery when wet. The timber packages were similar to those described in Case 1 (**Figure 5**). The bundle of planks sat on two square section timber bearers. Steel bands were run around the bundle of planks and the bearers to hold each package together. The bearers provided very little contact area and friction between the first and second tiers of the deck cargo. The lack of friction between the upper and lower tiers was the main cause of this accident.

Waterproof plastic covers

2. Maximise the friction between timber deck cargoes and hatch covers and between tiers of packaged timber. Avoid steel on steel contact where possible, and only use plastic wrapping incorporating a high friction coating.
3. Ensure that lashing arrangements, especially where fabric webbing lashings are used, are sufficient to prevent the cargo from moving laterally and strong enough to withstand the forces generated in rough sea conditions. The use of uprights and hog wires should be encouraged.
4. Ensure that any structures, for example timber rails, which are fitted to help secure timber deck cargoes, are strong enough to withstand the forces generated during rough sea conditions.

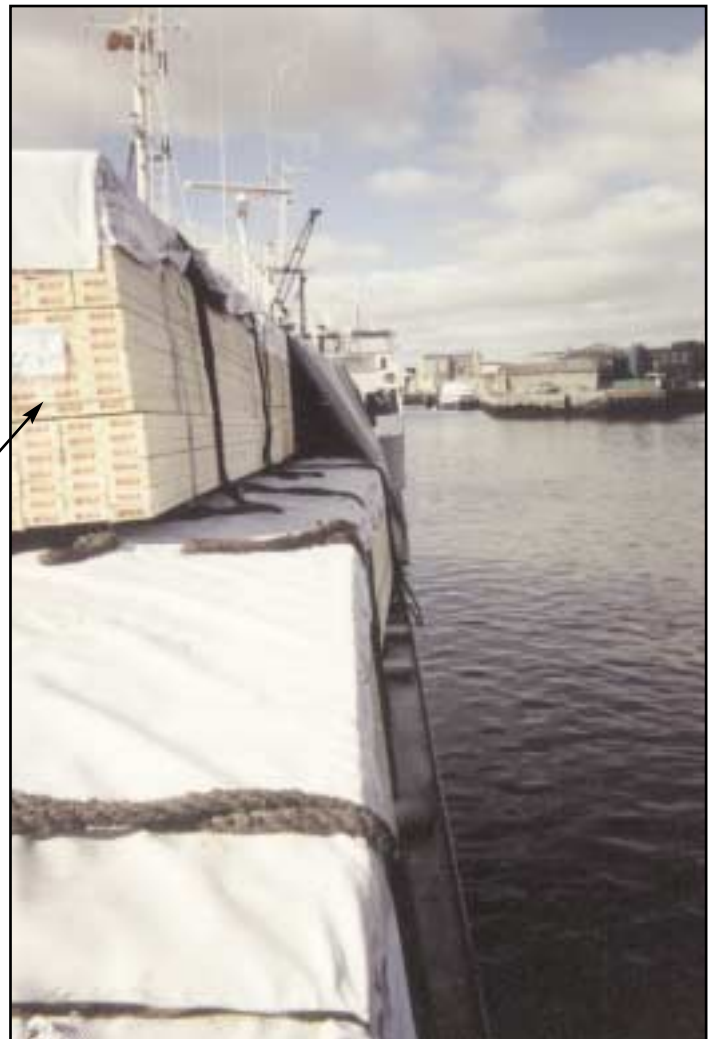
Figure 26

The vessel encountered a quartering swell while sailing across the North Sea on an autumn evening. She fell into a deep trough, which caused a large heel to port. When the vessel was heeled over, the upper tier of packages moved bodily to port. The shift resulted in an angle of list of about 10° to port, but none of the lashings parted. The vessel was turned, to put the weather on the bow, and the power was reduced. While hove to, ballast was added to the starboard side until she was more or less upright.

Upper tier of packages shifted to starboard

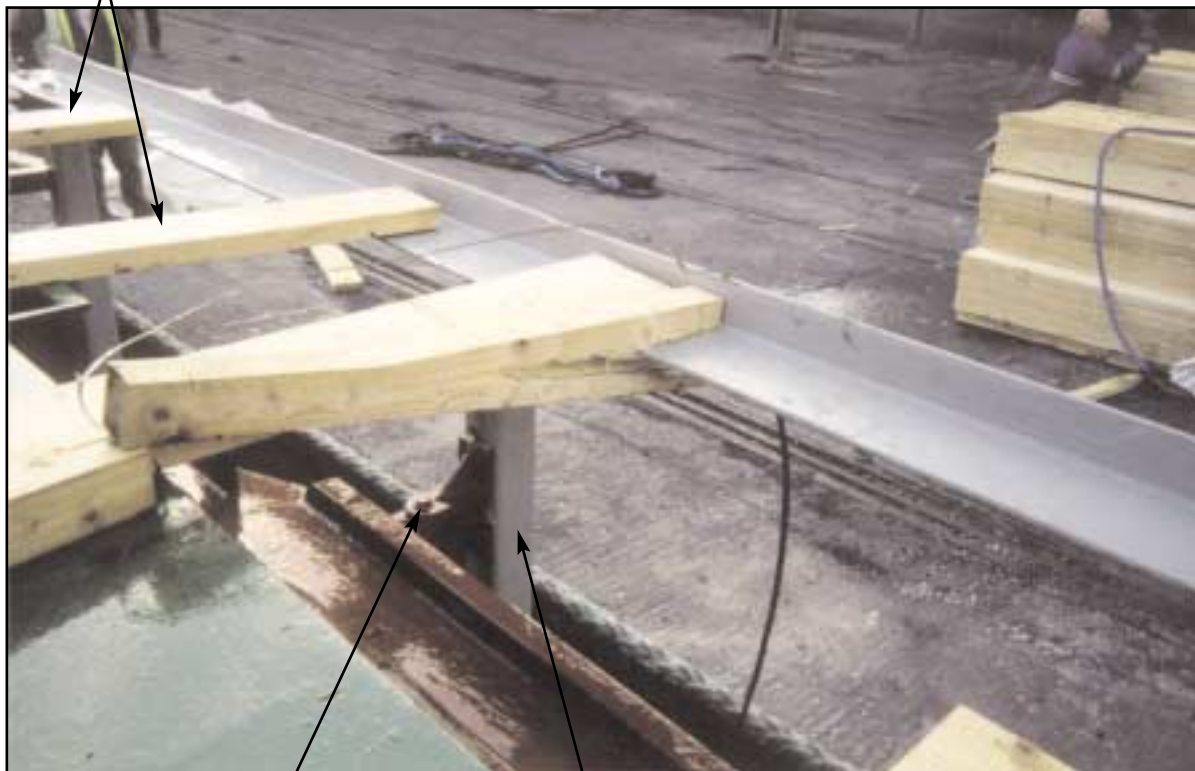
Figure 28

The friction between the lower tier and the hatch covers might well have been poor, but the timber rail prevented this layer from moving transversely. The timber rail comprised a steel framework consisting of stanchions along the main deck (**Figure 27**), which were connected to the sides of the hatch coamings with tie bars. An angle bar was welded to the tops of the stanchions. The timber deck cargo rested mainly on the hatch covers, but the outer parts rested on one surface of the angle bar. The upright part of the angle bar stopped the cargo shifting transversely (**Figure 28**).
