**SAFETY STUDY 1/2001**

**REVIEW OF  
LIFEBOAT AND LAUNCHING SYSTEMS'  
ACCIDENTS**

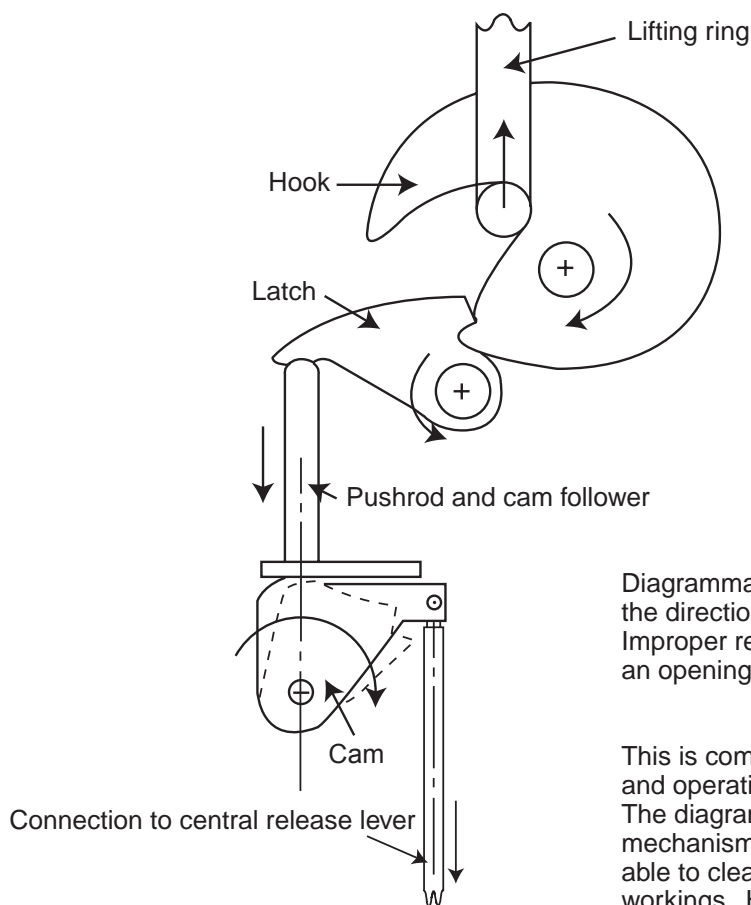
Figure 1

It has been found that crews generally have a poor understanding of the operating principles involved with release hooks, often because of inadequate training. This is not the only reason. Poor labelling, complex mechanisms and hard to follow operating instructions in some manufacturers' manuals have also featured as contributing factors **(see Figure 1)**.

Diagrammatic arrangement of hook release mechanism and the direction of movement of its components during release. Improper resetting of the cam, as shown dotted, can induce an opening moment leading to inadvertent release.

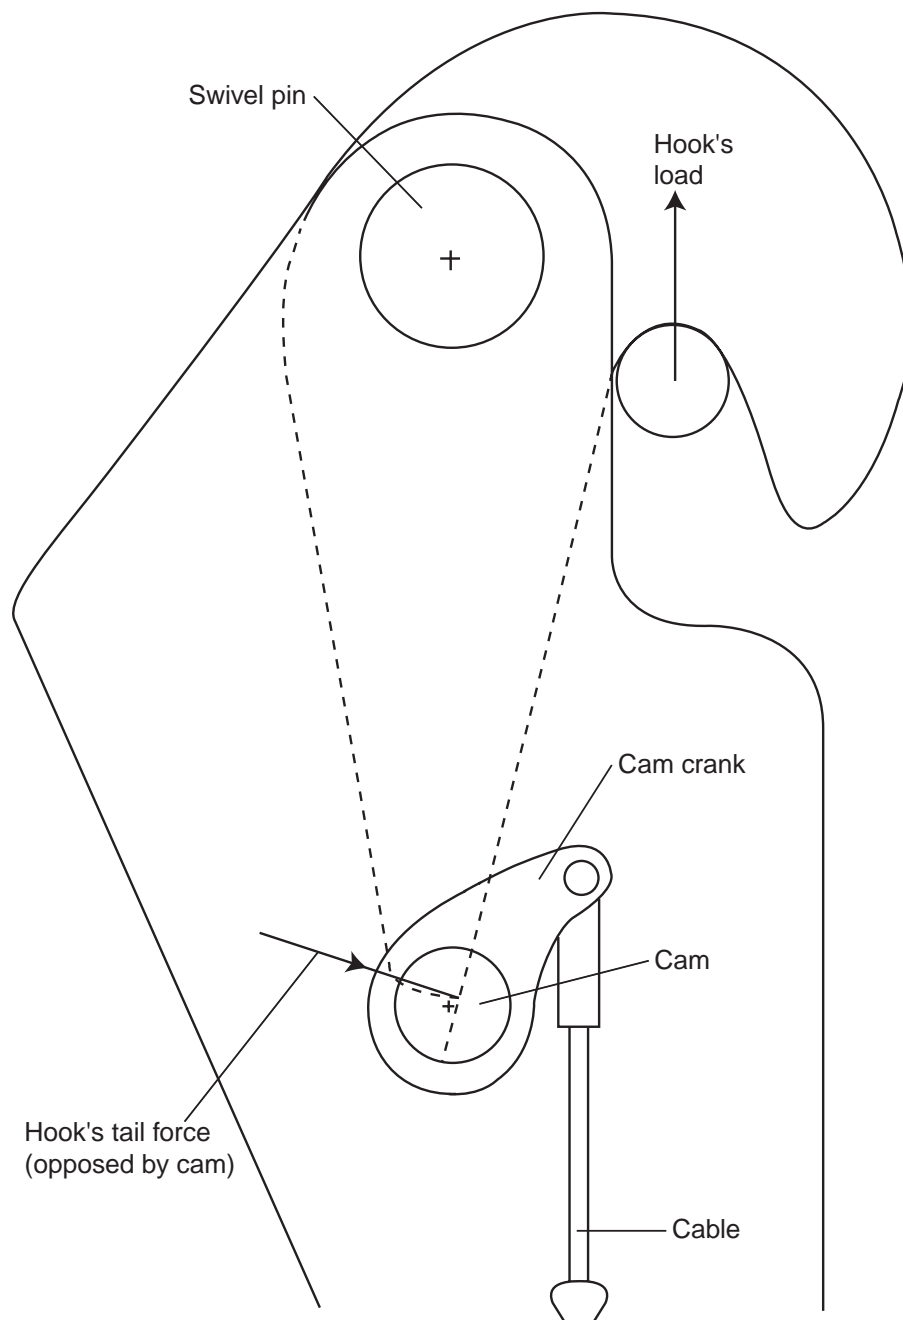
Figure 2

Analysis of a number of accidents reveals that premature hook release has often been caused by the failure to re-set it correctly when the lifeboat was being recovered from its previous launching. This shortcoming stems from a lack of understanding of the mechanism involved, inadequate training and poor maintenance. Once the hook has been incorrectly reset, spontaneous release is possible at any time before the lifeboat is next put in the water **(see Figures 2 and 3)**.

The central operating lever is placed adjacent to the coxswain's position, often in such a fashion that the gearing, quadrant and very important safety pin cannot be viewed easily. Indeed it is often impossible for the user to obtain the same view of the mechanism as it is shown on the instruction panel, he can see it only from above, making the important components difficult to identify. This problem is aggravated by these parts being below the bottom boards of the boat in an area of darkness.

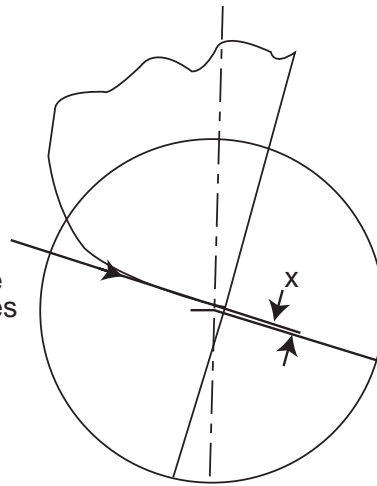
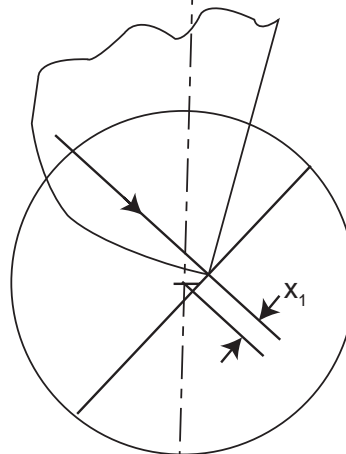
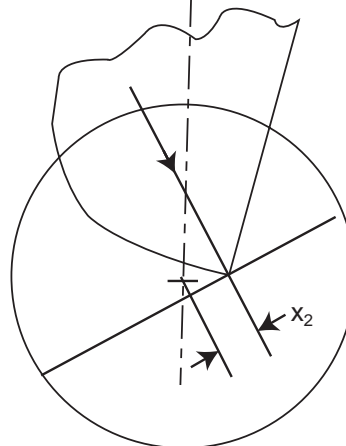
Figure 3

Hook and cam in fully closed position. Flat face of cam and tail of hook are in contact. This gives the minimum lever 'x' by which the force from the hook's tail generates an opening moment on the cam. This moment is resisted by the moment generated by the cable force.

Partially closed condition. Improper resetting of the cam when a boat is being recovered might generate this state. Can be aggravated by sticky cables. The size of the lever ' $x_1$ ' is much greater than that for the fully closed position ' $x$ '. This allows the force from the hook's tail to generate a much larger opening moment on the cam. It is possible for this moment to overcome that generated by the cable leading to rotation of the cam and spontaneous opening of the hook.

Further rotation of the cam leads to increase in the size of the lever to ' $x_2$ '. The moment generated on the cam is so large that it will almost certainly overcome the moment generated by the cable force. The hook is then able to fully open.

The above sequence shows the magnification in hook opening effects due only to the growth in lever of the force in the hook's tail. Other changes take place as the cam's face rotates, which result in an increase in magnitude of the hook's tail force and thus also the cam rotating moment. All of these effects indicate the importance of properly resetting the cam when recovering a boat.

Any other factors which increase the lever, such as wear of the hook's swivel pin and bush, will, when under load, allow the hook and its tail to rise relative to the cam. Even in the fully locked position the lever ' $x$ ' is then increased, as are the levers ' $x_1$ ' and ' $x_2$ ' during the later part of the opening sequence. A similar effect is achieved if the tip of the hook's tail, where it makes contact with the cam, is excessively worn.

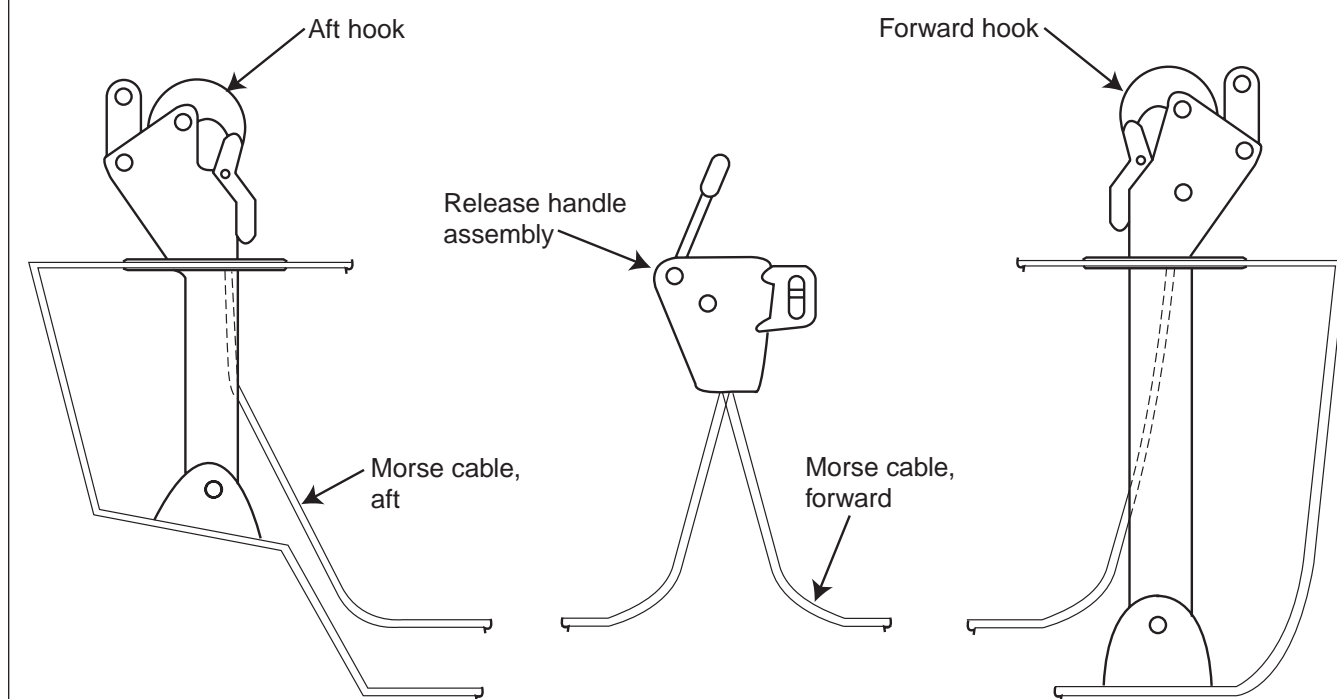
Figure 4

To comply with the requirement that both hooks are released simultaneously from a single control position, it is common for release mechanisms to include flexible cables to connect the control lever to the hook mechanisms (**see Figure 4**).

The MAIB has found, however, that these cables can seize if the stranded wire becomes corroded. This can result in the on-load release hook failing to close properly when being reset. This in turn has resulted in inadvertent release later. Once corroded these cables cannot be repaired effectively, and have to be replaced. The evidence shows that management and crews are often unaware that such replacement is necessary.

In response to one MAIB recommendation, a manufacturer amended its on-load release hook operation and maintenance manual to emphasise the importance of replacing damaged or corroded cables. It is not always the case. It is known that some other manufacturers do not draw attention to the inherent dangers of not replacing corroded cable.

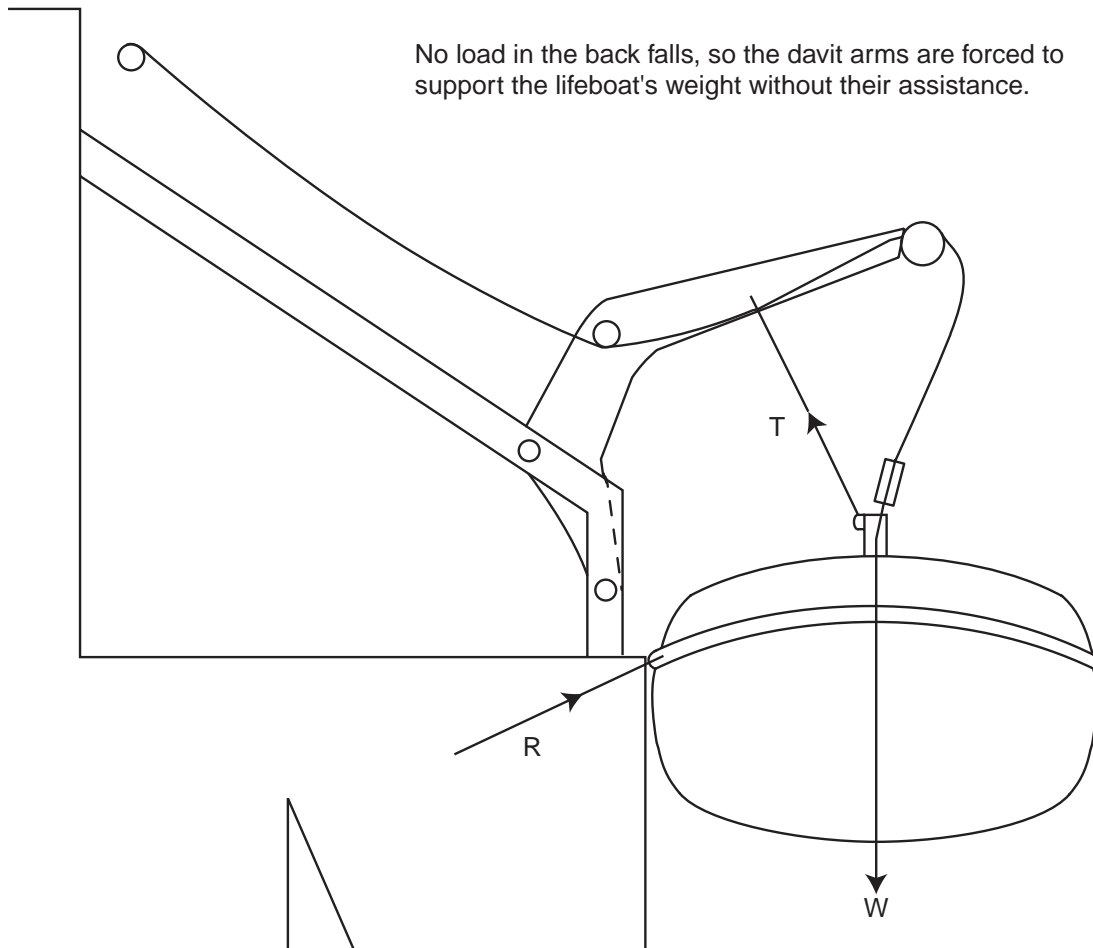
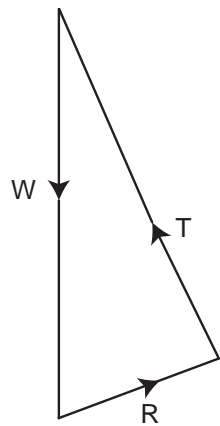
Figure 7

A second potential danger of not bowsing in a lifeboat is that a loaded lifeboat might overload the tricing pennants. If they fail (**see Figure 7**), the consequences can be serious. This is likely to occur if the lifeboat is brought hard against the ship's side. It can even lead to the falls going slack if the winch wire is paid out too far. Tricing pennant failure would again cause the boat to swing uncontrollably, endangering anyone who happened to be embarking at that particular moment.

Lifeboat lowered to embarkation level. However, winch is allowed to run to the extreme position where the falls become slack. The boat's gunwale is in heavy contact with the ship's side. The tricing pendants now take the boat's weight ( $W$ ) alone and their loading is much increased. A load that they are rarely designed to take.

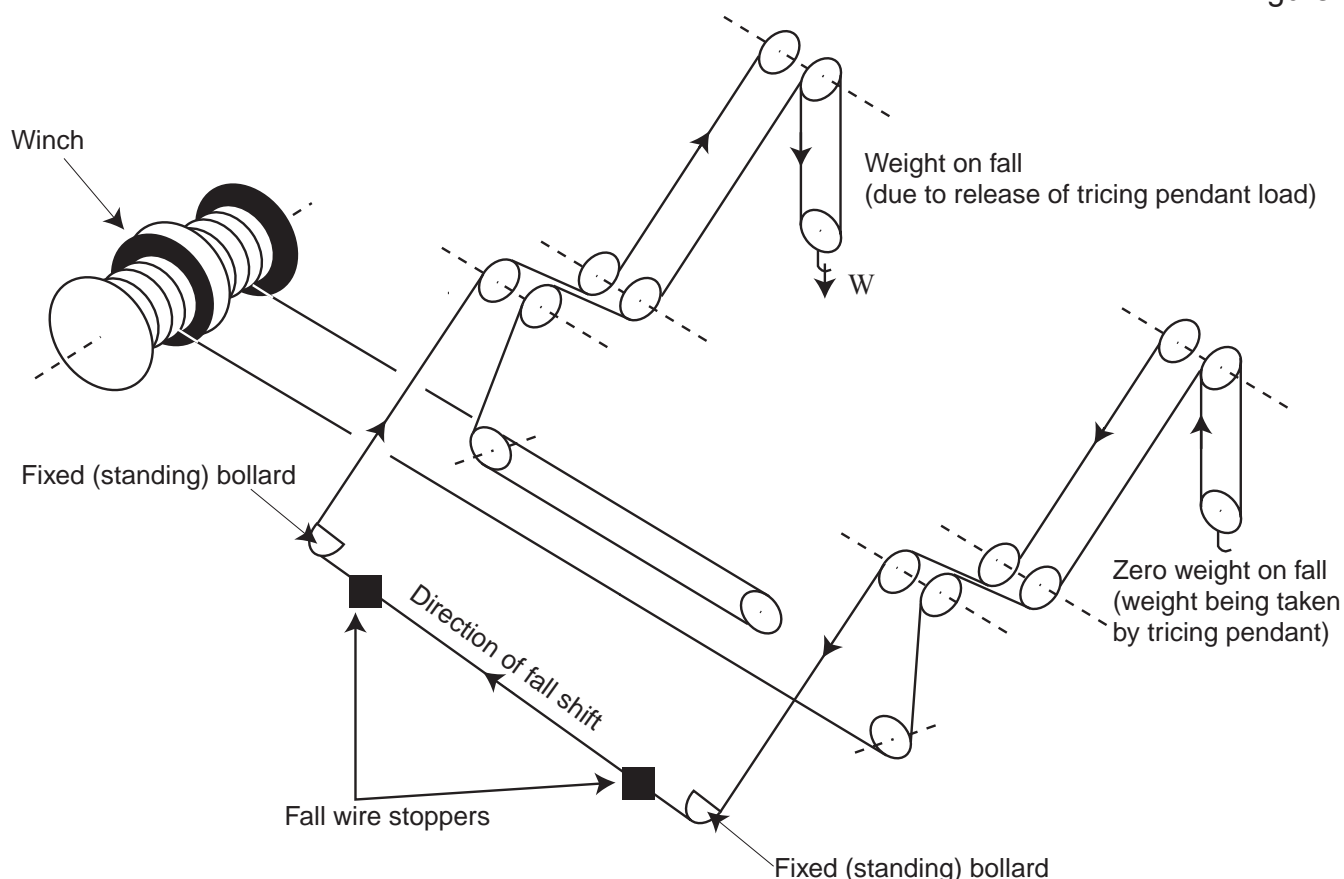
Figure 8

Failure of a single tricing pennant with slack falls has been known to have serious implications. When continuous falls are fitted, they will run out at the end where the failure has occurred. The lower block at the other end will simultaneously rise, sometimes sufficiently far and hard to hit the head of the davit arm. This imposes a dynamic overload on it and may lead to failure with the consequential repercussions for anyone in the lifeboat. This seemingly unlikely train of events has occurred in one boat where the crew was testing experimental tricing/bowsing gear (**see Figure 8**). It was a serious accident and people were killed.

When lowering the boat to embarkation level, the winch might be payed out so far that the falls go slack. Only the tricing pendants then take the boat's weight. Should one tricing pendant then fail, or is slipped, the weight at that end attempts to transfer to the falls. However, as there is no weight on the falls at the other end, because the remaining tricing pendant is still taking it, they can offer no balancing reaction. They then have a tendency to shift or slide towards the end where the tricing pendant has failed. This tendency is normally resisted by friction between the falls and the standing bollards. But, again, without load in the falls no significant friction force can be generated.

The shift may be sudden and might not be resisted by the fall wire stoppers.

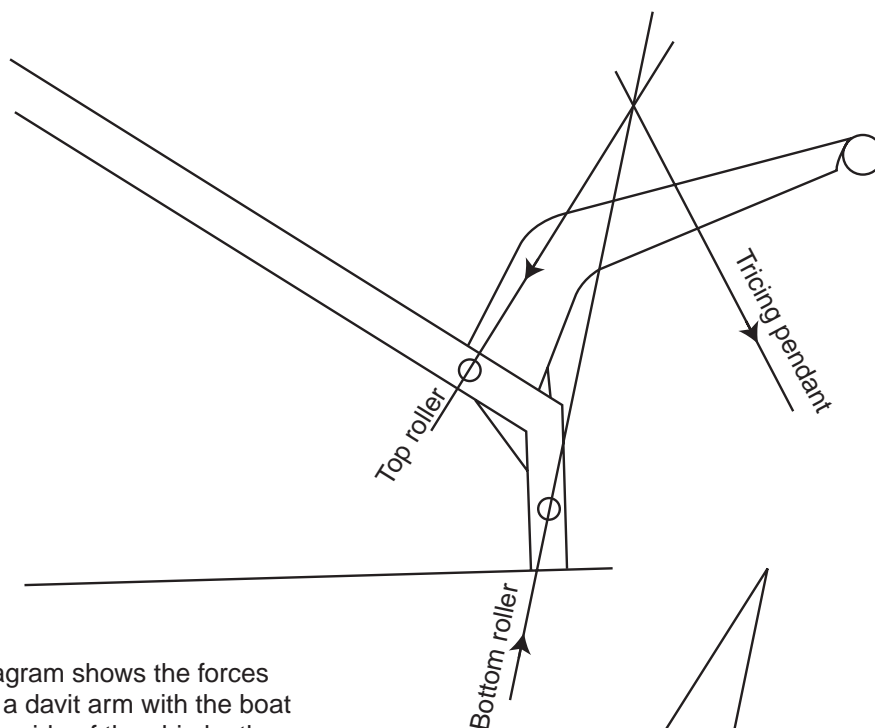
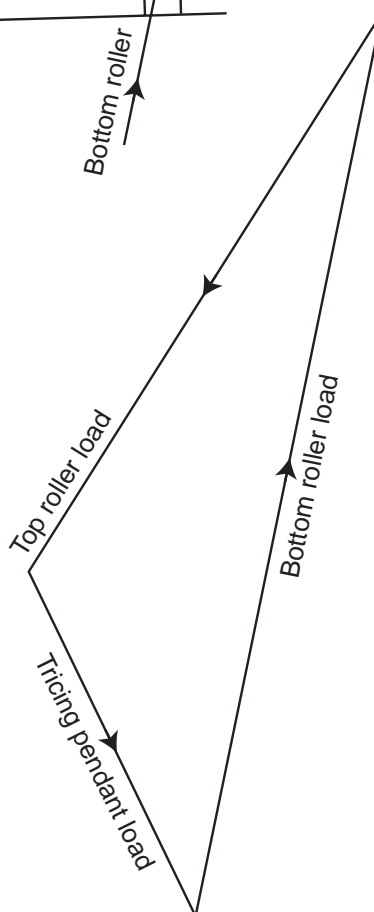
Figure 10

A further consequence of not properly bowing in a lifeboat can occur if the load bearing capacity of the davit arms is dependent on support offered by the back falls which lead inboard from the davit heads (**see Figure 9**). With the lifeboat at embarkation level, and supported by falls and tricing pennants, its weight is shared between them. The greater the proportion of weight taken by the tricing pennants, the less will be taken by the falls. This gives a corresponding reduction in the load on the back falls, which means that their contribution to supporting the davit arm is reduced. This results in an increased portion of the load being taken on the supporting structure of the davit arm and can, on some designs, overload it if the boat is fully laden (**see Figure 10**).

Above diagram shows the forces acting on a davit arm with the boat held to the side of the ship by the tricing pendants and with the falls slack. This is the condition shown in Figure 7. The only significant forces acting on the arm are the tricing pendant load, the top and bottom roller forces.

The diagram to the right is the above force system giving the relative magnitudes of the forces. Notice how much greater are the roller loads compared to the properly bowed in condition of Figure 9.

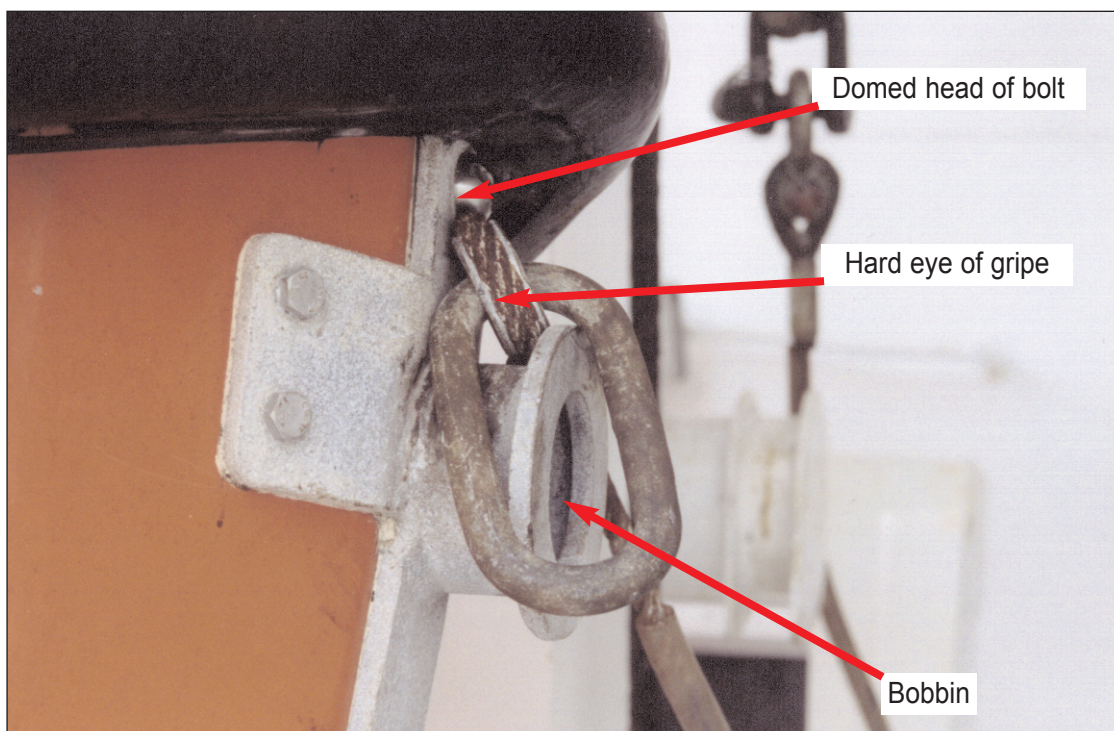
Figure 11

The MAIB received one report where the hard eye on the freed end of a gripe fouled the gripe's bobbin and the domed head of a mounting bolt (**see Figure 11**). This happened during the early stages of lowering. Fortunately it happened during an exercise where there was someone available on the vessel to free the gripe. Had this occurred in different circumstances, the lifeboat could have been loaded, lowered clear of its davits, and yet been prevented both from being lowered to the water and raised under control of the people in the lifeboat. Changing the size of the hard eye allowed the gripe to slide freely over the bobbin and cured the problem.

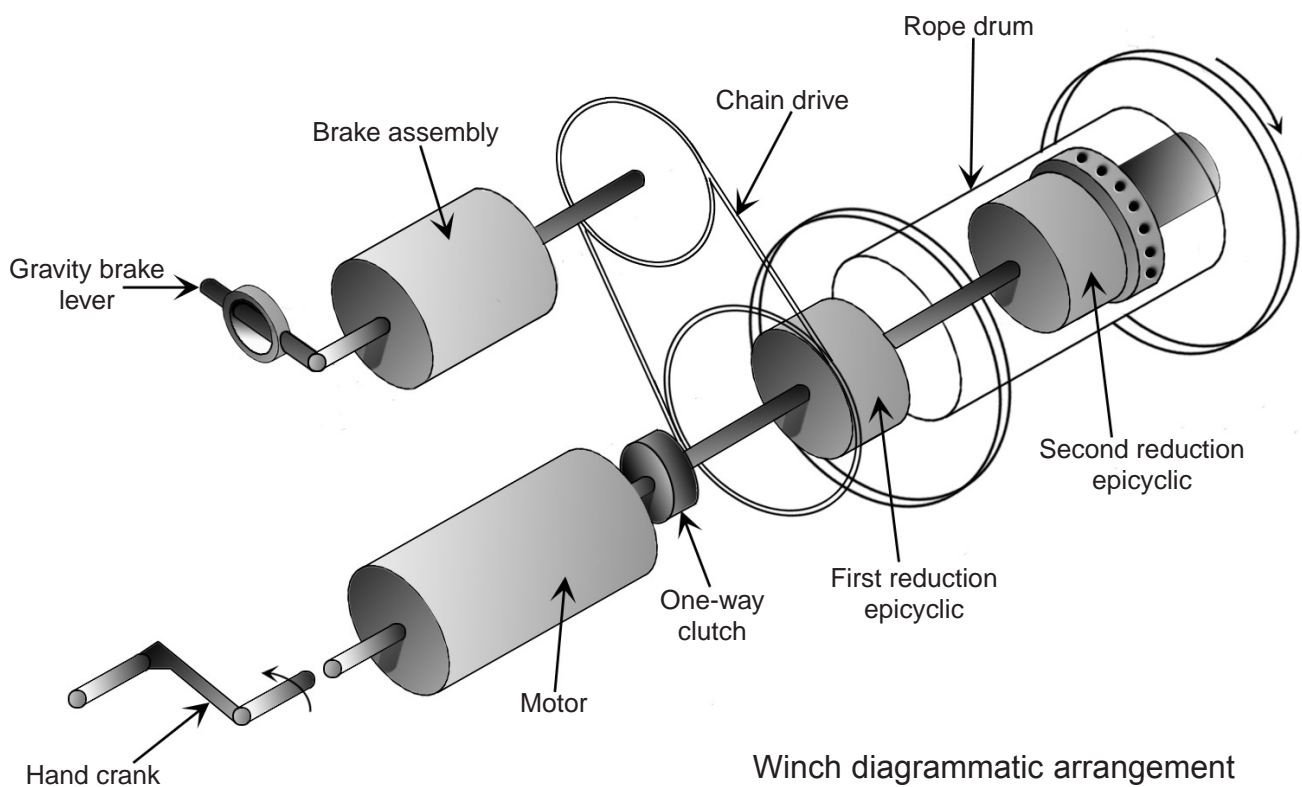
Figure 12

Some of these one-way clutches have failed in service. In such circumstances a lifeboat can lower uncontrollably and in some conditions, such as having bowing or tricing gear connected, it can tilt. The consequences for any occupants are likely to be serious.

Clutch failure can also lead to the lifeboat descending with neither the centrifugal nor manual brakes having any effect. Such failures have been found to occur immediately the hoisting motor has been stopped, when stowing the lifeboat, or when adjusting its position at embarkation level using the motor. The clutch is unable to re-lock after having run in the freewheel direction.
