CONTENTS

SPECIAL BULLETINS / INTERIM REPORTS

S2/2013 EC225 LP Super Puma	G-REDW	10-May-12	}	3
EC225 LP Super Puma	G-CHCN	22-Oct-12

LET L-410 UVP-E Turbolet	OK-ASA	05-Nov-12	17
--------------------------	--------	-----------	----

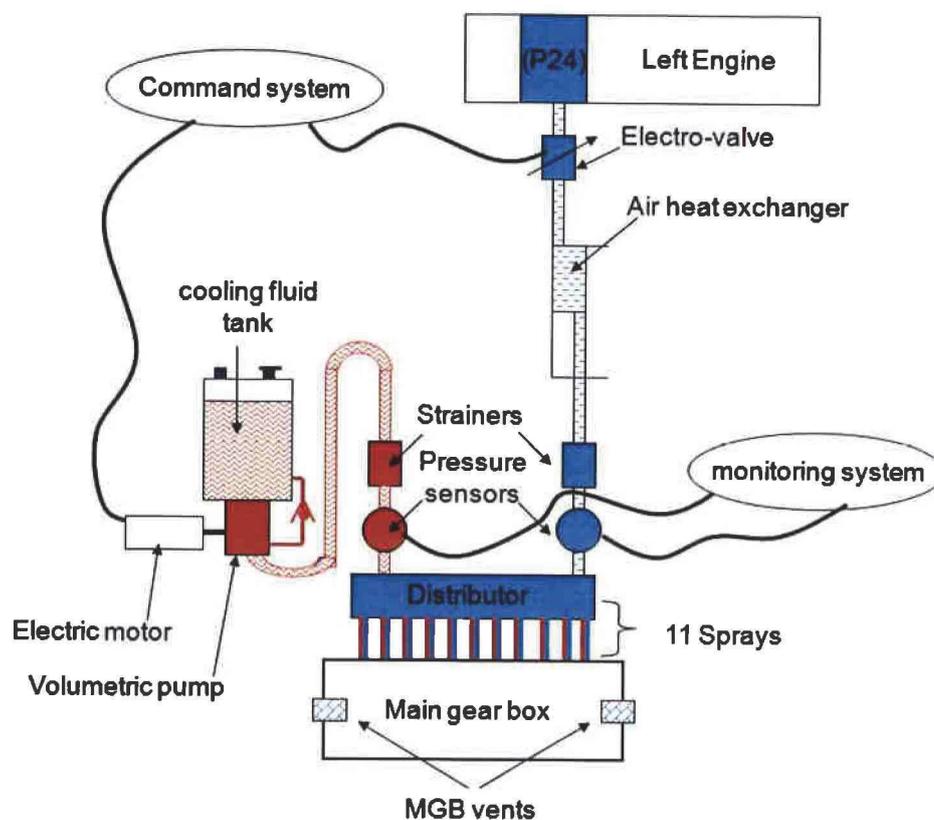
Figure 1

A MGB EMLUB caption will illuminate if low pressure is detected by either of the two pressure switches, one in the Hydrosafe 620 line and the other in the bleed-air line. It will also illuminate if there is an erroneous signal detected by the PCB. The caption is inhibited for approximately 30 seconds after the emergency lubrication system is activated, to allow the system to reach a steady-state. The MGB EMLUB caption is not latched.

Schematic of the Emergency Lubrication System

An error in the specification issued to the pressure switch manufacturer resulted in all EC225 LPs, with MOD 0752520 embodied, having a pressure switch configuration that results in illumination of the MGB EMLUB caption once the system is activated and after the 30 second delay. This was the most likely cause of the MGB EMLUB caption during the accident flights for G-REDW and G-CHCN.

The helicopter manufacturer is planning to introduce replacement pressure switches with lower thresholds and tighter tolerances, as well as improved maintenance procedures, that will provide the crew with an accurate indication of the status over the entire operating envelope of the helicopter.

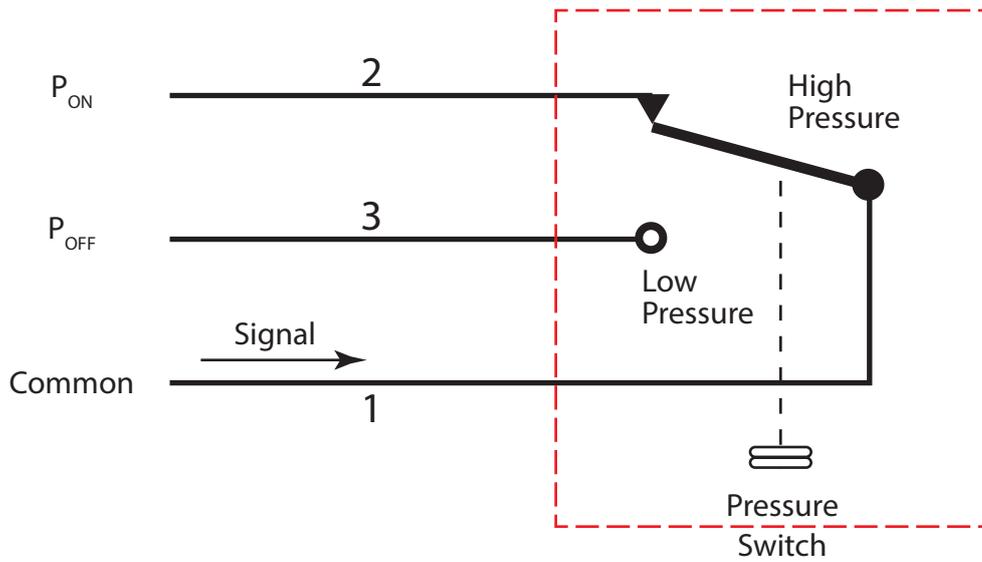
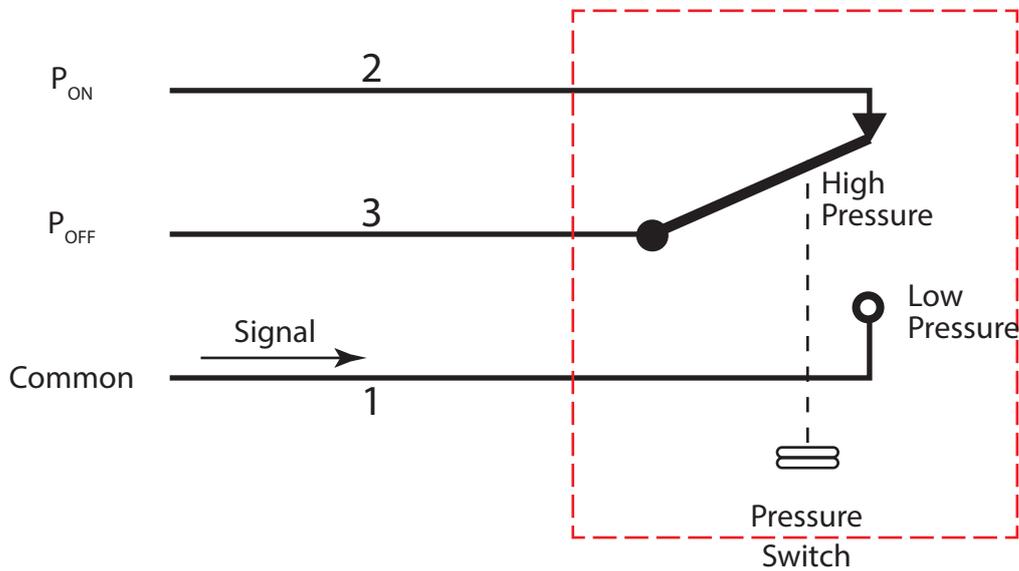
Figure 2

Before MOD 0752520

After MOD 0752520

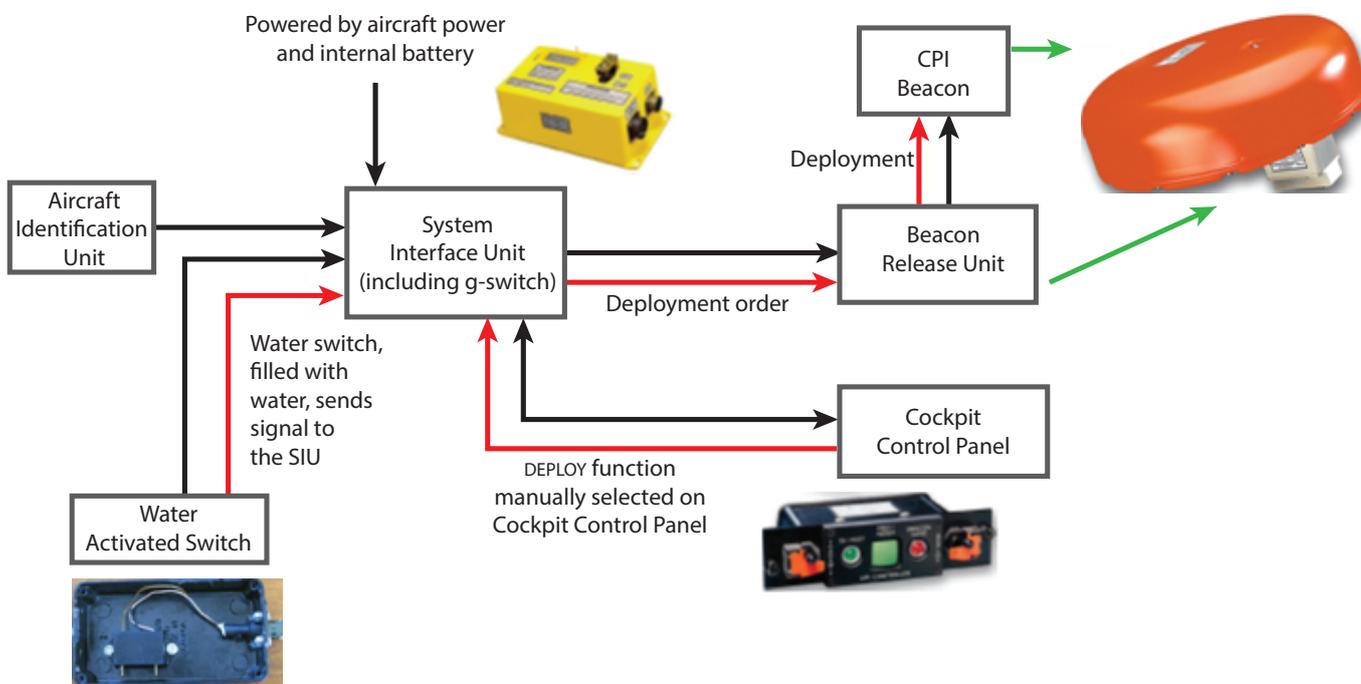
Figure 3
Schematic of Crash Position Indicator system

Although the G-CHCN CPI beacon correctly transmitted distress signals following the manual selection of the TRANSMIT function, all of the CPI system components were removed for testing. The cockpit control unit contained seawater and had suffered extensive internal deterioration due to corrosion, which rendered it incapable of operating. All of the other components were installed on the test bench and functioned correctly, leading to successful operation of the beacon release unit and deployment of the CPI. A visual examination of the water activated switch showed minor corrosion on one of the contacts, but no evidence of salt water deposits which may have indicated complete immersion in sea water. However, the external electrical connector was corroded, indicating that the water had reached at least that level. The activation code stored in the CPI system memory confirmed the manual TRANSMIT selection of the CPI during the accident. It was therefore concluded that there were no defects with these components that would have prevented the automatic deployment of the CPI beacon, had a manual TRANSMIT not been selected.

The CPI on G-REDW did not release automatically; photographs show the water level in the cabin was above the level of the water activated switch. Whilst further work is required to support any final conclusions, issues relating to the continuity of the helicopter wiring when submerged, the design of the water activated switch and the location of the water activated switch relative to the water level following the ditching are being investigated as possible causes for the non-deployment of the CPI.

It is recommended that the European Aviation Safety Agency requires the manufacturers of aircraft equipped with a Type 15-503 Crash Position Indicator system, or similar Automatically Deployable Emergency Locator Transmitter, to review and amend, if necessary, the respective Flight Manuals to ensure they contain information about any features that could inhibit automatic deployment.

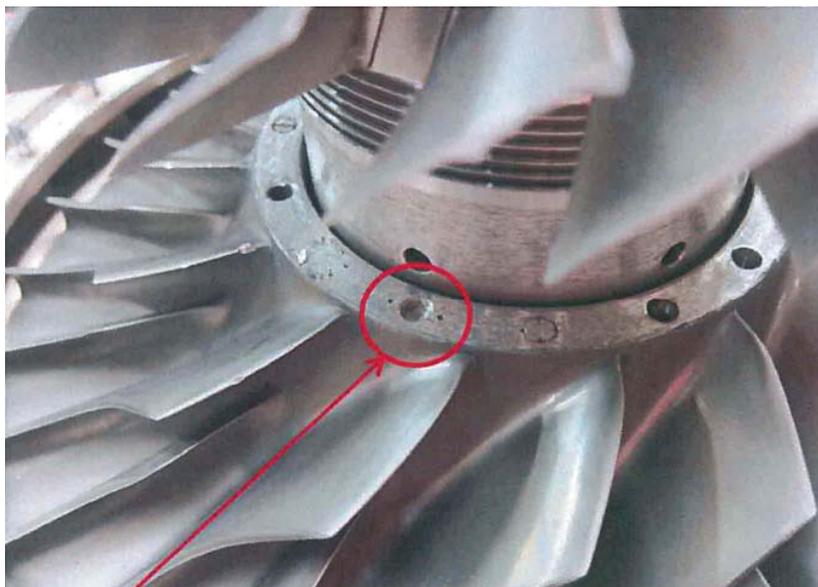
Figure 1

The left engine was removed from the aircraft and sent to the engine manufacturer for detailed examination, which revealed that a balance plug had broken and had released from the centrifugal compressor disc (Figure 1). Balance plugs are used to balance the compressor disc and are screwed into the disc beneath the compressor blade roots. They are secured to the disc by thread-locking adhesive in addition to centre-punch indentations at the edge of the balance plug holes. The balance plug had travelled along the gas path through the engine, causing damage to the centrifugal compressor, the gas generator and power turbine nozzle guide vanes and turbine blades (Figure 2), as well as damaging nine Intermediate Turbine Temperature (ITT) thermocouples.

Location of the detached balance plug

Following an investigation by the engine manufacturer, it was concluded that the broken balance plug had failed due to a fatigue crack originating from the thread root of the plug's uppermost screw thread. The fatigue crack's fracture surface exhibited crack initiation from multiple sites, consistent with intensive cyclical loading of the balance plug, caused by the plug becoming loose from the centrifugal compressor disc. Metallurgical examination of the broken balance plug showed that it was manufactured from the required grade of steel and that no anomalies were evident in the material's heat treatment, hardness or microstructure.

The engine manufacturer identified either insufficient assembly torque or ineffective securing of the plug after installation as possible causes for the balance plug becoming loose. The type of balance plug that failed in this incident has been withdrawn from use and the manufacturer is currently evaluating possible design changes to the remaining types of balance plug used in the M601-series of engines, in addition to changes to thread-locking adhesive compositions and plug tightening procedures.

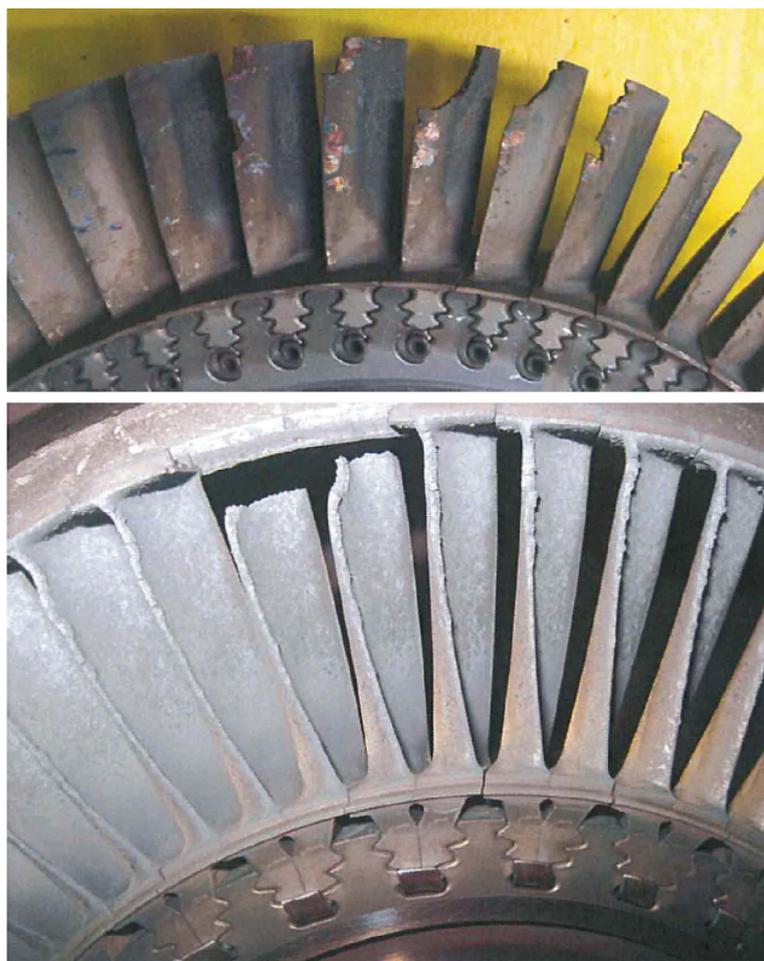
Figure 2

Damage to gas generator turbine (top) and power turbine (bottom)

The damage to the engine was contained within the engine casing and was insufficient to cause a significant loss of power.

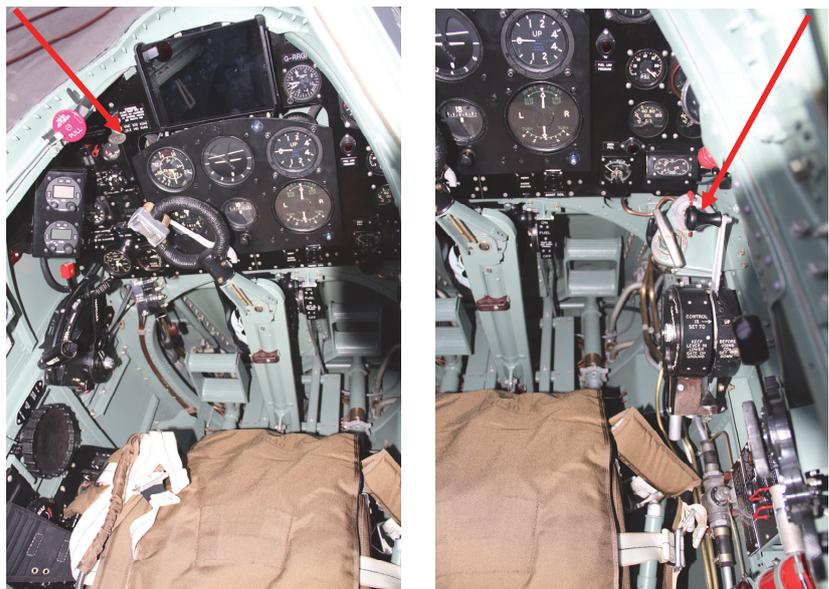
Figure 1

The aircraft had landed on Runway 27 at East Midlands Airport and was taxiing to vacate the runway when the undercarriage retracted, causing the wooden propeller to strike the runway and shatter. The pilot stated that he had intended to retract the flaps but inadvertently selected the undercarriage to UP: the levers are on different sides of the cockpit (Figure 1). It is apparently a usual practice to retract the flaps as soon as possible after landing to minimise the effect they have on cooling radiator airflow. There is no weight-on-wheels protection circuit.

Spitfire Mk XIX cockpit showing flap lever (arrowed left) and undercarriage selector (arrowed right)

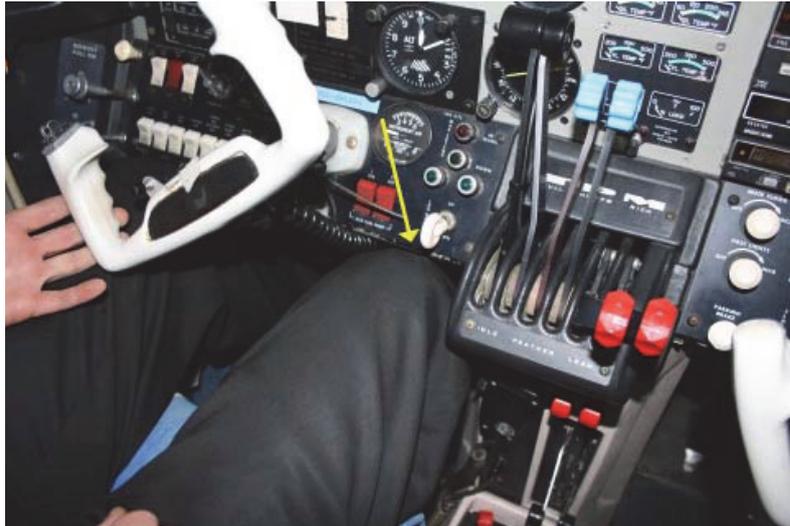
Figure 1

On 4 June 2009, a Beech Duchess 76 (registration EI-BUN) suffered a partial landing gear retraction during landing at Weston Airport, Co Kildare in Ireland. The Air Accident Investigation Unit (AAIU) established² that the student pilot's knee was within 5 cm of the landing gear lever when he was seated normally at the controls, and that it was possible for his knee to come into contact with the selector lever as his feet slid upwards to operate the wheel brake pedals. It was also noted that the safety detent was ineffective, and it was possible for his knee to knock the lever to the UP position without first pulling it to clear the detent. The AAIU report included a photograph depicting this situation, which is reproduced at Figure 1.

Extract from AAIU report: proximity of student's knee to landing gear selector lever

The statement above assumes that the detents of the switch functioned properly. Airplanes that are used for flight training will have a significantly greater number of landing gear cycles than airplanes not used for training. If the down (landing gear extended) detent was worn significantly or the spring had lost its ability to hold the handle in the detent, the likelihood of the switch being moved from the down position to the up position as a result of contact with the pilot's knee is increased.

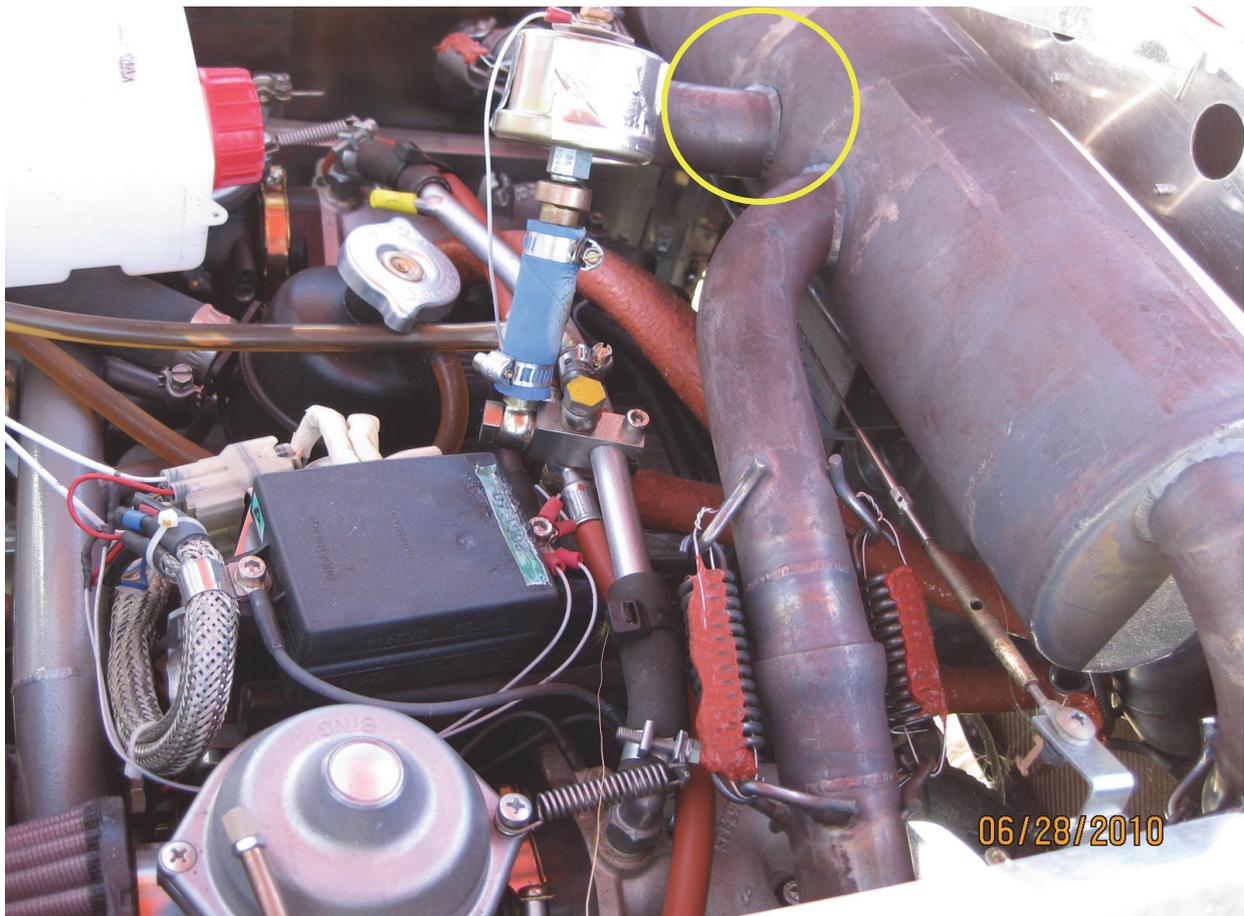
Figure 1

Upon examination, it was found that an exhaust pipe welded to the expansion box under the engine cowling had failed at the weld (Figure 1) and the hot gases thereby released had damaged several components in the area, including the throttle cable, and had partially melted the battery. It was clear that the throttle problems were caused by heat deterioration of the throttle cable and the landing gear system, which is electro-hydraulic, had been unable to function due to the battery damage. It should have been possible to actuate the standby free-fall landing gear extension, but this was not attempted by the pilot.

View of the engine compartment of a Titan T51 (not G-MUZY). Note presence of a crack (circled) in the exhaust similar to that thought to be responsible for the failure on G-MUZY

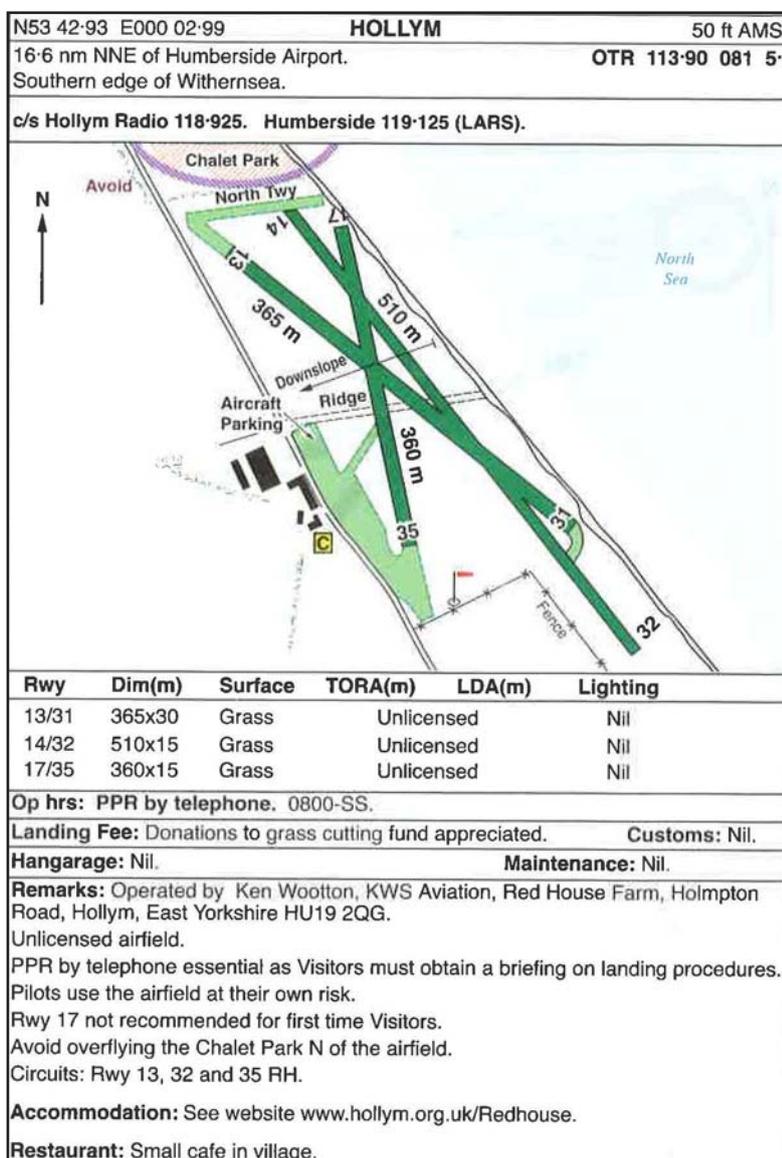
Figure 1
Airfield chart for Hollym

The pilot now realises that the term “cliff-top” runway was intended to describe Runway 32 but he states that it was difficult to discern this runway due to a lack of recent mowing and that it appeared closer to the cliff edge than depicted on the airfield chart. He

states that other diverting aircraft also had similar problems in establishing which the suggested runway was. He believes that it was the very wet condition of Runway 31 which led to the lack of braking action but is of the opinion that he made the correct decision to
