CONTENTS

(ALL TIMES IN THIS BULLETIN ARE UTC)

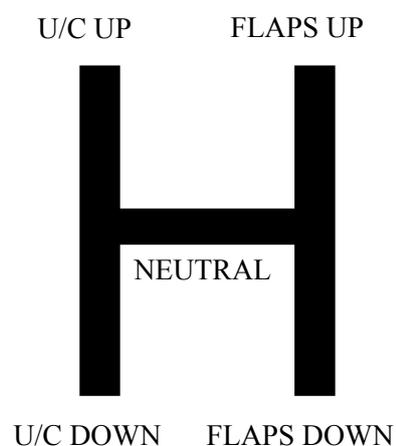
Figure 1

Schematic representation of the hydraulic selector lever gate

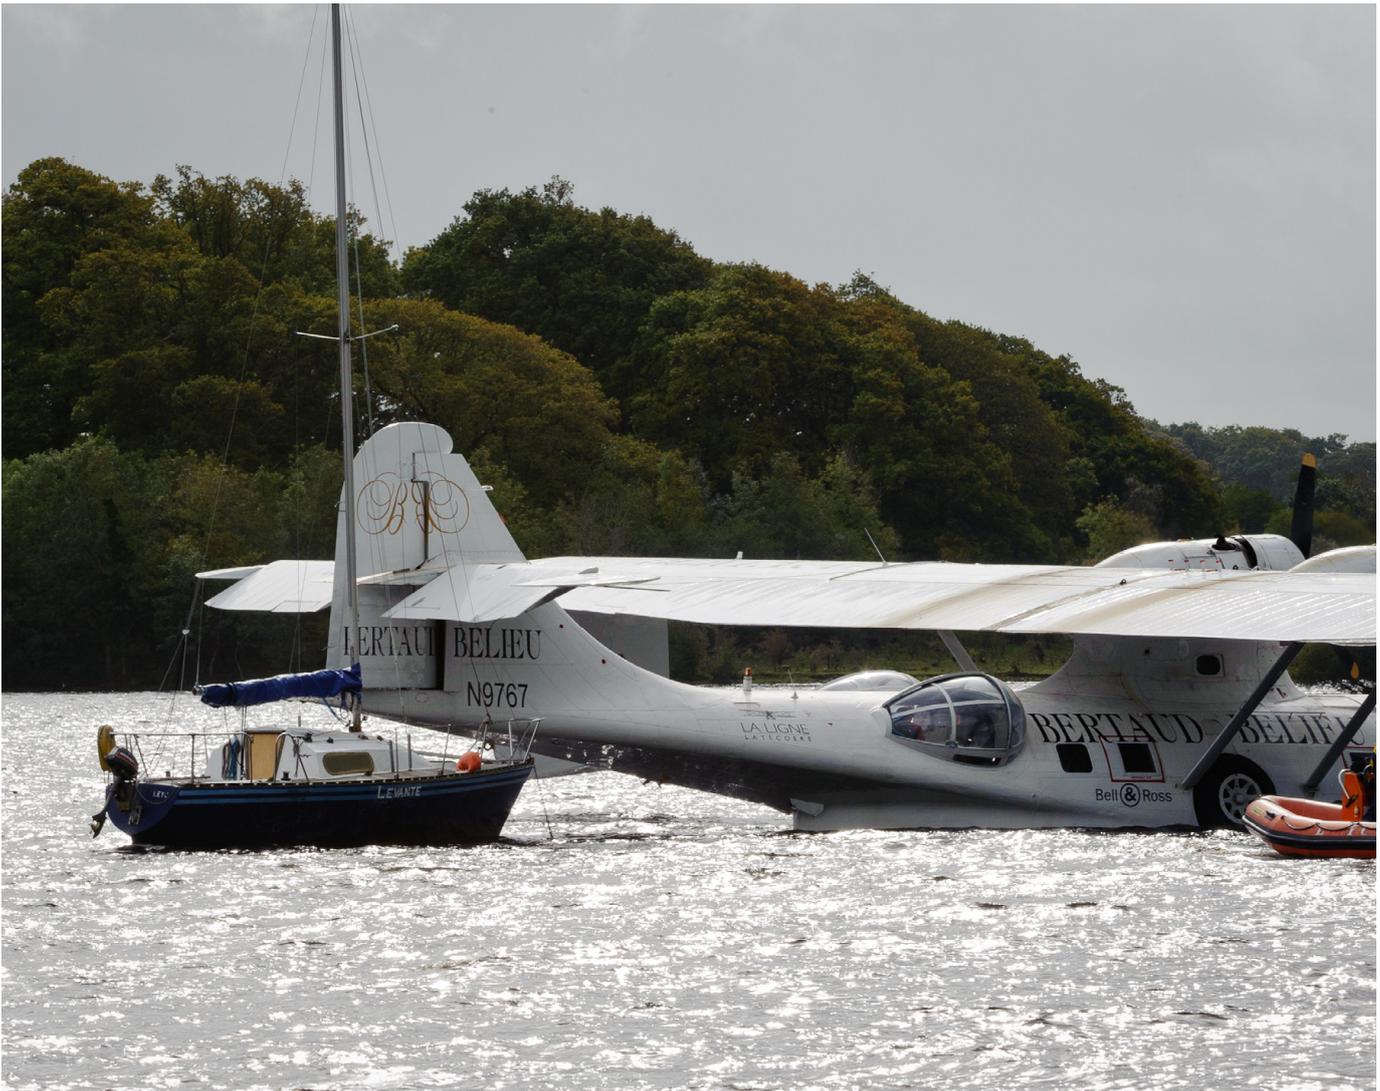
Figure 1

The marshal boat crews, the crew of the other Catalinas, and many other witnesses were surprised to see the engines on N9767 shut down and they assumed it must have a problem. The Chief Marshal with N9767's ground crewman were the first on the scene, and after a brief conversation they attempted to attach a line to N9767. The French ground crewman spoke limited English and the Chief Marshal could not speak French. Communications between the French ground crewman and the aircraft crew were predominately in French. Eventually a line was attached, but as they tried to take N9767 under tow, the line fell into the water and became tangled in the boat's propeller. The ground crewman then tried to prevent the boat from becoming separated from the Catalina, and ended up falling into the water. Another marshal boat arrived on scene and went to the aid of the ground crewman in the water, but its propeller also became tangled in the line, rendering the boat helpless. A third marshal boat arrived, but it was unable to prevent N9767 from drifting towards a moored yacht. Because of the proximity of small boats, N9767 was unable to restart its engines, and so it continued to drift backwards into the moored yacht, damaging its right elevator. (See Figure 1)

The Catalina contacting the yacht

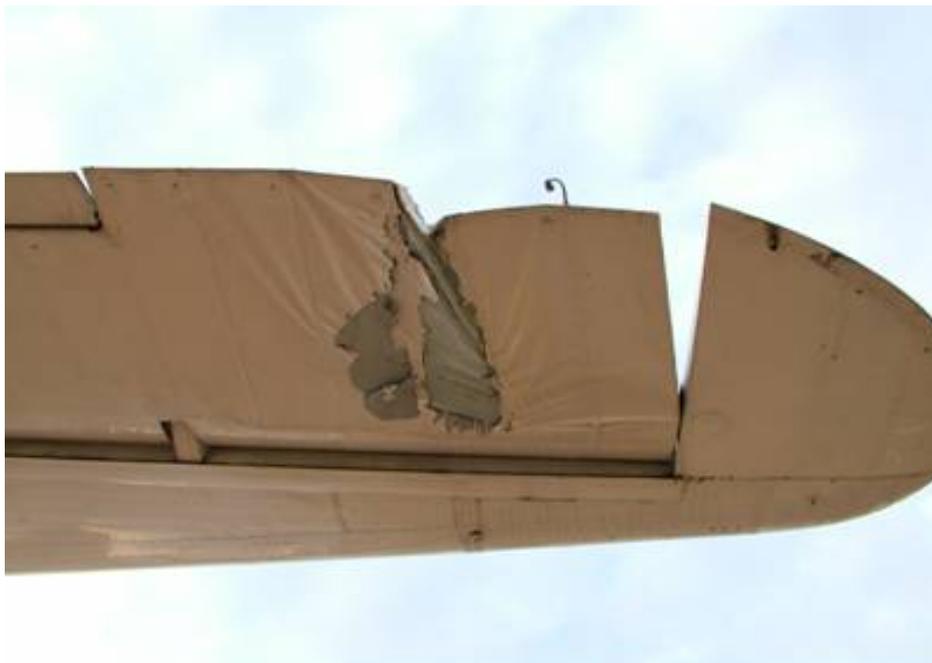
Figure 2

Damage to the Catalina's elevator

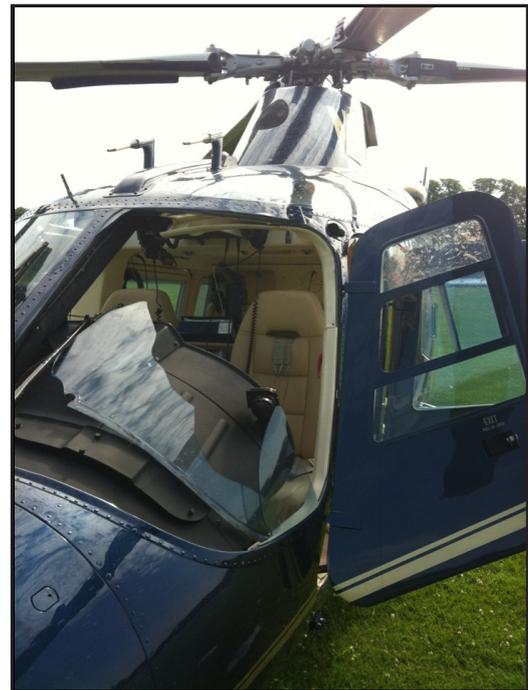
Figure 1

(Figure 1). The maintenance organisation's engineer reported that the largest of these was about 30 cm by 45 cm, several pieces were about 15 cm by 15 cm, and many other pieces were much smaller. He reported that none of the pieces had broken into sharp fragments. The windshield was of a type that had a thickness of $3.81 \text{ mm} \pm 0.5 \text{ mm}$ (part number 109-0310-27-3).

The photographic evidence revealed substantial blood spatter on the left door post adjacent to the commander's seat indicating that the bird probably struck this post after shattering the windshield. The bird, which was mostly intact, was found inside the helicopter and was identified as a Herring Gull. The bird was not sent for analysis but the typical weight of a Herring Gull is 690 to 1,495 g and the species is classified as 'High' on the Hazard Probability list¹.

Damage to the left windshield of N109TK

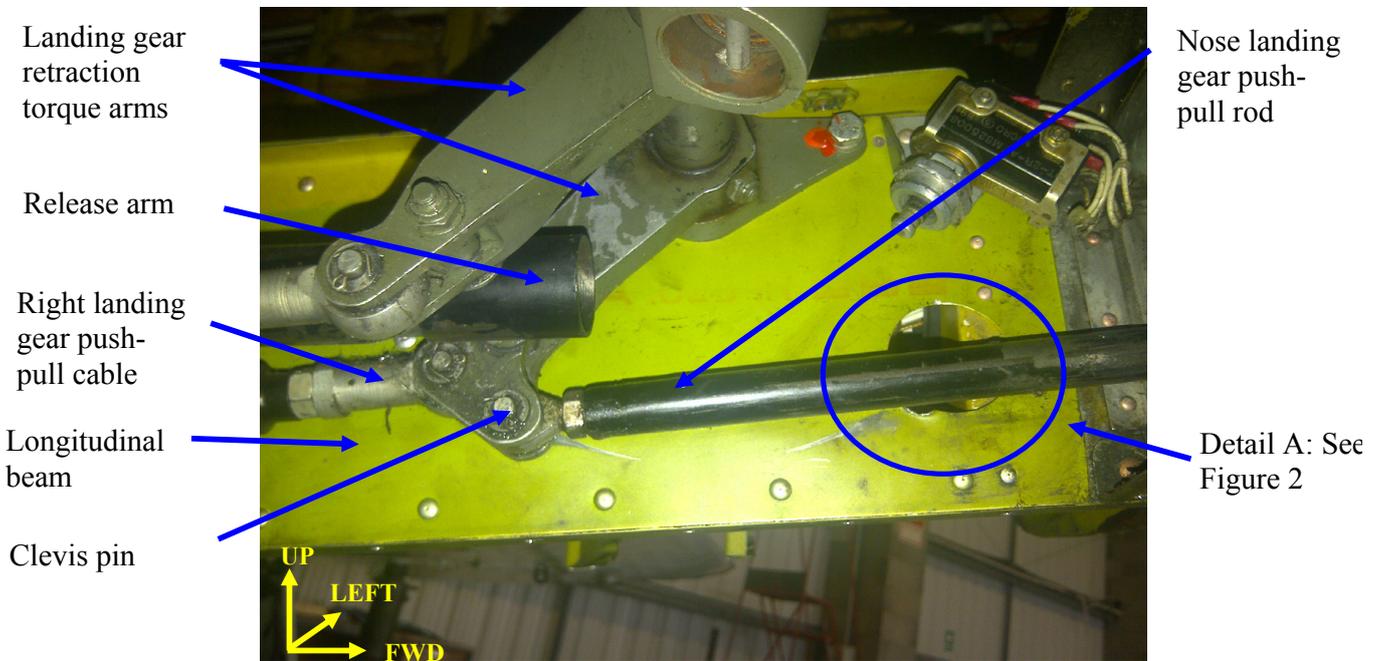
Figure 1

The pilot considers that the right landing gear oleo deflated during the takeoff run at Sherburn-in-Elmet. As a result the torque link became wedged against the edge of the wheel well during retraction, preventing the landing gear from retracting fully. The landing gear retraction motor would have continued to run, attempting to overcome the resistance caused by the jammed torque link. It is likely that the forces

View looking left on landing gear retraction system, landing gear in extended position

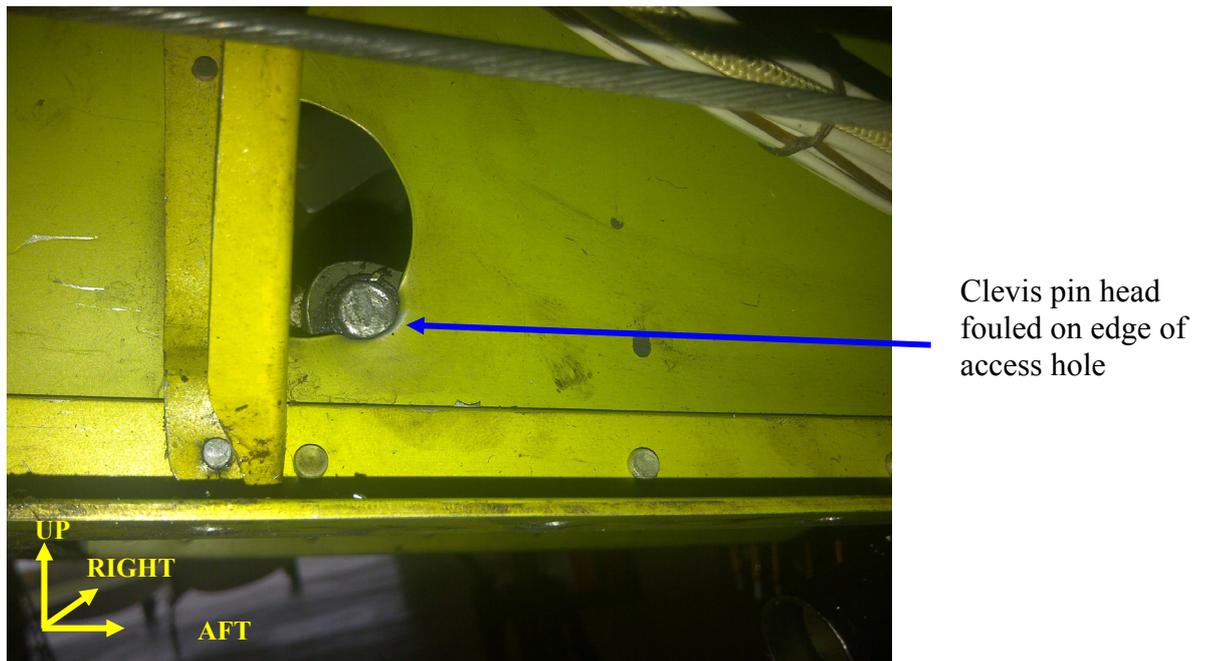
Figure 2

Detail A from Figure 1: Clevis pin fouled on edge of access hole in web of longitudinal beam, landing gear partially retracted

associated with this may have caused misalignment in the transmission assembly, sufficient to reduce the clearance between the nose landing gear push-pull rod and the longitudinal beam, leading to interference between the clevis pin and the beam. In this condition it was not possible to lower the landing gear either by the normal method or with the emergency extension

The reason for the right landing gear oleo deflation could not be determined from strip examination but all the seals were replaced as a precaution.

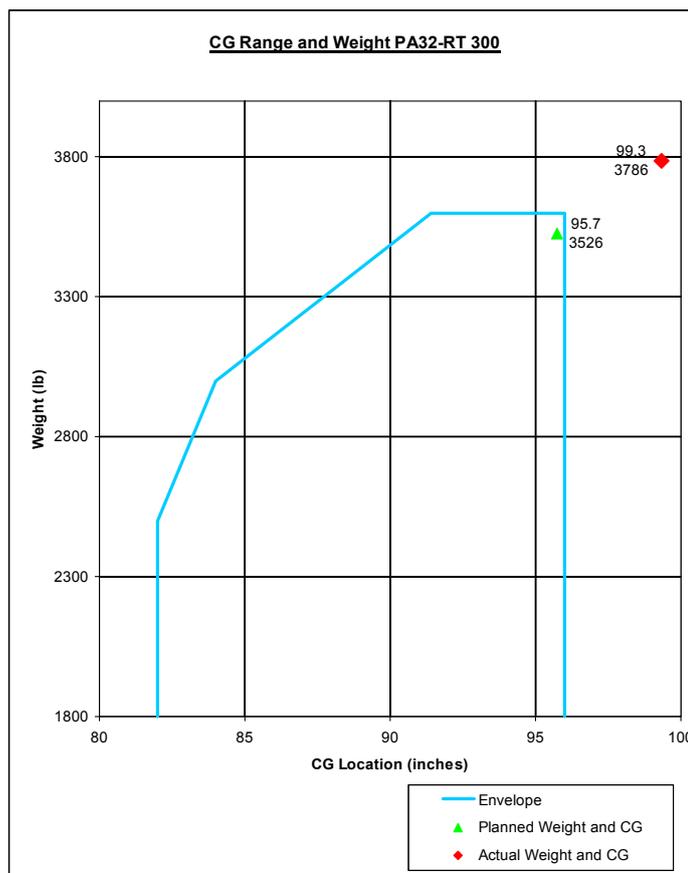
Figure 1,
Flight Envelope

The pilot stated that he did not have access to the actual passenger and baggage weights and therefore assumed values for his weight and balance calculation. He calculated a takeoff weight of 3,526 lb and a CG of 95.75 inches behind the datum. Analysis of aircraft weight and balance using the actual weights for the occupants and their baggage produced a takeoff weight of 3,786 lb and a CG of 99.34 inches aft of the datum, exceeding the weight limit by 186 lb, and CG aft limit by 3.34 inches. The CG range and weight chart, overlaid with these points, is shown in Figure 1.
