CONTENTS

SPECIAL BULLETINS

(ALL TIMES IN THIS BULLETIN ARE UTC)

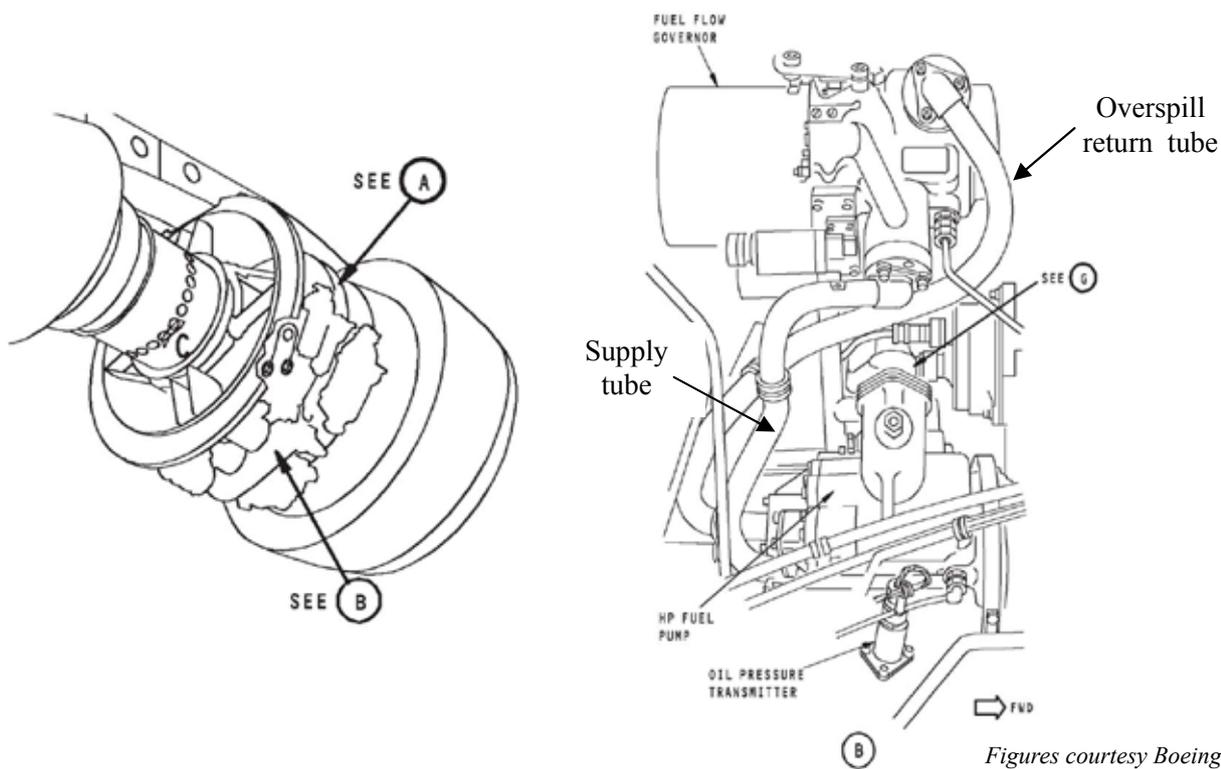
Figure 1

The operator's maintenance engineer traced the fuel leak to the seal ring between the HP fuel pump and the fuel flow governor (FFG) to HP fuel pump overspill return tube on the left-hand engine (shown in Figures 1 and 2). He therefore replaced this seal ring on both engines in accordance with the aircraft maintenance manual and a second maintenance engineer conducted a duplicate inspection, following which both engines were ground run at maximum static EPR to check for leaks. No fuel leaks were observed during this test and the aircraft was released to service.

Location of the HP fuel pump and FFG on the RB211-535E4 engine

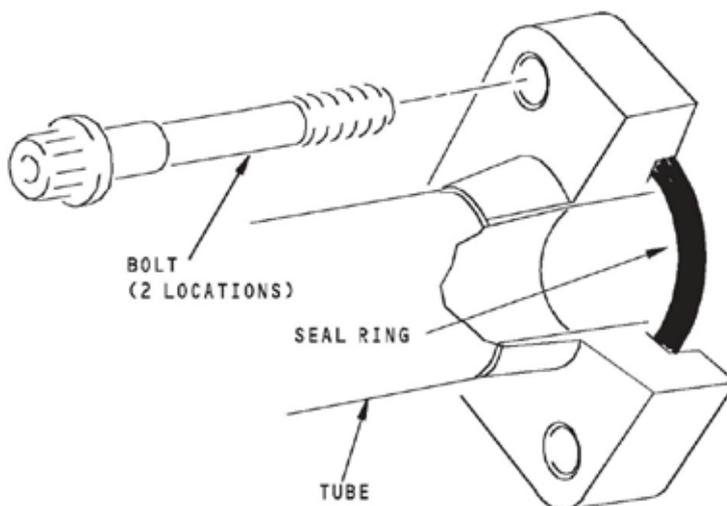
Figure 2

FFG fuel overspill return tube coupling at the HP fuel pump (post SB RB.211-73-B047)

Investigation undertaken by the engine manufacturer determined that the width of the seal ring groove in the fuel tube end adapter was insufficient to allow the seal ring to seat properly in the groove when the joint was compressed during torque tightening of the assembly. If the seal ring did not seat correctly, it was possible for it to become pinched at the corners of the groove. The action of vibration and fuel pressure fluctuations caused portions of the pinched seal ring to erode, resulting in a loss of sealing capability.

As the seal ring removed from the aircraft was discarded following the incident, contrary to the operator's maintenance organisation's procedures, it has not been possible to identify positively the cause of the fuel leak. However, given the recorded history of fuel leaks due to trapping and subsequent erosion of the seal ring on engines without SB RB.211-73-G230 embodied, it is considered that this is the most likely mechanism that caused the fuel leak in this incident.

In response, the engine manufacturer introduced a further SB, RB.211-73-G230, in November 2009 that increased the width of the seal ring groove from 2.60 mm to 4.15 mm. No engines incorporating this SB have subsequently experienced fuel leaks at the HP fuel pump fuel tube couplings. The engine manufacturer comments that compliance guidance contained in this SB currently recommends embodiment of this modification when the engine is disassembled for refurbishment or overhaul. The modification is currently optional on-wing, when the parts require renewal or when the fuel tube connections are disturbed during maintenance.

Recent human factors analysis by the engine manufacturer indicates acceptable reliability when tubes are replaced during planned on-wing maintenance. Hence a revision to the Service Bulletin is planned, to recommend on-wing replacement during planned maintenance and during unplanned overhaul shop visits. Hence, it is expected that this modification will be fully implemented into the fleet by the end of 2013 and progress against this target will be monitored.

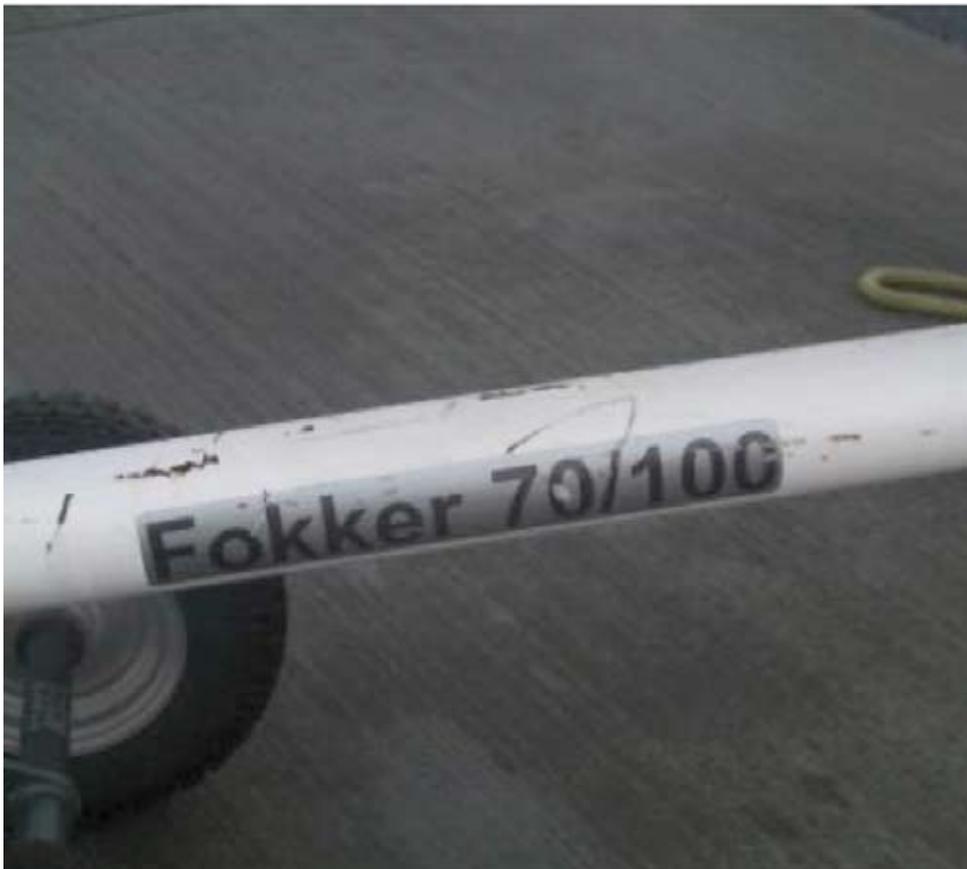
Figure 1

F100 towbar clearly marked
(photograph courtesy of ground handling company)

For all in-service towbars it recommended monitoring and periodic checking for clear markings, and that the service check by the towbar maintenance provider be revised to include a check for clear markings.

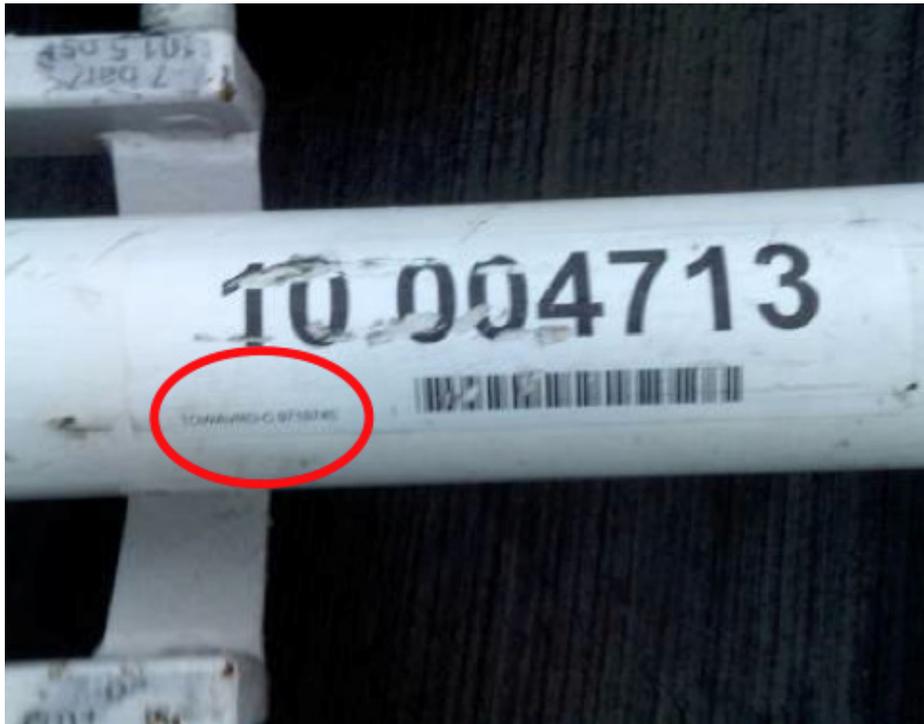
Figure 2

Avro RJ towbar markings circled
(*photograph courtesy of ground handling company*)

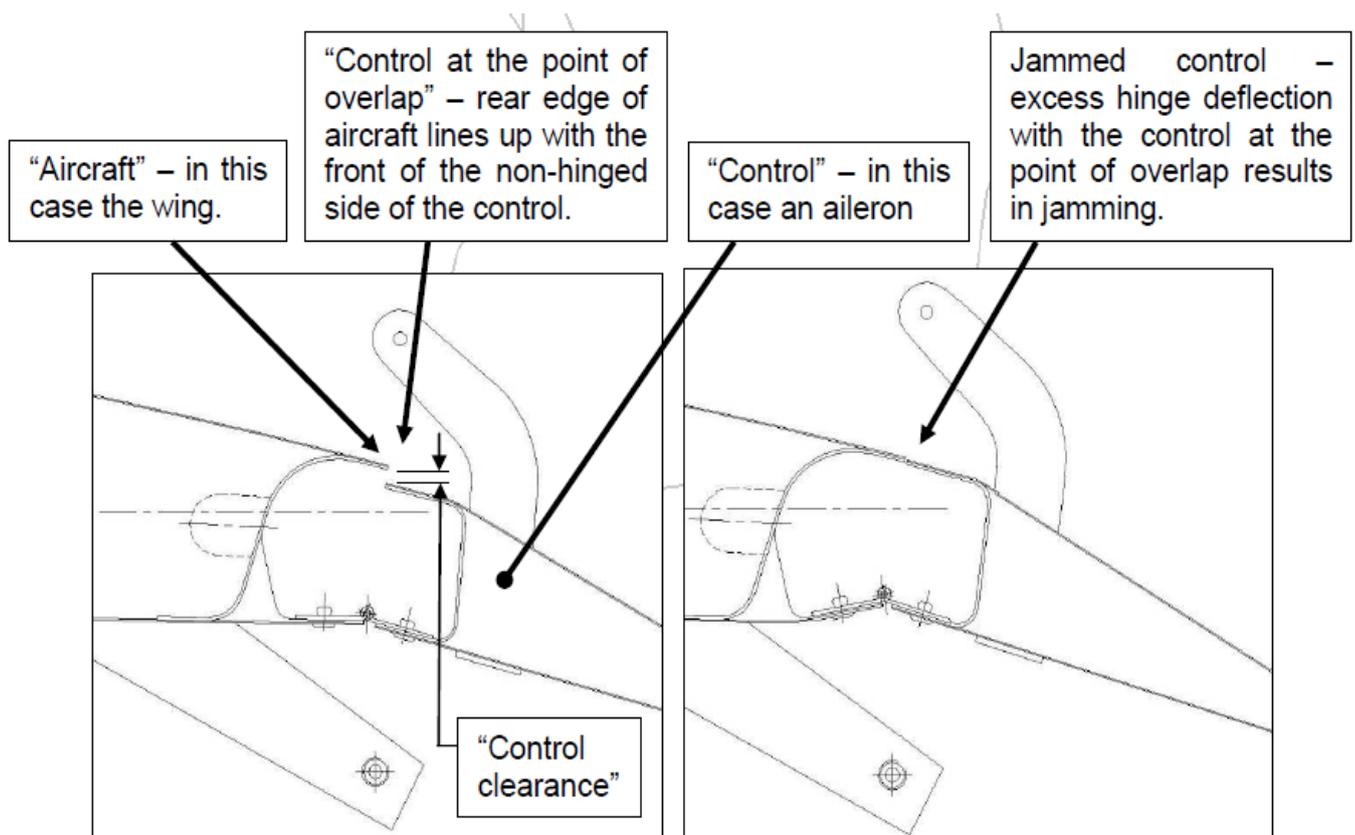
Figure 1 shows a generic control surface and how hinge deflection can result in a jammed condition. In this example it can be seen that a lack of clearance will result in rubbing, with a jam occurring when the surface moves to the point where there is no longer any overlap.

Illustration of a normal and jammed control, taken from JSB 019-2

Following the next incident, in July 2010, in which the rudder jammed in flight, the LAA reviewed their advice and re-issued the AILs, this time recommending that checks be conducted against JSB 019-1.

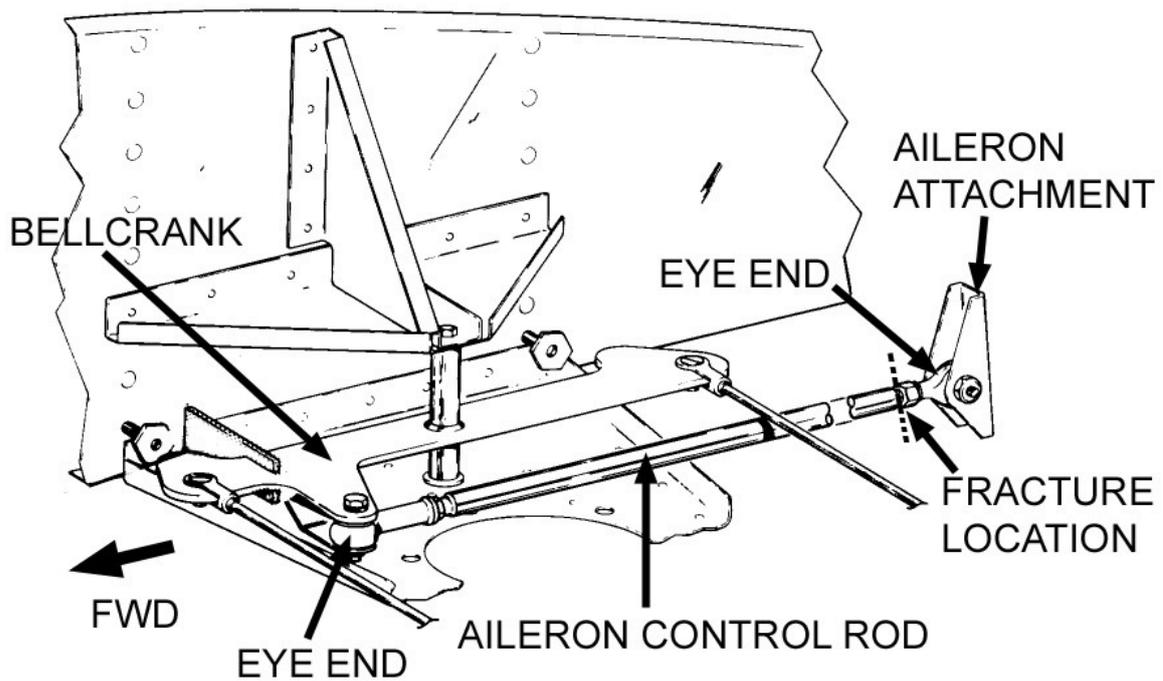
Figure 1

Shortly after departure the pilot noticed a loss of aileron control and made an uneventful diversion and landing using the rudder to control bank and heading. The eye end on the right aileron control rod had failed at the aileron due to reverse bending fatigue. This was caused by the bearing in the eye end having seized, due to corrosion and an absence of lubrication.

Location of aileron control rod and fractured eye end

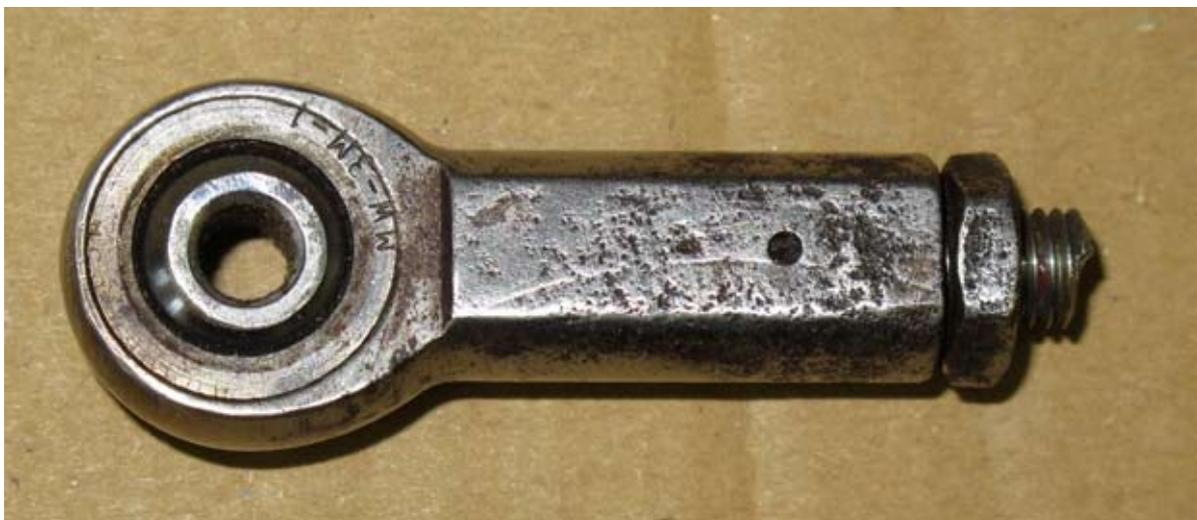
Figure 2

G-BTAM right aileron control rod eye end with fractured threaded shank

plain bearing of the eye end was seized. There was no evidence of lubricating oil inside the bearing and there was evidence of corrosion build-up between the ball

and the race of the bearing. There was also evidence of corrosion and corrosion pitting on the external surfaces of the eye end.

The aileron control rod end had failed as a result of reverse bending fatigue and this fatigue failure was probably a consequence of the bearing seizure in the eye end. Once the ball in the eye end had seized, any further movement of the aileron would only have been possible due to slippage of the bolt relative to the eye end. However, the eye end would not have rotated freely around the bolt so this would have introduced bending loads on the threaded shank. It was these repetitive bending loads which probably resulted in the rod end failing. Thus, the bearing had seized due to corrosion and an absence of lubricating oil and this corrosion was probably exacerbated by the aircraft being parked outside in an environment close to the sea with a '*severe*' corrosion risk. The pilot/owner candidly admitted that he should have inspected and lubricated the rod end bearing more frequently, given its operating environment.

The aircraft maintenance manual requires that the aileron control rod eye end bearing is lubricated every 100 hours with a MIL-L-7870 standard oil, which lubricates and provides protection against corrosion. The aircraft's last annual inspection was completed on 18 February 2010 at 3,488 airframe hours, when the rod end was reportedly lubricated. The pilot had subsequently carried out a 50-hour maintenance check on 11 June 2010, at 3,536 airframe hours, but had not lubricated the aileron control rod eye ends. The airframe hours at the time of the eye end failure were 3,586 hours – 2 hours short of when the next 50-hour check and the 100-hour lubricating check would have been required.
