## CONTENTS

**(ALL TIMES IN THIS BULLETIN ARE UTC)**

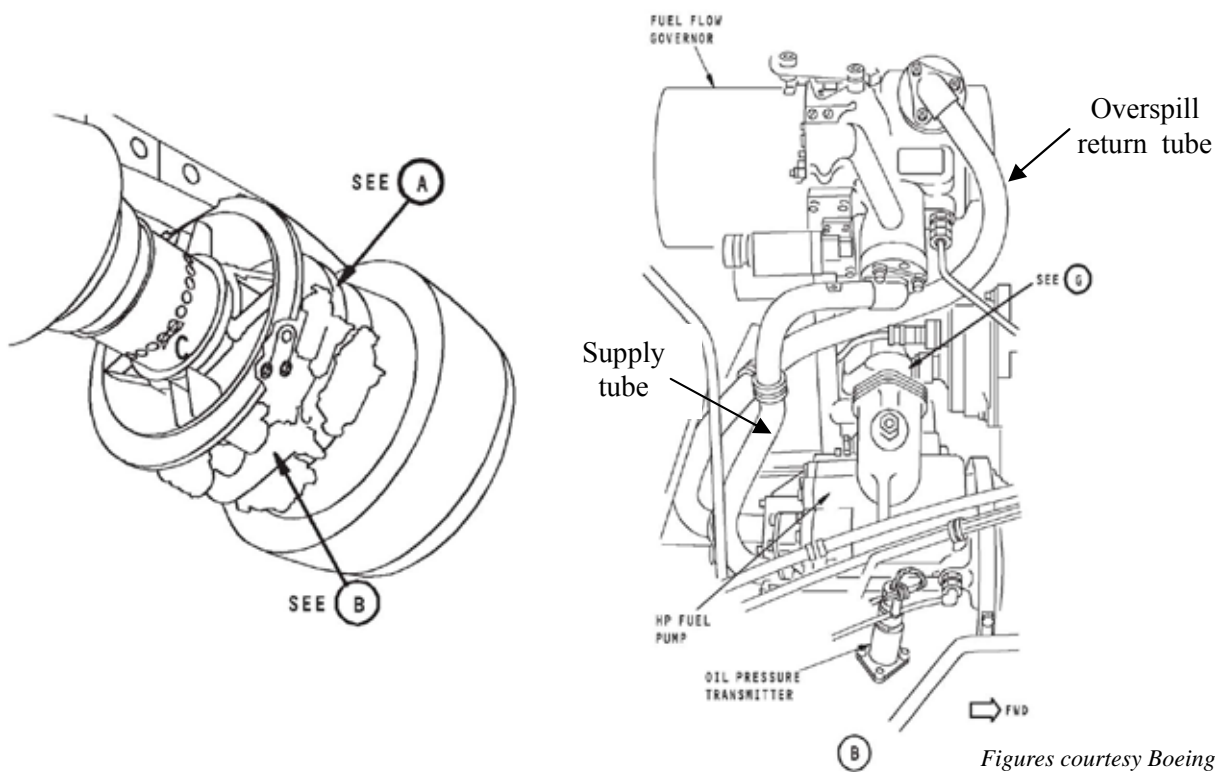
**Figure 1**

The operator's maintenance engineer traced the fuel leak to the seal ring between the HP fuel pump and the fuel flow governor (FFG) to HP fuel pump overspill return tube on the left-hand engine (shown in Figures 1 and 2). He therefore replaced this seal ring on both engines in accordance with the aircraft maintenance manual and a second maintenance engineer conducted a duplicate inspection, following which both engines were ground run at maximum static EPR to check for leaks. No fuel leaks were observed during this test and the aircraft was released to service.

Investigation undertaken by the engine manufacturer determined that the width of the seal ring groove in the fuel tube end adapter was insufficient to allow the seal ring to seat properly in the groove when the joint was compressed during torque tightening of the assembly. If the seal ring did not seat correctly, it was possible for it to become pinched at the corners of the groove. The action of vibration and fuel pressure fluctuations caused portions of the pinched seal ring to erode, resulting in a loss of sealing capability.

As the seal ring removed from the aircraft was discarded following the incident, contrary to the operator's maintenance organisation's procedures, it has not been possible to identify positively the cause of the fuel leak. However, given the recorded history of fuel leaks due to trapping and subsequent erosion of the seal ring on engines without SB RB.211-73-G230 embodied, it is considered that this is the most likely mechanism that caused the fuel leak in this incident.

In response, the engine manufacturer introduced a further SB, RB.211-73-G230, in November 2009 that increased the width of the seal ring groove from 2.60 mm to 4.15 mm. No engines incorporating this SB have subsequently experienced fuel leaks at the HP fuel pump fuel tube couplings. The engine manufacturer comments that compliance guidance contained in this SB currently recommends embodiment of this modification when the engine is disassembled for refurbishment or overhaul. The modification is currently optional on-wing, when the parts require renewal or when the fuel tube connections are disturbed during maintenance.

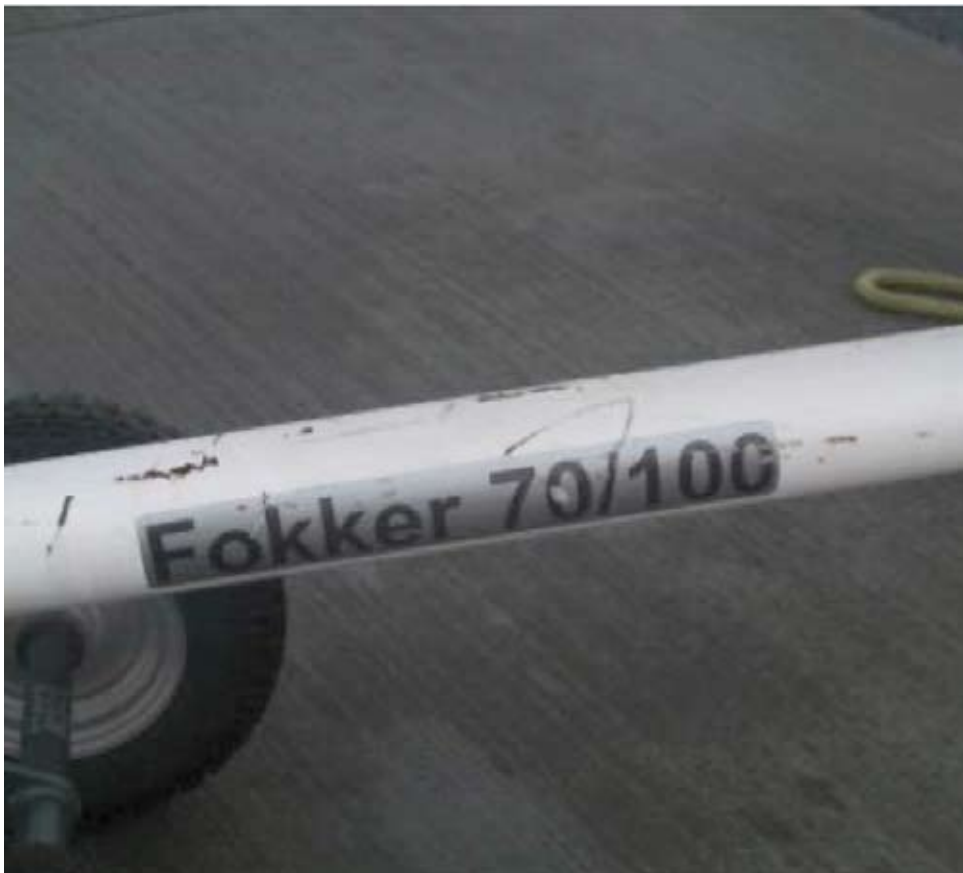
**Figure 1**

F100 towbar clearly marked  
*(photograph courtesy of ground handling company)*

For all in-service towbars it recommended monitoring and periodic checking for clear markings, and that the service check by the towbar maintenance provider be revised to include a check for clear markings.

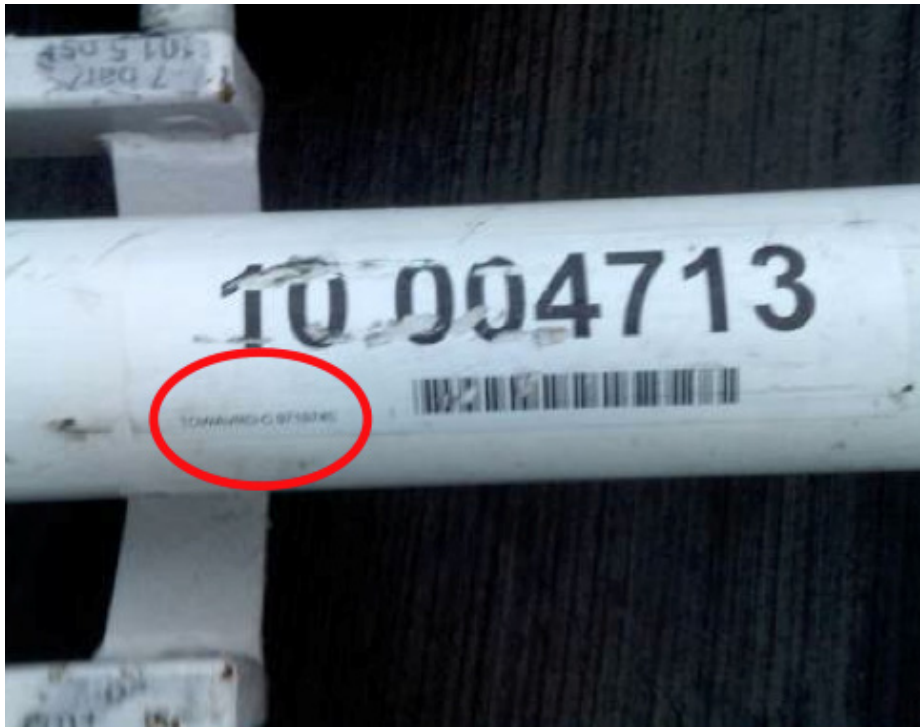
**Figure 2**

Avro RJ towbar markings circled  
(*photograph courtesy of ground handling company*)

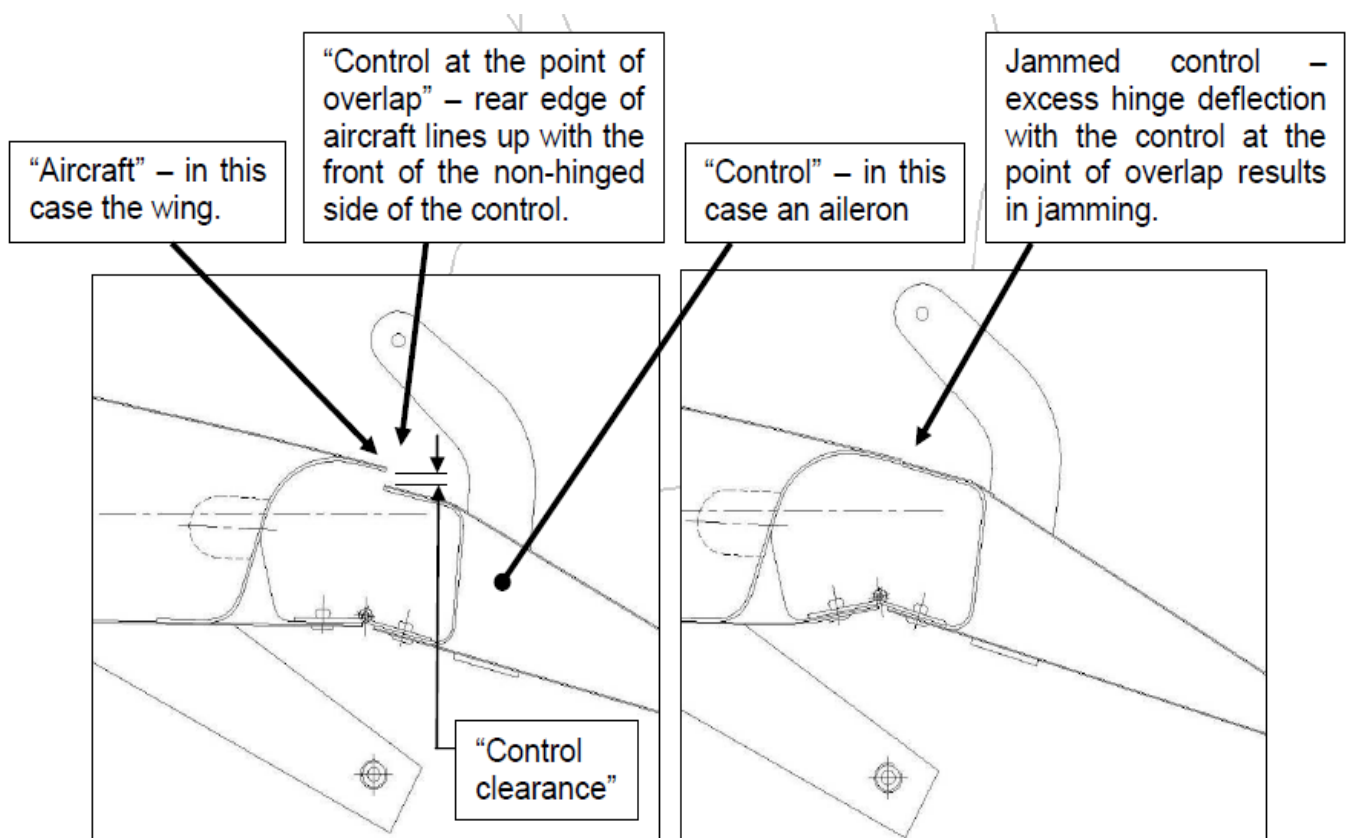
**Figure 1**

Figure 1 shows a generic control surface and how hinge deflection can result in a jammed condition. In this example it can be seen that a lack of clearance will result in rubbing, with a jam occurring when the surface moves to the point where there is no longer any overlap.

Illustration of a normal and jammed control, taken from JSB 019-2

Following the next incident, in July 2010, in which the rudder jammed in flight, the LAA reviewed their advice and re-issued the AILs, this time recommending that checks be conducted against JSB 019-1.

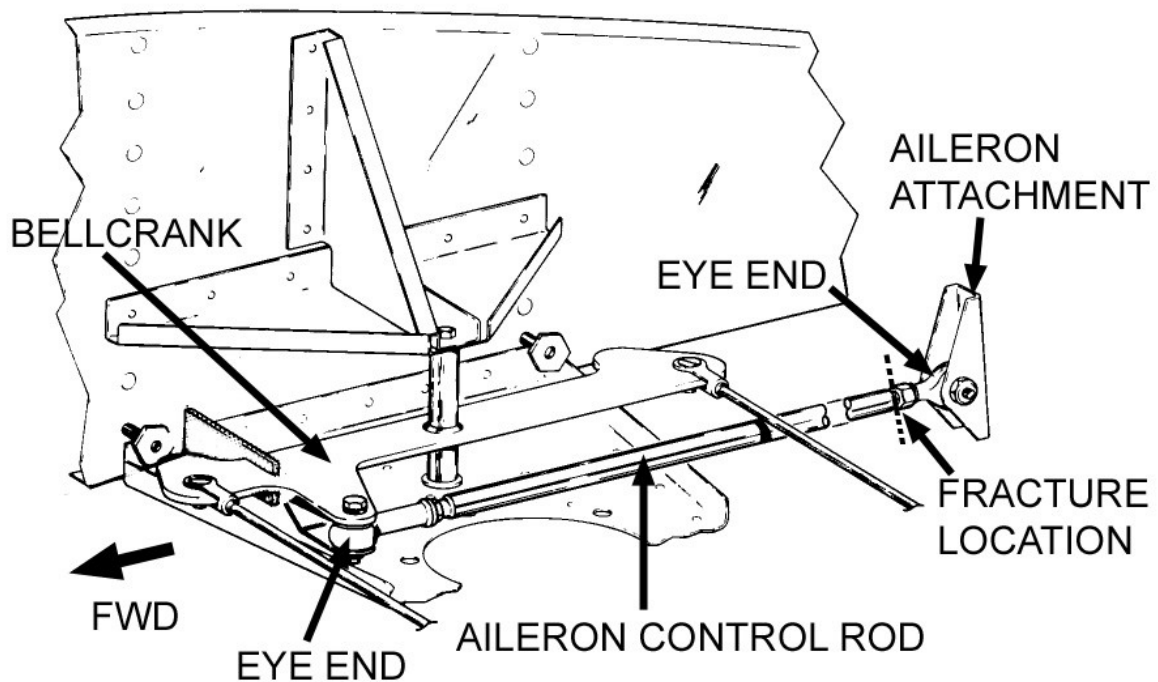
**Figure 1**

Shortly after departure the pilot noticed a loss of aileron control and made an uneventful diversion and landing using the rudder to control bank and heading. The eye end on the right aileron control rod had failed at the aileron due to reverse bending fatigue. This was caused by the bearing in the eye end having seized, due to corrosion and an absence of lubrication.

Location of aileron control rod and fractured eye end

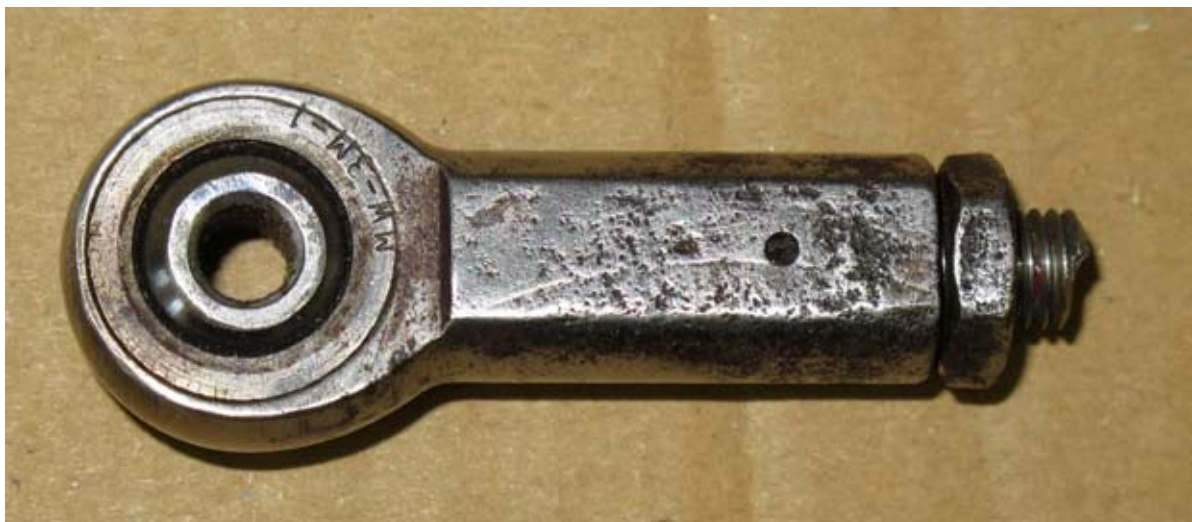
**Figure 2**

G-BTAM right aileron control rod eye end with fractured threaded shank

plain bearing of the eye end was seized. There was no evidence of lubricating oil inside the bearing and there was evidence of corrosion build-up between the ball

and the race of the bearing. There was also evidence of corrosion and corrosion pitting on the external surfaces of the eye end.

The aileron control rod end had failed as a result of reverse bending fatigue and this fatigue failure was probably a consequence of the bearing seizure in the eye end. Once the ball in the eye end had seized, any further movement of the aileron would only have been possible due to slippage of the bolt relative to the eye end. However, the eye end would not have rotated freely around the bolt so this would have introduced bending loads on the threaded shank. It was these repetitive bending loads which probably resulted in the rod end failing. Thus, the bearing had seized due to corrosion and an absence of lubricating oil and this corrosion was probably exacerbated by the aircraft being parked outside in an environment close to the sea with a '*severe*' corrosion risk. The pilot/owner candidly admitted that he should have inspected and lubricated the rod end bearing more frequently, given its operating environment.

The aircraft maintenance manual requires that the aileron control rod eye end bearing is lubricated every 100 hours with a MIL-L-7870 standard oil, which lubricates and provides protection against corrosion. The aircraft's last annual inspection was completed on 18 February 2010 at 3,488 airframe hours, when the rod end was reportedly lubricated. The pilot had subsequently carried out a 50-hour maintenance check on 11 June 2010, at 3,536 airframe hours, but had not lubricated the aileron control rod eye ends. The airframe hours at the time of the eye end failure were 3,586 hours – 2 hours short of when the next 50-hour check and the 100-hour lubricating check would have been required.
