CONTENTS

(ALL TIMES IN THIS BULLETIN ARE UTC)

ACCIDENT

Aircraft Type and Registration:	Dassault-Breguet Mystère-Falcon 900B, G-HMEV	
No & Type of Engines:	3 Honeywell TFE731-5BR-1C Turbofan engines	
Year of Manufacture:	1986	
Date & Time (UTC):	20 January 2007 at 1651 hrs	
Location:	Approximately 7 nm south-west of Worthing, Sussex	
Type of Flight:	Commercial Air Transport	
Persons on Board:	Crew - 2	Passengers - None
Injuries:	Crew - None	Passengers – N/A
Nature of Damage:	Severe No 3 Engine damage, nacelle cowl holed, slight damage to the horizontal stabiliser	
Commander's Licence:	Airline Transport Pilot's Licence	
Commander's Age:	38 years	
Commander's Flying Experience:	6,515 hours (of which 3,002 hours were on type) Last 90 days - 139 hours Last 28 days - 45 hours	
Information Source:	AAIB Field Investigation

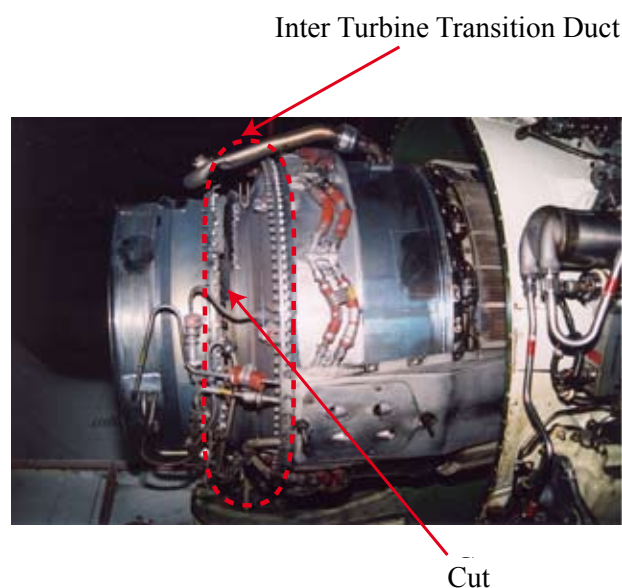
Figure 3

The rear part of the No 3 Engine ITTD had been cut through circumferentially just forward of its aft flange, round 310°. The edges of the cut had been bent outwards, producing a gap in the duct of up to 2 inches (Figure 3). An 8-inch length of the circumference on the left side remained intact. The panels covering the engine hot section had sustained multiple impact damage in a band centred on the cut in the ITTD, together with overheating

discoloration of the paint in this area. The damage included extensive holing of the panels; one area of holing coincided with the hole in the cowl.

No 3 Engine Turbine Assembly

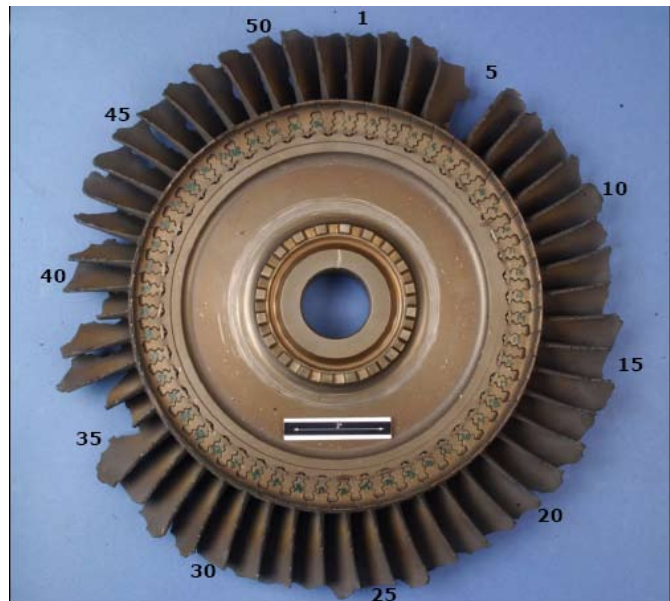
Figure 4

The outer portion of all Stage 2 blades had broken off, generally at around 1.5-2.0 inches from the root platform. However, three of the blades had fractured at around 0.5 inches from the root platform and one (No 5, numbered from a clocking index mark on the disk) had fractured at the platform (Figure 4). The outer portion of all Stage 3 blades had broken off, generally at around 70% span. Only a relatively small amount of the debris fractured from the turbine assembly remained with the powerplant, most of it having been ejected overboard. In particular, most parts of the Stage 2 and Stage 3 stators were absent.

The nature of the damage indicated that the disruption had resulted from a failure in the Stage 2 or Stage 3 of the LP turbine assembly. The leading edge damage to the Stage 1 turbine blades was consistent with the effects of limited forward penetration of debris into this region. The fracture surfaces of those stator and turbine blade parts that were available had features consistent with failure due to overload and no signs were found of pre-existing fractures, with the exception of the Stage 2 No 5 blade, as described below.

Stage 2 LP Turbine

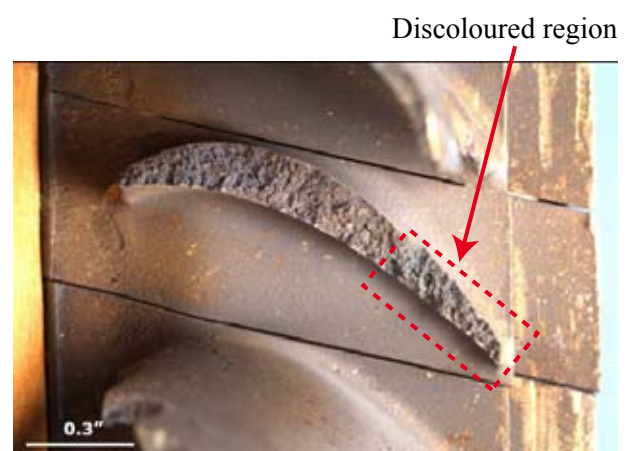
Figure 5

The fracture surface of the No 5 blade exhibited a discoloured region, extending over the rear one-third of the section, where the surface had a darker

appearance than for the remainder of the fracture (Figure 5). Detailed scanning electron microscope (SEM) examination of the discoloured region showed features of heavy oxidation and areas with a smooth appearance, lacking typical fracture features. The characteristics indicated that these areas had been unbonded, ie the material had been separated before the blade had failed. Features evident with the SEM on the

Stage 2 LP Turbine No 5 Blade

un-discoloured part of the fracture indicated that it had resulted from overload. The chordwise extent of the pre-existing crack was around 0.3 inches.

Positive evidence was found of a defect in the Stage 2 No 5 turbine blade, consistent with a hot tear formed during casting. It appeared likely that a defect of the type found could cause a separation fracture of the blade under normal operating loads within the blade's operating time since new and that this had led to the turbine disruption. However, there was no evidence to determine whether the fracture of this blade had in fact initiated the turbine assembly break-up sequence, or had resulted from it, if the initiation event was the failure of

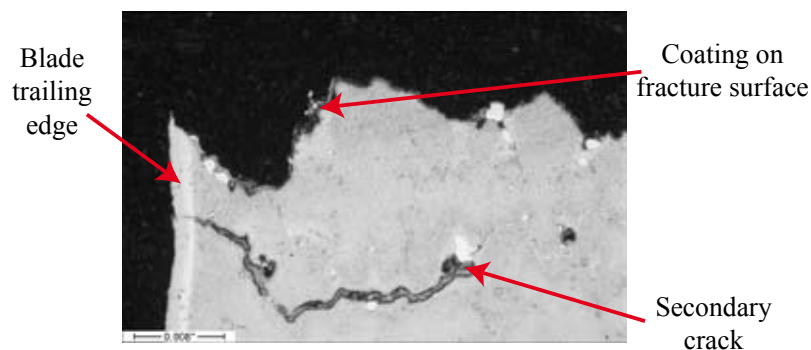
Figure 6

A section cut through the discoloured region revealed a relatively thick coating on the fracture surface, with the appearance of an oxidation product (Figure 6). The sectioning also revealed a secondary crack, beneath the separation fracture surface and generally parallel to it, also coated with the oxidation-type material. The secondary crack extended to the surface of the blade at the trailing edge but, on the plane of the section, was not open at the surface. Some alloy depletion was evident in the parent material beneath the coating layer on both the separation fracture and the secondary crack, also indicative of oxidation effects. Energy dispersive x-ray analysis of the coating layer material revealed the presence of the IN100 base metal elements and of oxygen, again indicative of an oxidation product. Aluminium was not present in a high concentration.

The presence of the secondary crack and the oxidisation both of its surface and of the discoloured region of the separation fracture were evidence of pre-existing cracks in this area that had been open at the blade surface while exposed to the hot oxidising environment. The features were indicative of a casting defect; the metallographic

Section through Discoloured Region of
Stage 2 LP Turbine No 5 Blade

appearance suggested that this had been a ‘hot tear’ (see below). The absence of appreciable aluminium in the oxidisation layers suggested that the cracks had not been open at the blade surface when the aluminide blade coating had been applied.

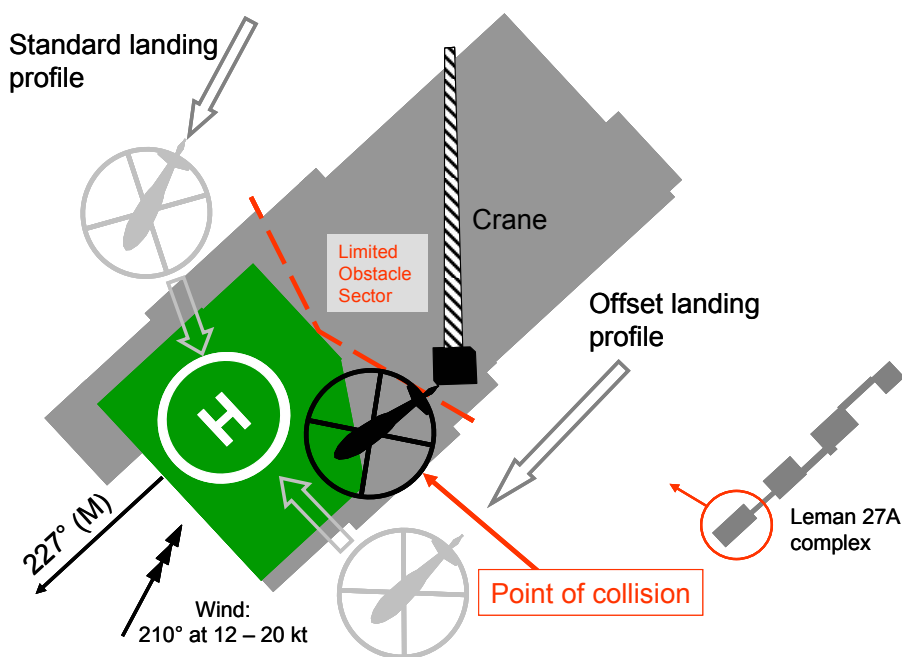
Figure 1

The helicopter had struck guardrails on the crane at a point 12 ft above the deck (Figure 1). It suffered damage to the tail Fenestron fairing and the emergency locating transmitter, which was housed within, was triggered. The helicopter was subsequently transferred by surface vessel to an onshore engineering base for a more detailed inspection. The full extent of the damage was still to be determined at the time of writing, but was likely to be more extensive than the first assessment indicated.

Helicopter's position at point of collision, with examples of standard and offset approaches as described in the operations manual.

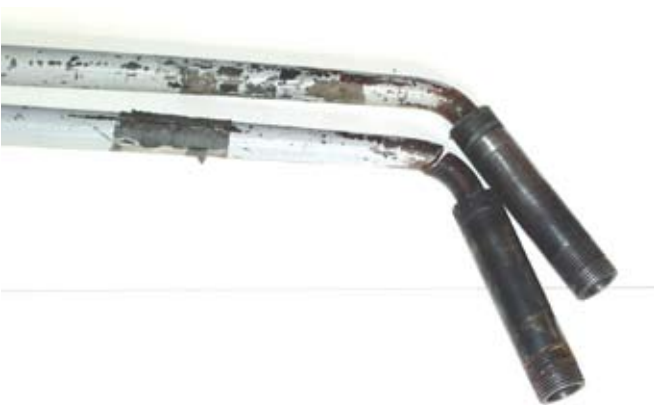
Figure 2

The right and left main gear legs, see Figure 2, were recovered to the AAIB and then sent to a metallurgist for examination. The metallurgist determined that the

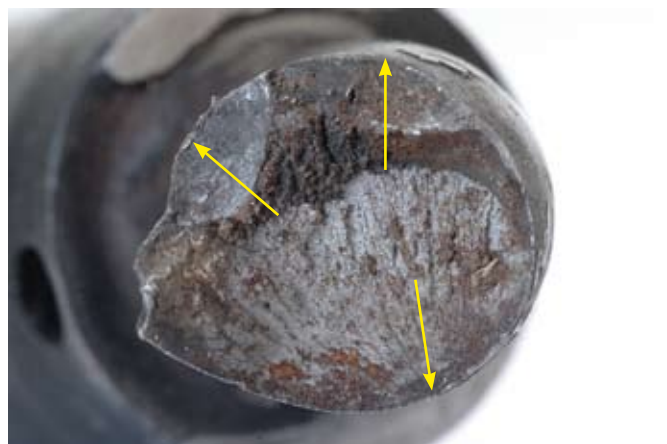
Figure 3

failure had resulted from a low-cycle, high-peak cyclic stress, fatigue mechanism that had initiated in three positions, see Figure 3, although the conditions could not be explained by the normal service loading in a gear leg with uniform properties throughout its volume.

The hardness was measured at several locations in the vicinity of the failure and the material was found to be very soft in the centre (circa 200 HV) and very hard on the surface (greater than 600 HV). It was concluded that the fracture had resulted directly from the use of incorrect heat treatment methods after the strut was fabricated.
