COMMERCIAL AIR TRANSPORT

(ALL TIMES IN THIS BULLETIN ARE UTC)

MESSAGE FROM THE CHIEF INSPECTOR OF AIR ACCIDENTS

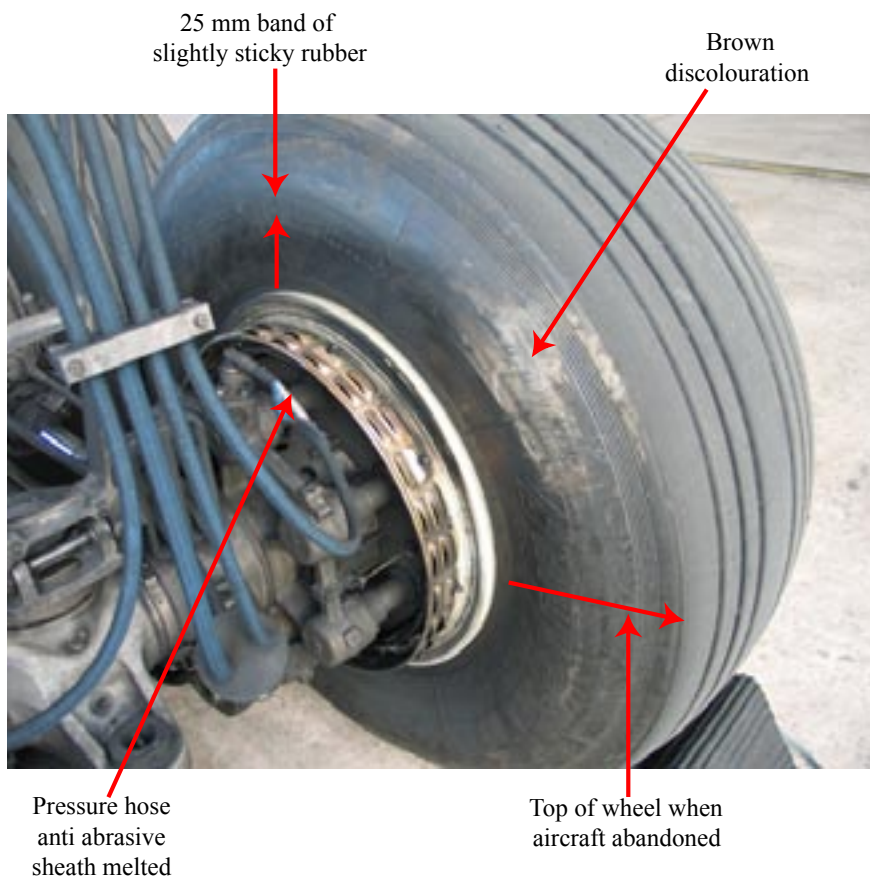
Figure 5

The damage on each pipe was approximately 16 cm long and was on the side of the pipes facing the wheel. There was also slight damage to the inside of the No 10 tyre, consisting of a small brown area of discoloration at the 12 o'clock position, and two areas where the rubber had just started to turn sticky, indicating that these areas had been exposed to temperatures between 100°C and 150°C. Apart from this slight damage, the tyre appeared to be in good condition, Figure 5.

the path of the fire. Nevertheless, there was evidence of light sooting around the top of the No 10 inner wheel rim and on the lower part of the door attached to the MLG leg. The soot pattern indicated that the smoke from the fire passed over the inside of the No 10 wheel at the 11 o'clock position, looking inboard.

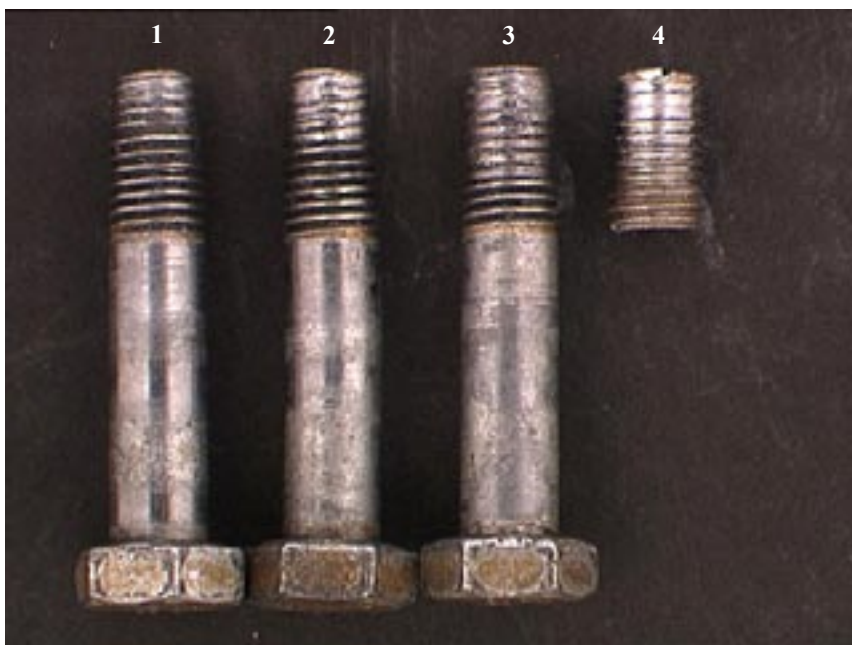
Figure 2 (left)

The four rear support retaining bolts (Figure 1, item 4)
(Note: The numbering of bolts has no relationship to the positions that they were fitted in the rear support; this was not known)

All four retaining bolts had differing amounts of thread stripping. Four threads were stripped from bolt No 1, five from bolt No 2, eight from bolt No 3 and four from bolt No 4. After re-assembling the rear spring support to the fuselage structure, it was apparent that engagement by the attachment bolts with the anchor nuts should reach at least the eighth thread of the bolt and that four threads would protrude beyond the nut. This showed that at the time of thread stripping, only bolt No 3 was fully engaged in its anchor nut. Either four or five threads were stripped from bolts Nos 1, 2 and 4, indicating that these bolts were not fully engaged in their anchor nuts.

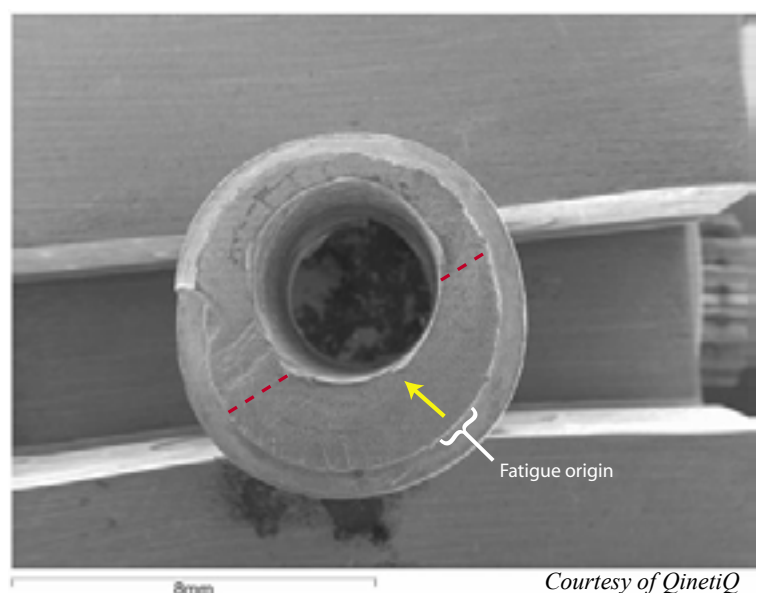
Figure 3 (right)

The three attachment bolts and the remaining section of the fourth bolt, together with the sections of fuselage structure with the mounted self-locking anchor nuts, were submitted for metallurgical examination. This examination showed that bolt No 4 bolt failed due to bending fatigue and the remaining three were pulled from the anchor nuts causing the bolt threads to strip (Figures 2 & 3). The fatigue crack in bolt No 4 had initiated at multiple origins in the thread root and propagated across approximately half the bolt's diameter prior to a final

overload failure. The multiple origins of the fatigue were at one side of the bolt indicating that it was due to bending fatigue. As the orientation of the bolt in the structure was not known, it is not possible to determine the direction of the loading that was responsible for the fatigue in relation to the fore/aft axis of the aircraft. In addition to the fatigue crack observed in bolt No 4, fatigue cracks were also observed in the thread roots of bolt No 1.

Fracture surface of retaining bolt No 4 (fatigue limit highlighted by the red dashed line and direction of growth indicated by yellow arrow)

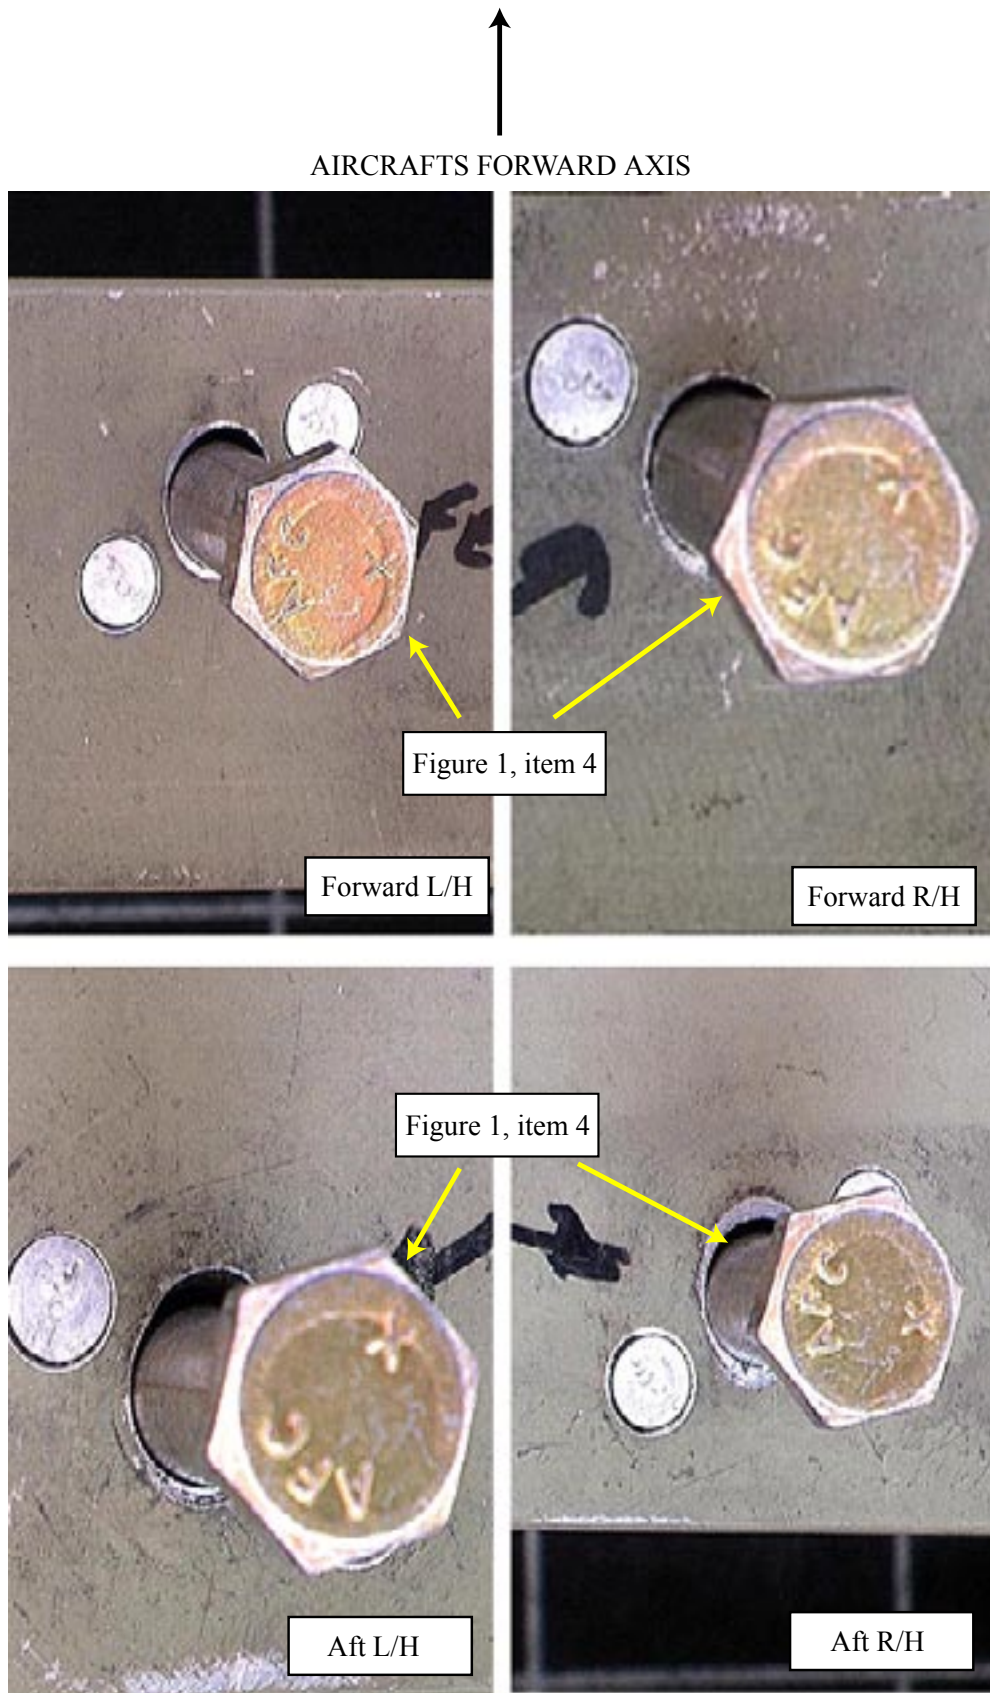
Figure 4

Elongation of the rear support retaining bolt holes in the aircraft's structure

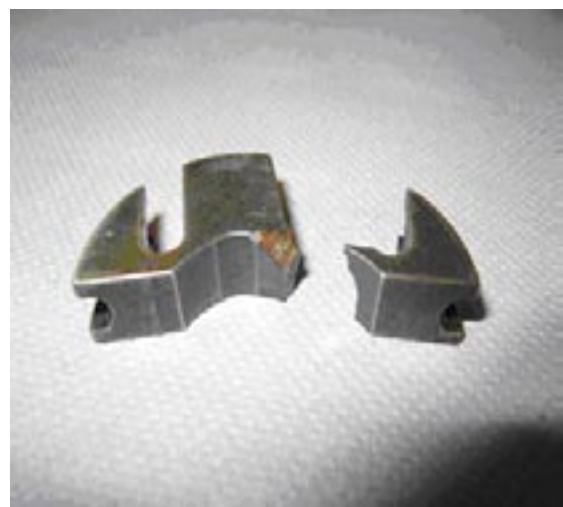
Figure 2

The propeller was then dismantled. The propeller cylinder was found to contain an appropriate quantity of apparently suitable oil, which was clean and bright in colour. The cylinder should be part filled with hydraulic oil to MIL-H-5606 specification. During removal of the feathering spring, the remains of one of the propeller pitch locks was found in the base of the propeller piston together with one of its retaining bolts. The remaining bolt had been partially pulled from its housing and had been distorted. The pitch lock was found in two pieces, having failed across an area of minimum wall thickness adjacent to one of the machined slots used to allow the lock to move under the influence of centrifugal forces in normal operation. (See Figure 2.)

The pitch lock was identified as being part number A-1590. This is an uncoated weight with an open design of slot. It is no longer available, having been replaced on an attrition basis with coated weights, part numbers B-317 and B-318 as appropriate for the propeller. These parts have a different slot design.

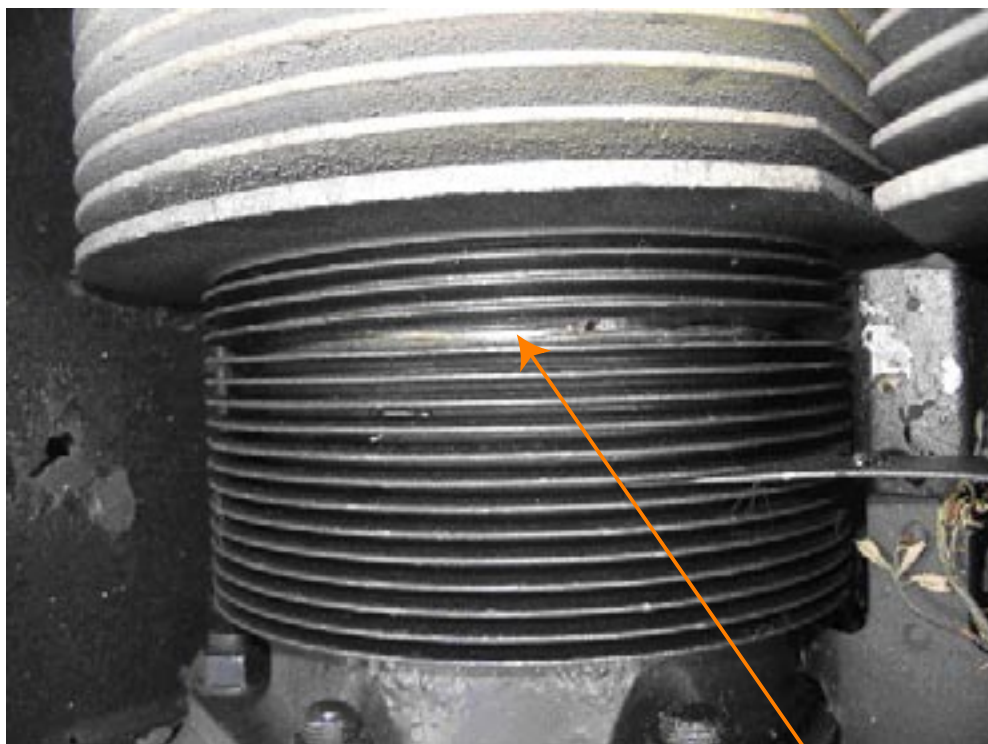
AAIB has not performed a metallurgical examination of this failure but, from discussions with the maintenance organisation, it was almost certainly due to metal fatigue originating in corrosion pitting on the outer surface of the cylinder at the base of the fins. This is a known problem with parts which have a long calendar history and/or very low utilisation. Interrogation of the CAA's Mandatory Occurrence Report database showed that they had been notified of 18 cases of cracking and/or

separation of cylinders over the last ten years, occurring to several different makes and models of engine but all sharing similar construction and layout. The date of original manufacture of the subject cylinder is not known, but it was recorded as being fitted to this engine in August 1996 and had run 1,570 hours since that time. The standard of the cylinder itself suggested that it was of a considerably earlier manufacturing date.

Figure 1
Circumferential failure in cooling fin root

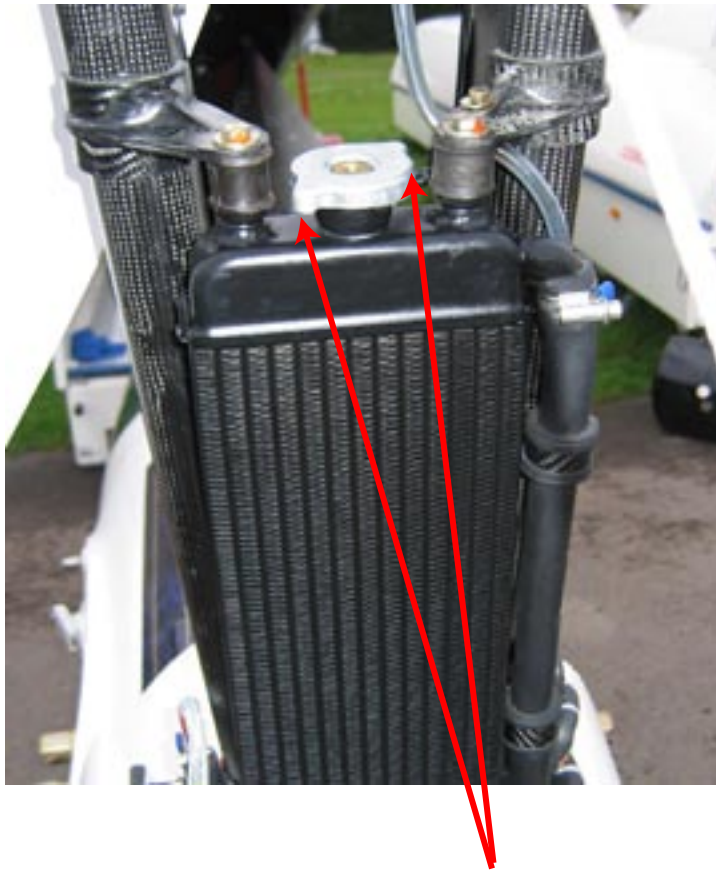
Figure 1

than normal white staining around the radiator filler, consistent with a coolant loss in flight. A maintenance engineer, familiar with the engine, offered the opinion that the position of the radiator within the mast made positioning the cap onto the filler somewhat awkward, and that it was possible to replace the cap incorrectly, allowing coolant to escape under pressure.

Note: Lugs of cap only just pass upper radiator mounts.
Cap shown in fully closed position.

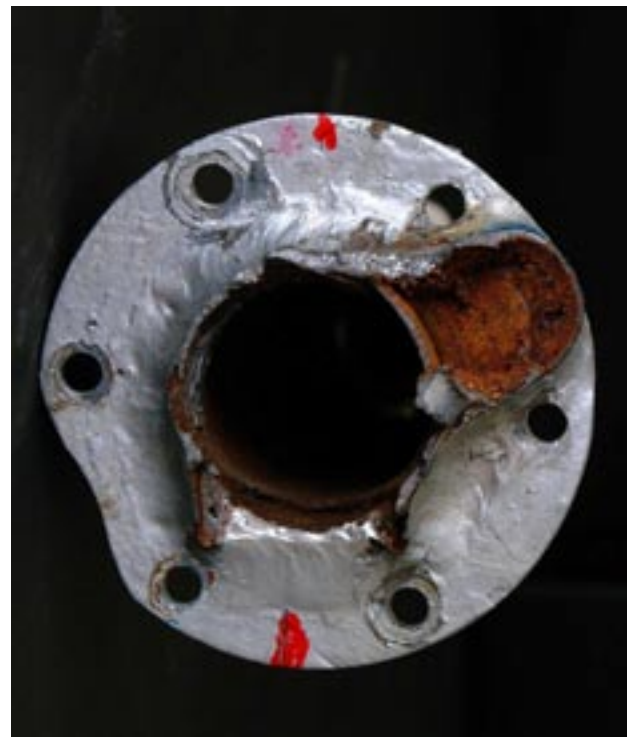
The right stub axle of G-ATKH was the subject of a dedicated metallurgical examination using visual and low magnification techniques. The view in Figure 2 (below) was taken from a view along the axle centre line in an outboard direction, with the landing load being in a direction vertically upwards as depicted.
