FISHING ACCIDENT REPORT

Engine Room Fire in an 11.6 metre Wooden Creel Boat

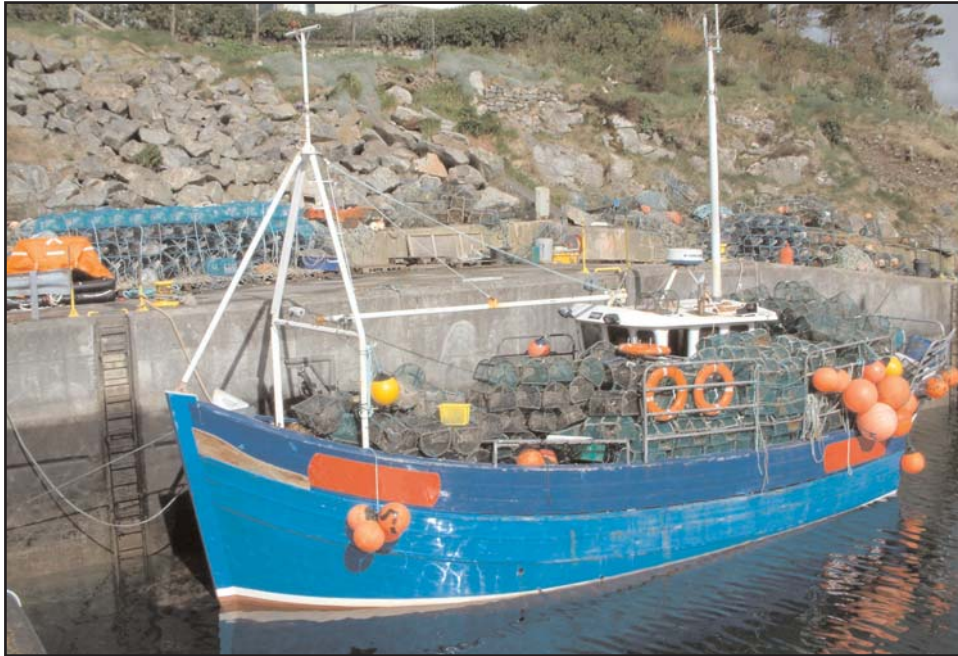
All the evidence suggests that the cause of the fire was an electrical defect that ignited cable insulation and, subsequently, the main electrical distribution panel and the wooden bulkhead between the engine room and accommodation area.
