MARINE ACCIDENT INVESTIGATION BRANCH

## FLYER TO SHIPPING INDUSTRY

### ***CP VALOUR:***

#### **FAILURE OF BRIDGE TEAM MANAGEMENT AND ONBOARD AUDITING**

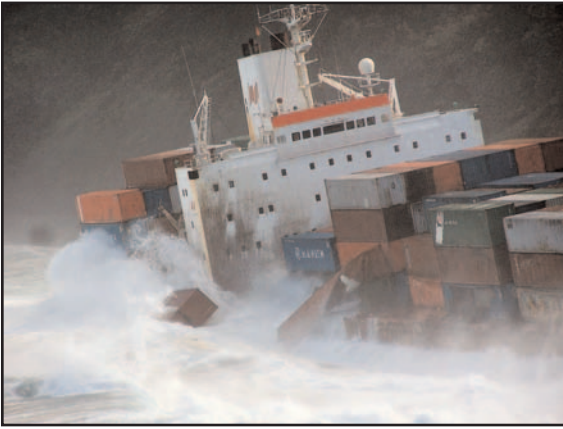
The 15,145gt Bermuda registered container vessel CP Valour, grounded in a bay off the NW coast of the island of Faial, Azores, on 9 December 2005. The next day, in worsening weather conditions, the vessel's hull began to fracture, causing substantial pollution. The subsequent salvage operation was unsuccessful and, about 3 weeks later, she was declared a constructive total loss and abandoned.

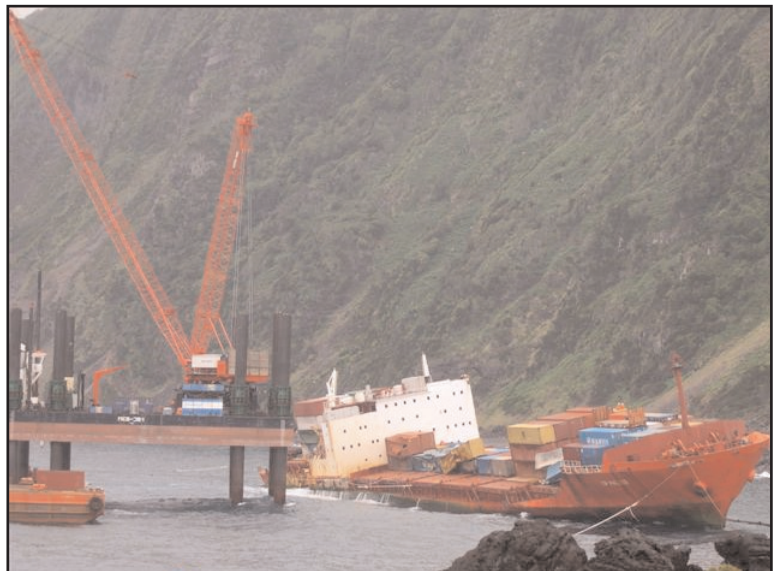
Initial salvage attempts by a local tug were unsuccessful and the vessel was driven further aground the next day as the wind veered to blow directly into the bay. The 1172 MT of heavy fuel oil and 118 MT of gas oil onboard began leaking in to the sea. By the time a powerful salvage tug was on scene and able to assist, the vessel was hard aground and unable to be moved and she was abandoned on 25 December 2005.
