MARINE ACCIDENT INVESTIGATION BRANCH

## FLYER TO THE SHIPPING INDUSTRY

### *THE CALYPSO:* FIRE - 6 MAY 2006

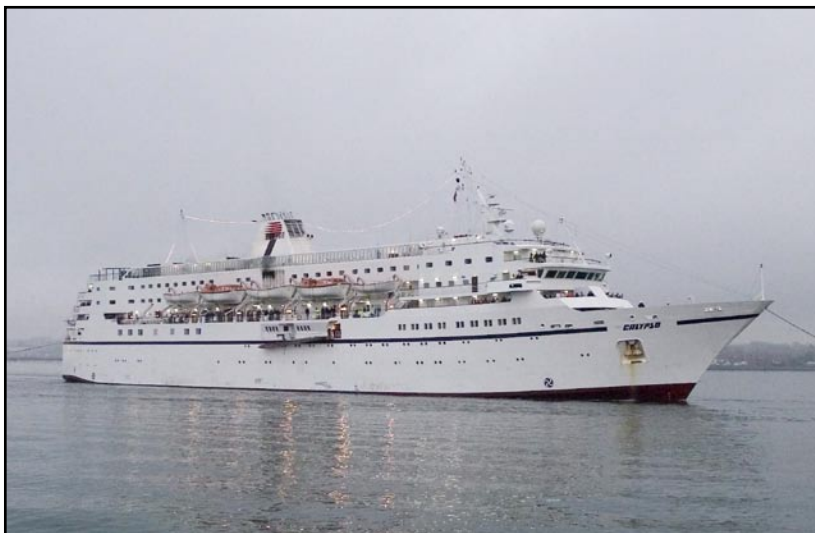
The MAIB investigation found that the fire had been caused by the failure of a two-bolt flange in a low pressure fuel pipe on one of the main engines. Both bolts securing the flange had failed due to fatigue. The engine manufacturer had been aware for over a decade of the design fault which caused the two-bolt flanges to fail due to high fluctuating back pressures from the fuel injection pump and it had issued safety bulletins through its worldwide service network. However, the managers of this ship were not aware of the bulletins.

1. Owners and/or chief engineers should ensure that they have a complete set of manufacturer's safety bulletins which are relevant to the main engines of their ships. Better to be pro-active than wait for something to go wrong.

2. It is commonly believed that fuel fires on engines occur due to leaks on high pressure lines only. That is not the case, spray or fuel mist from a low pressure line can also be dangerous. When inspecting engine fuel systems, it is worthwhile paying special attention to low pressure as well as the high pressure systems.
