MARINE ACCIDENT INVESTIGATION BRANCH

FLYER TO THE MERCHANT SHIPPING INDUSTRY

OUZO:

ACCIDENT WITH THREE FATALITIES 21 AUGUST 2006

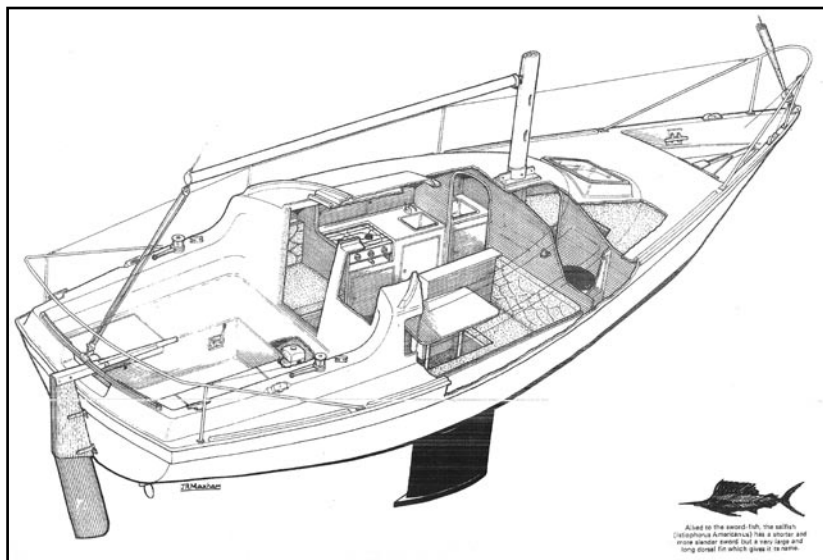
The yacht *Ouzo* sailed from Bembridge, Isle of Wight (IOW), bound for Dartmouth, Devon on the evening of 20 August 2006 with her three regular crew on board. The last record of the yacht was at 2230 when she went out of range of the Southampton/Portsmouth VTS radar system in Sandown Bay. At this time it is believed that the yacht was sailing close hauled in a south-south-westerly direction.

The body of one of the crew members was found in the sea just before midday on 22 August about 10 miles south of the

Nab Tower. At about 1900 on the following day, the bodies of the other two crew were recovered from the sea. They had all been wearing inflated lifejackets and good quality yachting clothing. Despite extensive surface and sub-surface searches no trace of the yacht has been found.

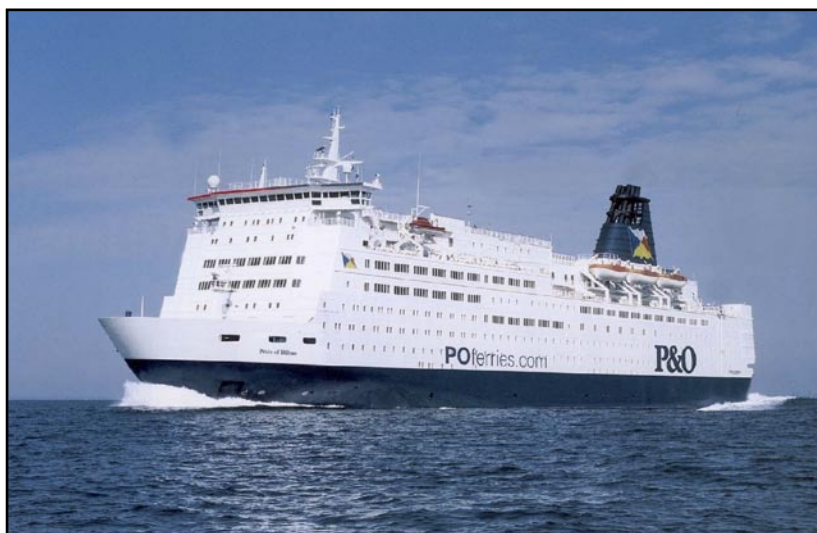
Voyage data recorder (VDR) records from ships that had been in the area during the night of 20/21 August were recovered and analysed by MAIB inspectors and it was discovered that the ferry *Pride of Bilbao* had been involved in an incident with a yacht 6 miles south of the Isle of Wight in the early hours of 21 August. The investigation concluded that she had either collided with, or passed so close to *Ouzo* at that time, and that the yacht had been swamped or capsized by the vessel's wash.

The watchkeeping officer and the lookout had seen the yacht at the last minute but had been unable to keep well clear. The sighting of a single red and then, possibly, a white light astern of the ferry after the incident was considered, by the watchkeeping officer, sufficient indication that the yacht was safe. The ferry continued to Bilbao without taking further action.
