MARINE ACCIDENT INVESTIGATION BRANCH

FLYER TO THE LEISURE INDUSTRY

OUZO:

ACCIDENT WITH THREE FATALITIES 21 AUGUST 2006

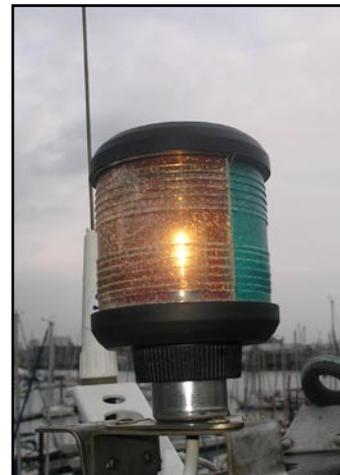
2. The lookout on the ferry had not seen the yacht until it was very close ahead. This gives rise to a number of possible factors including, from the yachtsmen's point of view:

- i. The lenses of navigation light units similar to the one fitted to *Ouzo* are prone to crazing which substantially reduces their efficiency. **(as shown on photo)**

Yacht owners should make every effort to ensure that their navigation lights are fully effective, and their characteristics understood.
