MARINE ACCIDENT INVESTIGATION BRANCH

FLYER TO THE YACHT DESIGN, BUILDING AND REPAIR INDUSTRY

MAX FUN 35 YACHT *Hooligan V*: KEEL DETACHMENT, CAPSIZE AND LOSS OF ONE CREW

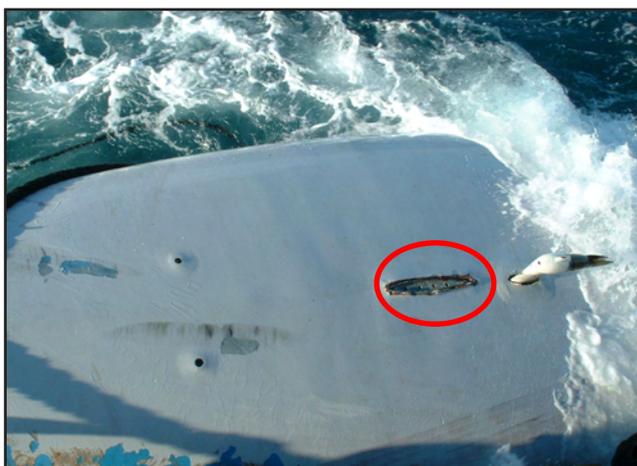
Investigations found that the fabricated steel keel had failed just below the fillet weld connecting the fin to the taper box (**Figure 1**). Laboratory metallurgical analysis confirmed that the keel had suffered fatigue failure in the fillet weld area, which had been subjected to high bending stresses. Defects were also found in the keel taper box welds, and two of the three keel bolts had also failed.

Analysis of the “original” design calculations confirmed that they did not achieve the required Safety Factor of 2. The “as built” keel safety calculations were worse, and these were exacerbated by the addition of the extra bulb weight. The fabricated keel was unable to withstand the “in service” bending stresses and this led to the conditions of failure.

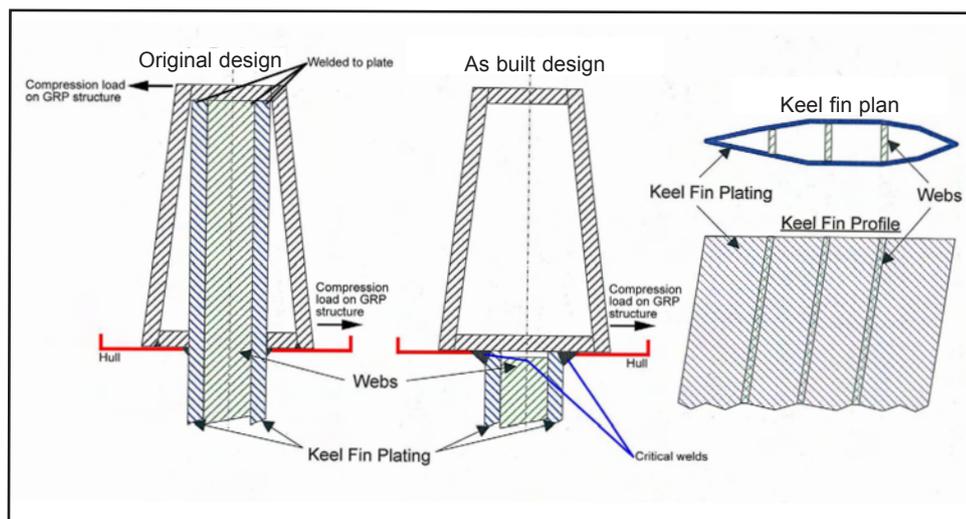
It was further discovered that the builder had sub-contracted the hollow keel construction to a steel fabricator who had no marine experience. The fabricator changed the original design, and incorporated a fillet weld in a critical area, to ease manufacture and reduce costs, but without the supporting calculations to assess the stresses to which the keel would be subjected (**Figure 2**). He did not consult on the changes with the designer. Although the designer was made aware of the keel changes by the boat builder, he did not validate them. In 2005 the owner contracted a UK yacht designer to optimise the yacht for IRM and IRC racing purposes. This involved adding 160kg

of lead to the keel bulb. Once again, there were no supporting calculations, nor were checks made against the “original” or “as built” design drawings to ensure that the modification would not adversely affect the design to cope with the “in service” loads.
