MARINE ACCIDENT INVESTIGATION BRANCH

## FLYER TO THE YACHT DESIGN, BUILDING AND REPAIR INDUSTRY

### MAX FUN 35 YACHT *Hooligan V*: KEEL DETACHMENT, CAPSIZE AND LOSS OF ONE CREW

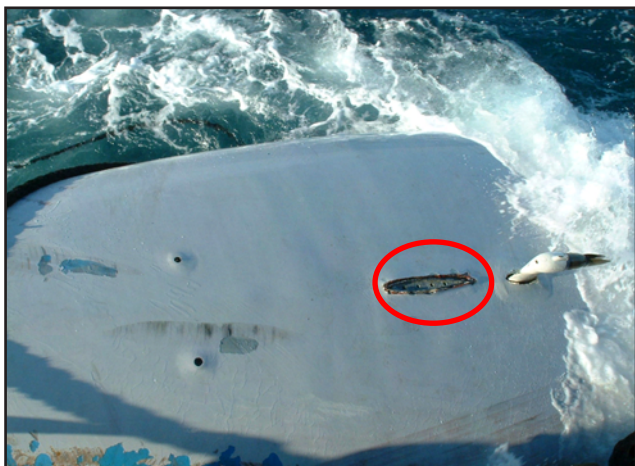
Investigations found that the fabricated steel keel had failed just below the fillet weld connecting the fin to the taper box (**Figure 1**). Laboratory metallurgical analysis confirmed that the keel had suffered fatigue failure in the fillet weld area, which had been subjected to high bending stresses. Defects were also found in the keel taper box welds, and two of the three keel bolts had also failed.

Analysis of the “original” design calculations confirmed that they did not achieve the required Safety Factor of 2. The “as built” keel safety calculations were worse, and these were exacerbated by the addition of the extra bulb weight. The fabricated keel was unable to withstand the “in service” bending stresses and this led to the conditions of failure.

When the boat was taken out of the water at the end of the 2006 racing season, considerable detachment of the keel’s epoxy filler and anti-fouling was found. There was also evidence of possible fine cracking in the steel adjacent to the fillet weld, but this went undetected and so the last chance to prevent the accident was missed.

- The repairer was not sufficiently experienced to appreciate why the keel filler and coating detachment occurred. He occupied himself with removing the corrosion products and priming the bare keel metal rather than finding the reason for the detachment which was probably due to keel flexing. Fabricated steel keels are vulnerable to bending stresses. Where there is doubt, repairers should seek advice on the suitability of using Non-Destructive Examination techniques to determine the keel condition.

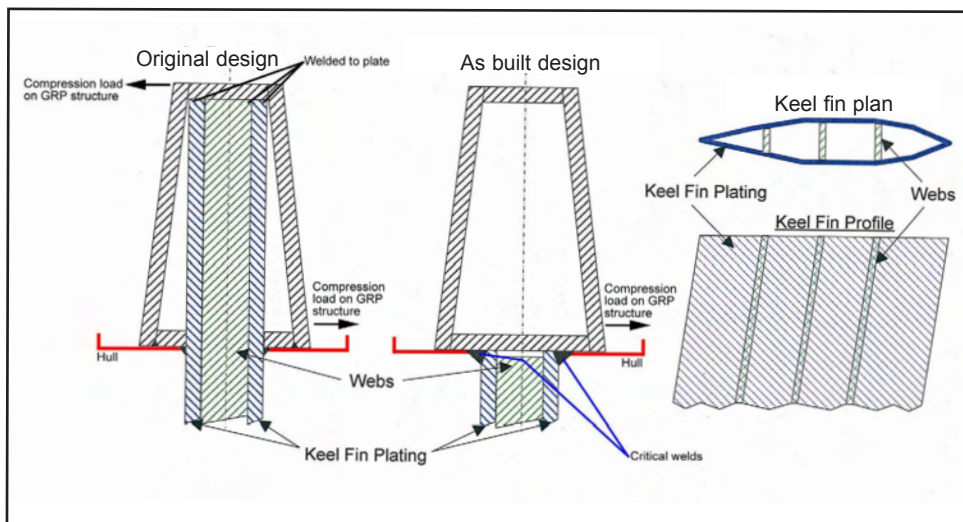
It was further discovered that the builder had sub-contracted the hollow keel construction to a steel fabricator who had no marine experience. The fabricator changed the original design, and incorporated a fillet weld in a critical area, to ease manufacture and reduce costs, but without the supporting calculations to assess the stresses to which the keel would be subjected (**Figure 2**). He did not consult on the changes with the designer. Although the designer was made aware of the keel changes by the boat builder, he did not validate them. In 2005 the owner contracted a UK yacht designer to optimise the yacht for IRM and IRC racing purposes. This involved adding 160kg

of lead to the keel bulb. Once again, there were no supporting calculations, nor were checks made against the “original” or “as built” design drawings to ensure that the modification would not adversely affect the design to cope with the “in service” loads.
