MARINE ACCIDENT INVESTIGATION BRANCH

FLYER TO THE LEISURE INDUSTRY

Foundering of a motor cruiser with the loss of three lives

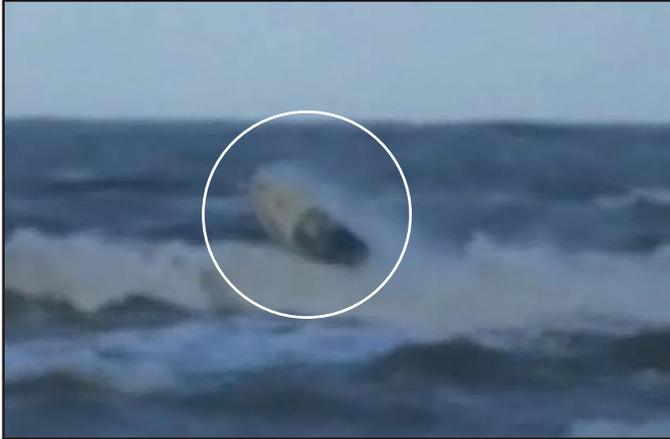
Vessel as control was lost

At the harbour entrance, the boat encountered a succession of steep waves, estimated at 4 to 5m in height. As the boat rose to the first wave, one crew member fell aft. The boat continued out and met a second breaking wave of similar height. As the boat passed over this crest, the skipper and his brother fell through the open canopy at the stern and into the sea. The boat lost power, and drifted along the seaward side of the harbour until a large breaking wave caused it to capsize, throwing the skipper's partner into the sea. Despite rapid rescue attempts, the crew all perished in the accident. The boat was driven ashore and broke up in the surf.

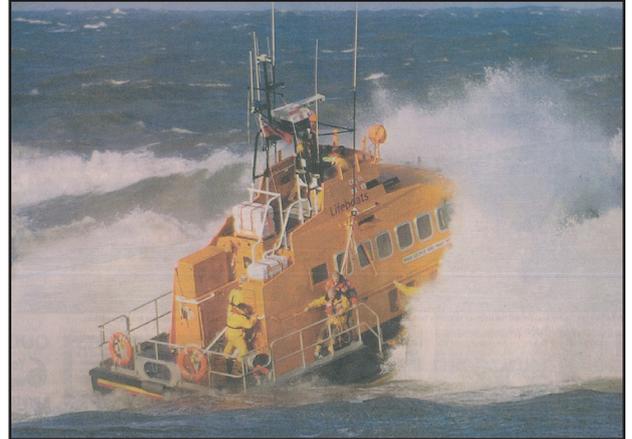
Rescue operation
