MARINE ACCIDENT INVESTIGATION BRANCH

## FLYER TO THE LEISURE INDUSTRY

### Foundering of a motor cruiser with the loss of three lives

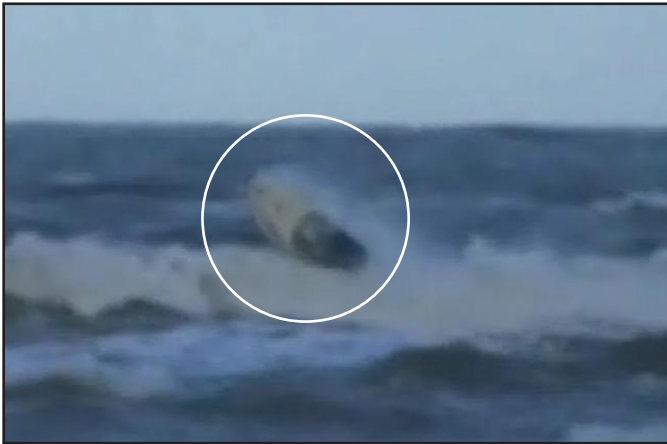
Vessel as control was lost

At the harbour entrance, the boat encountered a succession of steep waves, estimated at 4 to 5m in height. As the boat rose to the first wave, one crew member fell aft. The boat continued out and met a second breaking wave of similar height. As the boat passed over this crest, the skipper and his brother fell through the open canopy at the stern and into the sea. The boat lost power, and drifted along the seaward side of the harbour until a large breaking wave caused it to capsize, throwing the skipper's partner into the sea. Despite rapid rescue attempts, the crew all perished in the accident. The boat was driven ashore and broke up in the surf.

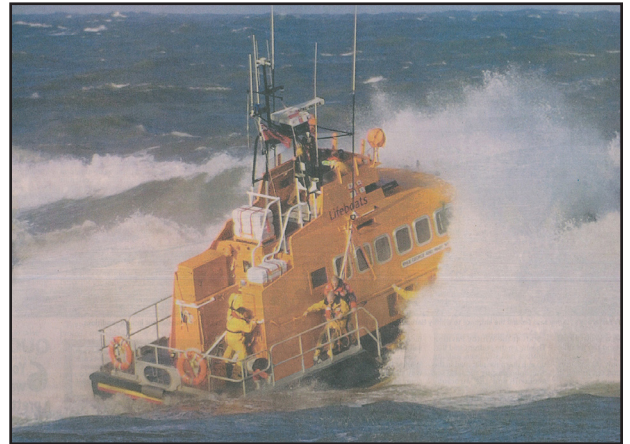
Rescue operation
