MAIB

MARINE ACCIDENT INVESTIGATION BRANCH

FLYER TO THE LARGE YACHT INDUSTRY *LADY CANDIDA*: total loss due to a fire caused by accumulated lint in a tumble dryer, 28 July 2007

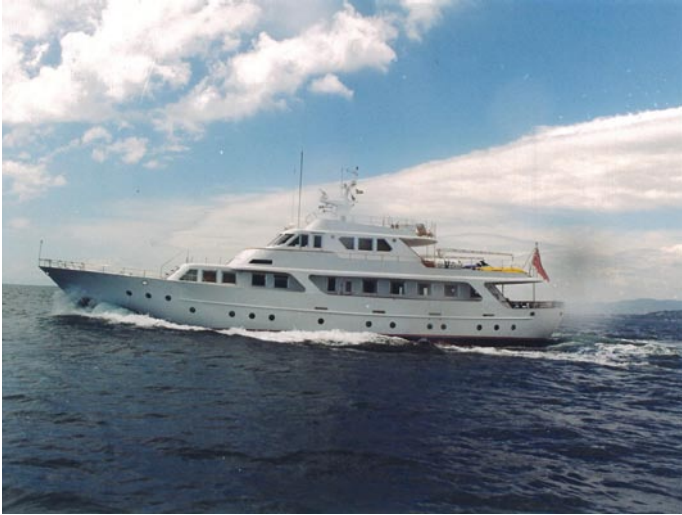
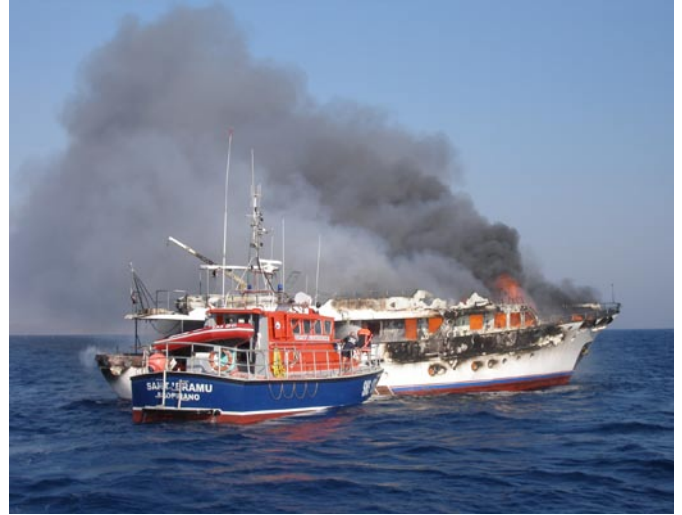
Photograph courtesy of Marine Nationale

However, the fire had already spread through the tumble dryer vent pipe and had ignited the laundry's false plywood ceiling. The crew were unable to start the main fire pump, and the emergency fire pump was not readily accessible. Despite the crew's efforts to fight the fire with portable extinguishers, it continued to spread and was soon out of control.

1. The source of the fire was lint, which had accumulated in the tumble dryer and blocked its air outlet. This caused the dryer to operate for longer periods than normal. The resultant heat generated was sufficient to ignite the lint. **Lint is a highly combustible material and should never be allowed to accumulate in dryer outlets. Filters and ventilation ducts need to be cleaned regularly.**
2. It is likely that the fire detection system did not operate because the batteries fitted to the smoke sensors were either flat or had been removed. **Where fire detection systems are not compliant with SOLAS II-2/7 and sensors rely on a single source of power, extra vigilance has to be exercised to ensure that the power source is always available. Batteries should be checked regularly and systems should be tested at frequent intervals.**
