MARINE ACCIDENT INVESTIGATION BRANCH

## FLYER TO THE SHIPPING, TANK STORAGE AND CARGO INSPECTION INDUSTRIES

### *Jo Eik*

#### Release of cargo vapours resulting in two casualties

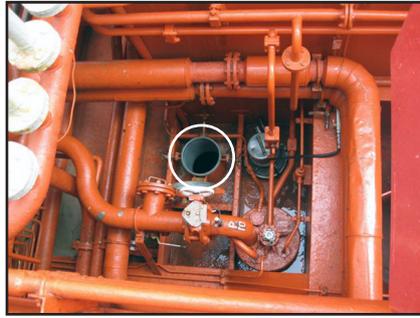
The ship's cargo Procedures and Arrangements Manual specified that the fixed washing systems should be the normal method of tank cleaning. However, only 7 out of 65 were functional, so it had become normal practice to use the portable washers which were passed through open Butterworth hatches. As the tank atmosphere was agitated, dense cargo vapours were driven through the open hatch and accumulated in the enclosed area around it.

Although part of the weather deck, the area around the hatch fell into the International Maritime Organization's definition of an enclosed space. However, this was not identified by the crew, so there were no warning signs. Despite the strong pungent smell of the released vapours, the hazards were not recognised. The casualties exhibited the classic signs of  $H_2S$  / mercaptan inhalation.

Open inboard hatch

- **Potentially dangerous spaces not being identified** – on *Jo Eik* the area around the Butterworth hatch was effectively in an enclosed space. The surrounding construction impeded air flows from dissipating cargo vapours. There are many such areas on ships. They should be identified and risk assessments conducted to determine the appropriate risk control measures.
