MARINE ACCIDENT INVESTIGATION BRANCH

FLYER TO THE SHIPPING, TANK STORAGE AND CARGO INSPECTION INDUSTRIES

Jo Eik

Release of cargo vapours resulting in two casualties

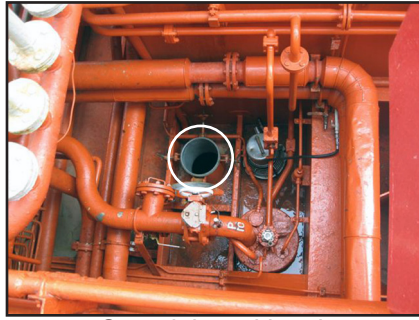
The ship's cargo Procedures and Arrangements Manual specified that the fixed washing systems should be the normal method of tank cleaning. However, only 7 out of 65 were functional, so it had become normal practice to use the portable washers which were passed through open Butterworth hatches. As the tank atmosphere was agitated, dense cargo vapours were driven through the open hatch and accumulated in the enclosed area around it.

Although part of the weather deck, the area around the hatch fell into the International Maritime Organization's definition of an enclosed space. However, this was not identified by the crew, so there were no warning signs. Despite the strong pungent smell of the released vapours, the hazards were not recognised. The casualties exhibited the classic signs of H_2S / mercaptan inhalation.

Open inboard hatch

- **Potentially dangerous spaces not being identified** – on *Jo Eik* the area around the Butterworth hatch was effectively in an enclosed space. The surrounding construction impeded air flows from dissipating cargo vapours. There are many such areas on ships. They should be identified and risk assessments conducted to determine the appropriate risk control measures.
