MARINE ACCIDENT INVESTIGATION BRANCH

FLYER TO THE SHIPPING INDUSTRY *STENA VOYAGER:* THE SHIFT OF AN ARTICULATED ROAD TANKER 28 JANUARY 2009

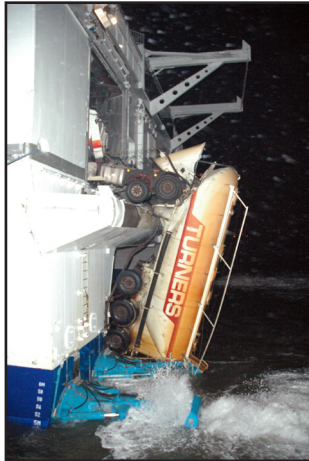
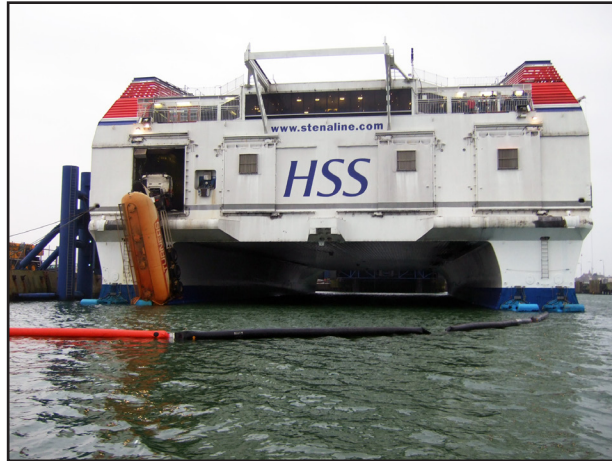
An articulated road tanker crashed through a stern door of the high speed service 1500 (HSS 1500) vessel *Stena Voyager* shortly after the ferry had commenced a scheduled crossing from Stranraer, Scotland to Belfast, Northern Ireland. The vehicle's semi-trailer came to rest on the vessel's port water jet units; its tractor unit remained on the vehicle deck. The ferry was quickly stopped and her crew were able to make the vehicle secure before returning to Stranraer.

Contrary to instructions posted on the vehicle deck, the vehicle's parking brakes had not been applied and it had been left out of gear. Although the vehicle had been lashed to the deck and its rear wheels chocked, this failed to stop it from rolling backwards as *Stena Voyager* accelerated. As neither the lashing points on the ferry's deck nor those fitted to the vehicle accorded with the applicable international and national codes of practice, the crew were unable to lash the vehicle as required by the ferry's cargo securing manual. The lashing straps were also found to be of insufficient strength and post accident tests strongly indicate that the chocks were not correctly positioned.
