MARINE ACCIDENT INVESTIGATION BRANCH

FLYER TO THE SHIPPING INDUSTRY

RIVERDANCE

Listing incident followed by the grounding of a ro-ro cargo vessel at Cleveleys Beach

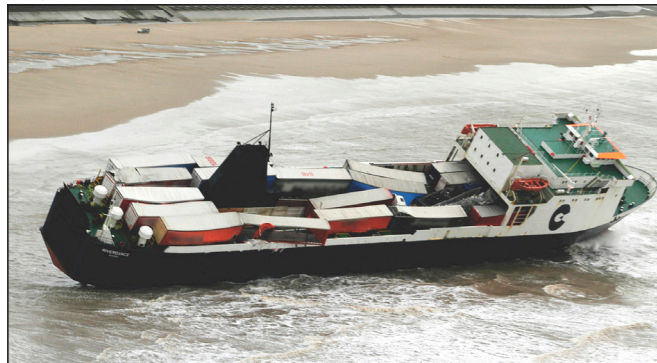
On 31 January 2008, the Bahamas registered ro-ro cargo vessel, *Riverdance*, grounded and became stranded on the Shell Flats, off Cleveleys Beach, Lancashire. The prevailing severe weather conditions prevented the vessel from being refloated, and subsequent attempts to salvage her failed. *Riverdance* was finally cut up in-situ. Fortunately, the crew were all safely recovered and there was no pollution.
