FLYER TO THE SHIPPING INDUSTRY

Grounding of the product tanker *ASTRAL*, after dragging anchor off the Isle of Wight, England, on 10 March 2008

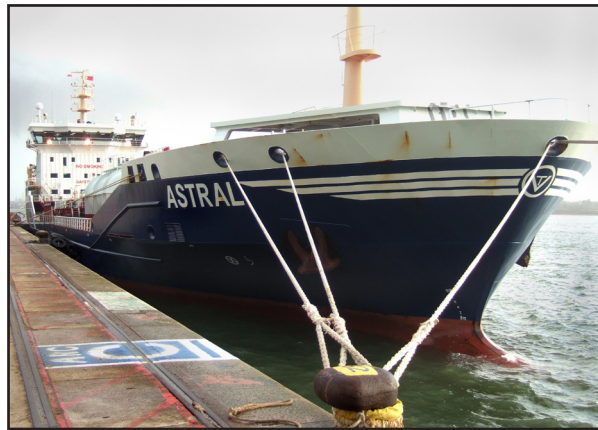
Astral

On 10 March 2008, the Swedish registered tanker *Astral* dragged her anchor in Storm Force 10 winds and grounded on the Princessa Shoal, east of the Isle of Wight. The vessel sustained indentations to her hull and extensive damage to her rudder and steering gear; there was no pollution and the vessel remained watertight.
