MARINE ACCIDENT INVESTIGATION BRANCH

FLYER TO THE SHIPPING INDUSTRY

***BEN-MY-CHREE*: COLLAPSE OF THE PASSENGER WALKWAY DUE TO UNINTENDED ENGINE MOVEMENT IN PORT**

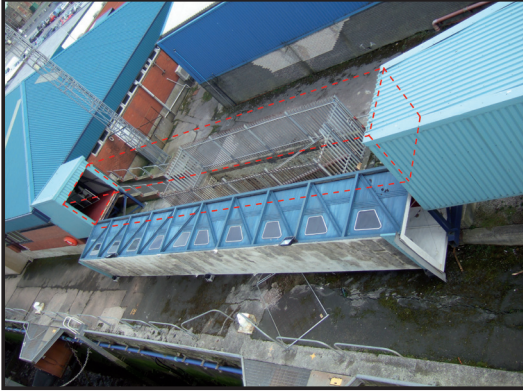
The third engineer, who had previously been concentrating on bunkering, transferred controls to the bridge, and the chief officer, not observing that the starboard engine was running, put both engines' pitch control levers to the full ahead position. Within a few seconds, the vessel surged ahead, causing serious damage to the passenger access structure. The foot-passenger walkway detached at both ends and collapsed onto the quayside, and the gangway fell from the vessel's side shell door and was left hanging on a single rope. Fortunately, there were no injuries. Eight passengers were trapped in the gangway compartment of the shore structure and had to be rescued by the fire service.

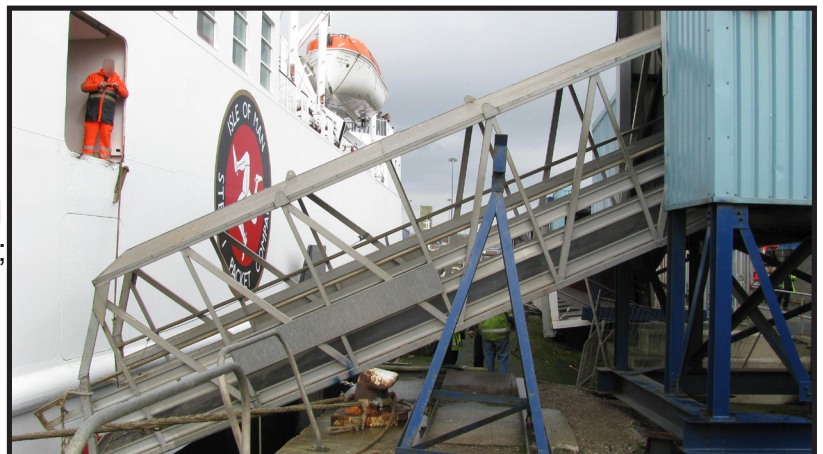
The Health & Safety Executive (HSE) completed an investigation into the failure of the passenger access structure. The investigation identified that the quay on which the passenger access structure was built had suffered considerable settlement over the years; the walkway was secured to the rest of the structure with only two small bolts at either end; and there were no records of inspections or maintenance

work having been carried out on the structure. The HSE issued several recommendations to Heysham Port, which are relevant to all passenger terminals. These include:

- *An inspection regime, similar to that for bridges, should be adopted with the findings of the inspection recorded and any remedial work identified should be carried out within an appropriate timescale. Particular attention should be given to safety critical parts of the structure. The inspection should be carried out by a competent person.*
- *For the procurement, operation and maintenance of ship to shore structures, reference should be made to the guidance provided in CIRIA Report C518, Safety in Ports, ship to shore linkspans and walkways.*
