FLYER TO THE SHIPPING INDUSTRY

BRO ARTHUR:

FATALITY OF A SHORE WORKER IN No 2 CARGO TANK

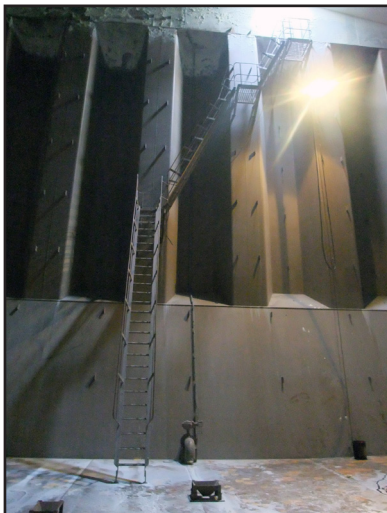
Figure 1

During the evening of 19 February 2010, a 3-man team of German shore workers entered No 2 cargo tank to “sweep” the remains of a cargo of stearin, a derivative of crude palm oil, into the cargo pump suction well to maximise the cargo discharge. On leaving the tank (**Figure 1**), one of the workers was fatally injured when he fell about 18 metres onto the tank top.

- Risk assessments need to be thorough if they are to be of use in identifying the most appropriate control measures. When working at height, including entering or exiting cargo tanks, due consideration should be given to the use of safety harnesses or fall arrestors.

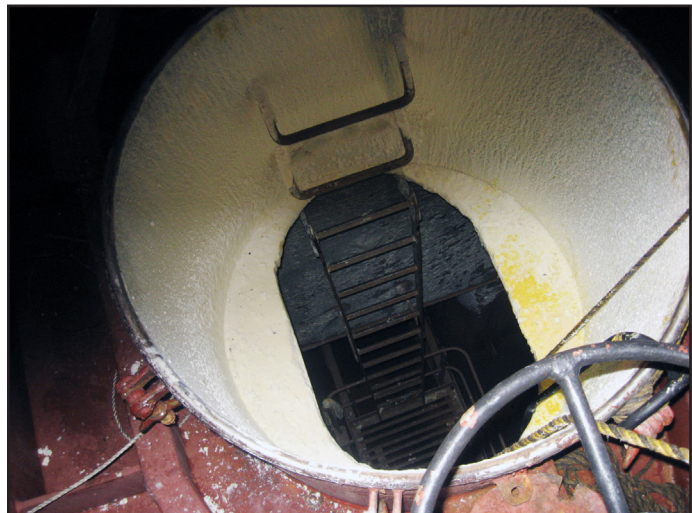
Figure 2

The postmortem toxicology report identified that the casualty had a variety of prescription and illegal drugs in his blood which would have caused severe impairment. All the evidence suggests that the casualty fell from the vertical ladder (**Figure 2**). His heavily cargo-contaminated gloves could easily have caused him to lose his hand grip on the slippery surface and the risk of his falling would have been exacerbated by his impaired physical condition. The investigation also found that the mandatory two-monthly dangerous space casualty recovery drills had not been practised for a considerable time.
