FLYER TO THE SHIPPING INDUSTRY

RMS Queen Mary 2: The catastrophic failure of a capacitor and explosion in the aft harmonic filter room

**Marine Accident Investigation Branch
December 2011**

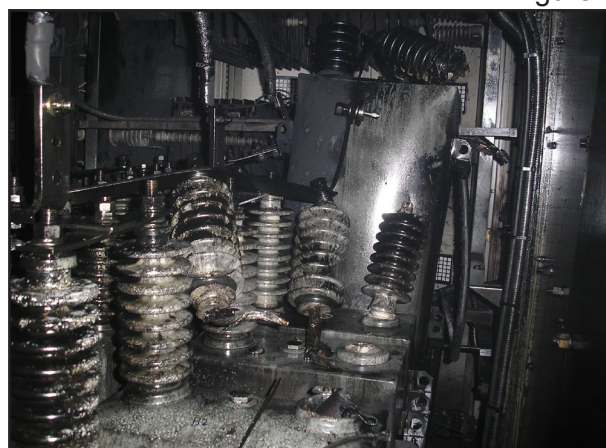
Figure 1

By 0439, the crew had confirmed that the explosion had taken place in the aft harmonic filter¹ (HF) which was situated in a compartment next to the aft MSB room. After establishing with thermal imaging cameras that there were no hot spots, they ventilated the area and isolated the aft HF and MSB from the rest of the 11000 volt electrical network. The crew were able to restore some electrical power supplies and, by 0523, QM2 was underway using two propulsion motors powered from the forward MSB. Subsequent inspection of the aft HF revealed that one of its capacitors (**Figure 1**) had failed catastrophically due to internal over-pressure and another had developed a severe bulge.

Harmonic filter capacitors

The vessel had a history of HF capacitor failures, at an average rate of one per year. Although the exact cause of the capacitor failures could not be determined, it was concluded that capacitor degradation was probably caused by a combination of transient high voltage spikes due to frequent switching operations and occasional network overvoltage fluctuations. The capacitor deterioration had not been detected, and because there were no internal fuses or pressure relief devices, it had continued until the capacitor casing failed catastrophically.

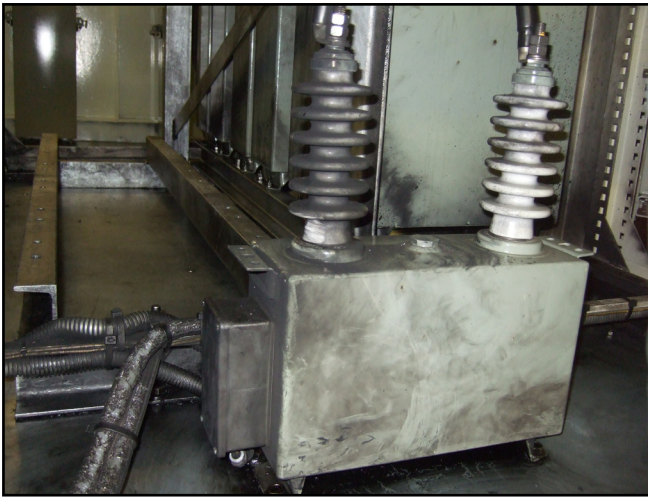
Figure 2a

The only protection against catastrophic failure of the capacitors was a current imbalance detection system. It consisted of a current transformer (**Figure 2a**) which was connected to the capacitor circuit. Under normal conditions, little or no current should have flowed through the transformer. When a capacitor degraded, the current flow across the circuit became unbalanced and induced a current in the transformer's secondary winding. The system was set to give an alarm when the imbalance reached 400mA and to trip at 800mA. After the accident, the transformer's windings were found to have failed (**Figure 2b**). There had not been any alarms on this part of the system for several years and it was likely that the imbalance detection system had not worked for some time.

The current transformer used in imbalance current detection system

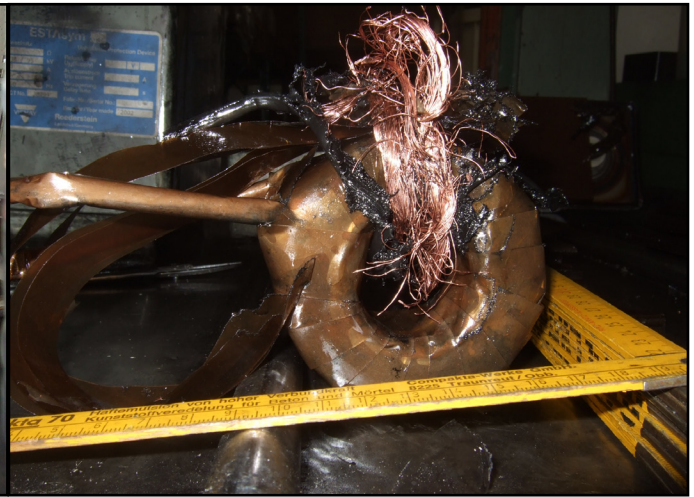
Figure 2b

Damaged transformer windings

This caused the alarm display to read 0mA giving a false indication that the capacitors were in good condition.

Although detection of an unbalanced current was the only protection system for the harmonic filters, it had no backup and did not fail safe. Routine tests of the system were by the secondary current injection method, and by-passed the transformer.

- Protection systems for critical equipment must 'fail safe', and should be thoroughly tested at regular intervals to prove that all sub-components are functioning correctly. **In particular, harmonic filters with current imbalance protection systems should be thoroughly checked by a competent person at the earliest opportunity.**
