## FLYER TO THE SHIPPING INDUSTRY

### **RMS Queen Mary 2: The catastrophic failure of a capacitor and explosion in the aft harmonic filter room**

**Marine Accident Investigation Branch  
December 2011**

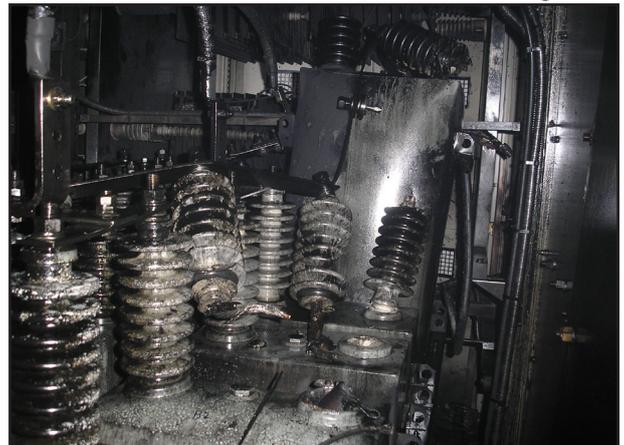
Figure 1

By 0439, the crew had confirmed that the explosion had taken place in the aft harmonic filter<sup>1</sup> (HF) which was situated in a compartment next to the aft MSB room. After establishing with thermal imaging cameras that there were no hot spots, they ventilated the area and isolated the aft HF and MSB from the rest of the 11000 volt electrical network. The crew were able to restore some electrical power supplies and, by 0523, QM2 was underway using two propulsion motors powered from the forward MSB. Subsequent inspection of the aft HF revealed that one of its capacitors (**Figure 1**) had failed catastrophically due to internal over-pressure and another had developed a severe bulge.

Harmonic filter capacitors

The vessel had a history of HF capacitor failures, at an average rate of one per year. Although the exact cause of the capacitor failures could not be determined, it was concluded that capacitor degradation was probably caused by a combination of transient high voltage spikes due to frequent switching operations and occasional network overvoltage fluctuations. The capacitor deterioration had not been detected, and because there were no internal fuses or pressure relief devices, it had continued until the capacitor casing failed catastrophically.

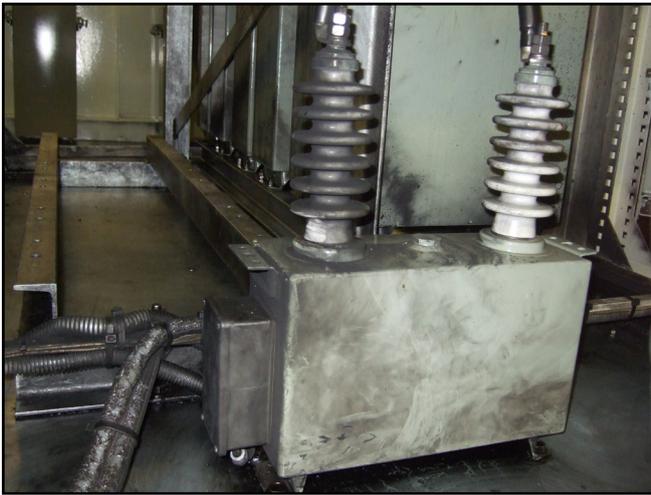
Figure 2a

The only protection against catastrophic failure of the capacitors was a current imbalance detection system. It consisted of a current transformer (**Figure 2a**) which was connected to the capacitor circuit. Under normal conditions, little or no current should have flowed through the transformer. When a capacitor degraded, the current flow across the circuit became unbalanced and induced a current in the transformer's secondary winding. The system was set to give an alarm when the imbalance reached 400mA and to trip at 800mA. After the accident, the transformer's windings were found to have failed (**Figure 2b**). There had not been any alarms on this part of the system for several years and it was likely that the imbalance detection system had not worked for some time.

The current transformer used in imbalance current detection system

- Protection systems for critical equipment must 'fail safe', and should be thoroughly tested at regular intervals to prove that all sub-components are functioning correctly. **In particular, harmonic filters with current imbalance protection systems should be thoroughly checked by a competent person at the earliest opportunity.**

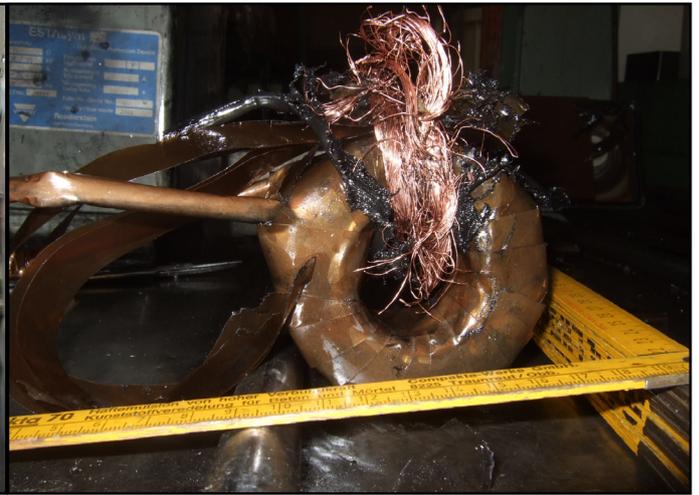
Figure 2b

Damaged transformer windings

This caused the alarm display to read 0mA giving a false indication that the capacitors were in good condition.

Although detection of an unbalanced current was the only protection system for the harmonic filters, it had no backup and did not fail safe. Routine tests of the system were by the secondary current injection method, and by-passed the transformer.
