MARINE ACCIDENT INVESTIGATION BRANCH

## FLYER TO SMALL HIGH-SPEED CRAFT OPERATORS ACCIDENT TO PASSENGER ON A DELTA 8.5M RIB

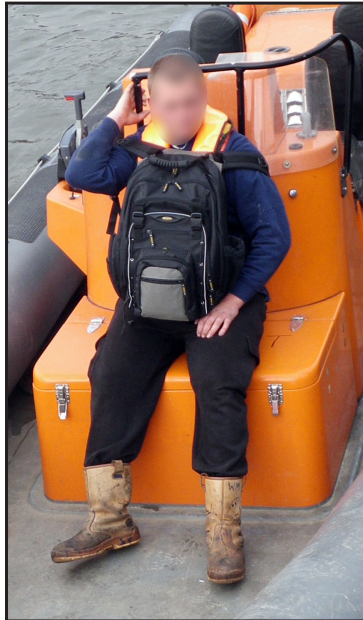
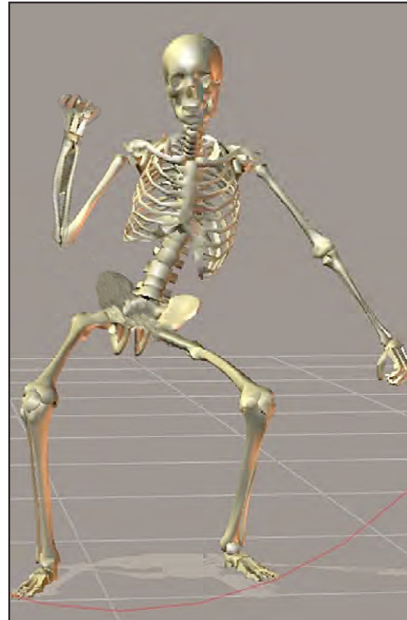
At approximately 0708 on 6 May 2010 a male passenger on a Delta 8.5m rigid inflatable boat (RIB) suffered lower back wedge compression fractures while the boat was transporting him, together with fellow workers, to a jack-up rig on the River Thames.

The injury occurred when the man landed heavily onto the lid of a locker, which was used as a seat, after he had been momentarily lifted off the lid due to the motion of the craft. At the time of the accident there was a light wind with a slight sea.

- Operators of high-speed craft should conduct Whole Body Vibration and shock impact risk assessments in accordance with the requirements of the Vibration Regulations to reduce the risk of injury to their employees and passengers to a level which is as low as reasonably practicable (MGN 353 (M+F) refers).
- Helmsmen should be made aware, through appropriate training, of the risks posed to crew and passengers from shock impacts when conducting high speed passages or when encountering large waves or wakes at lower speeds.
