FLYER TO RO-RO VESSEL OPERATORS AND THE PORTS INDUSTRY

Commodore Clipper – Fire on the main vehicle deck due to an overheating reefer cable connection

**Marine Accident Investigation Branch
November 2011**

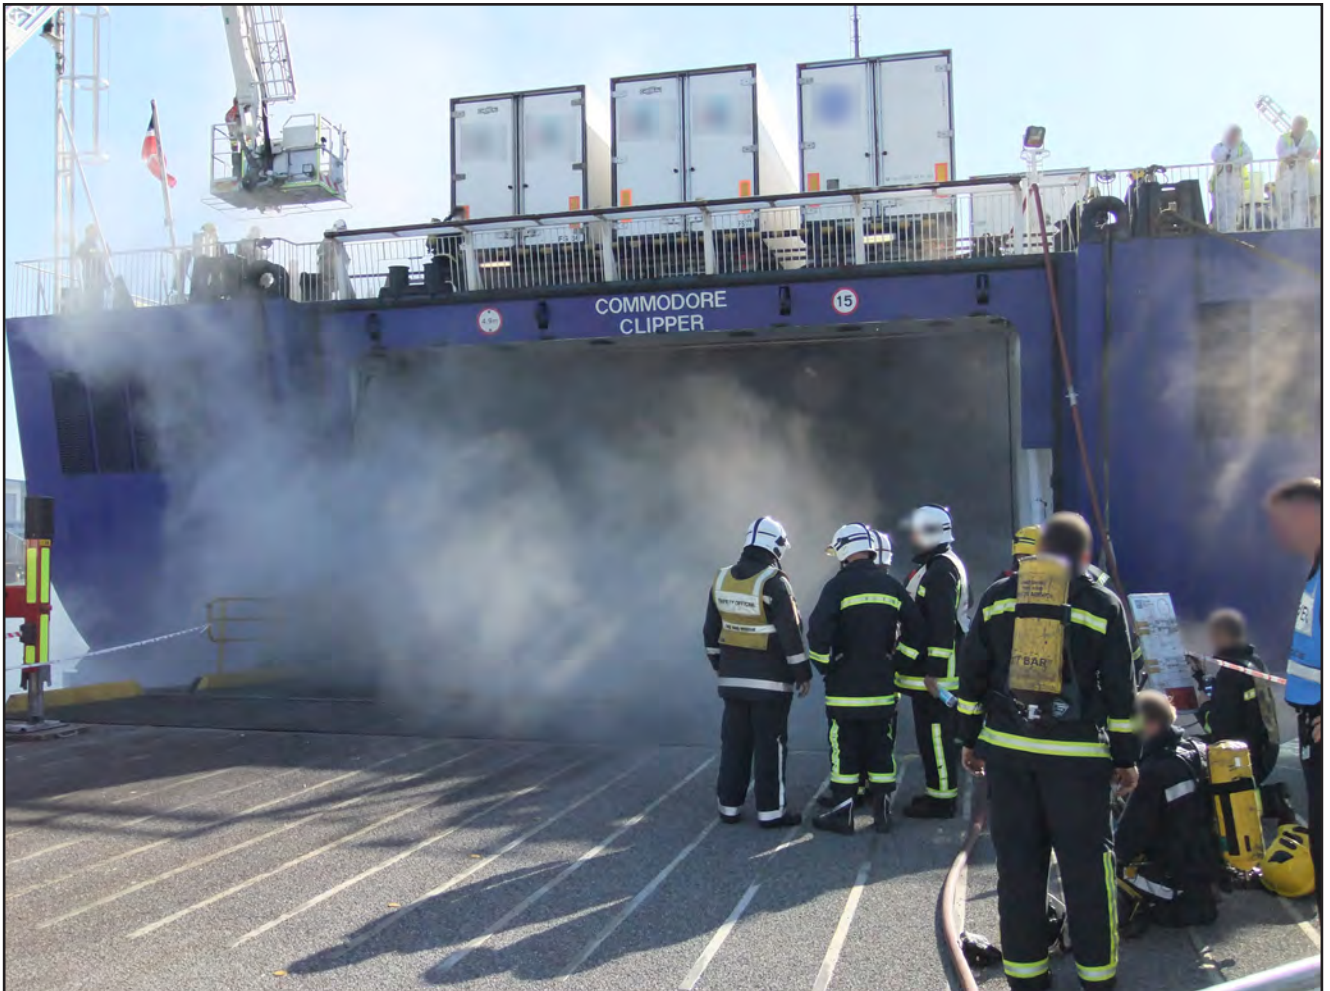
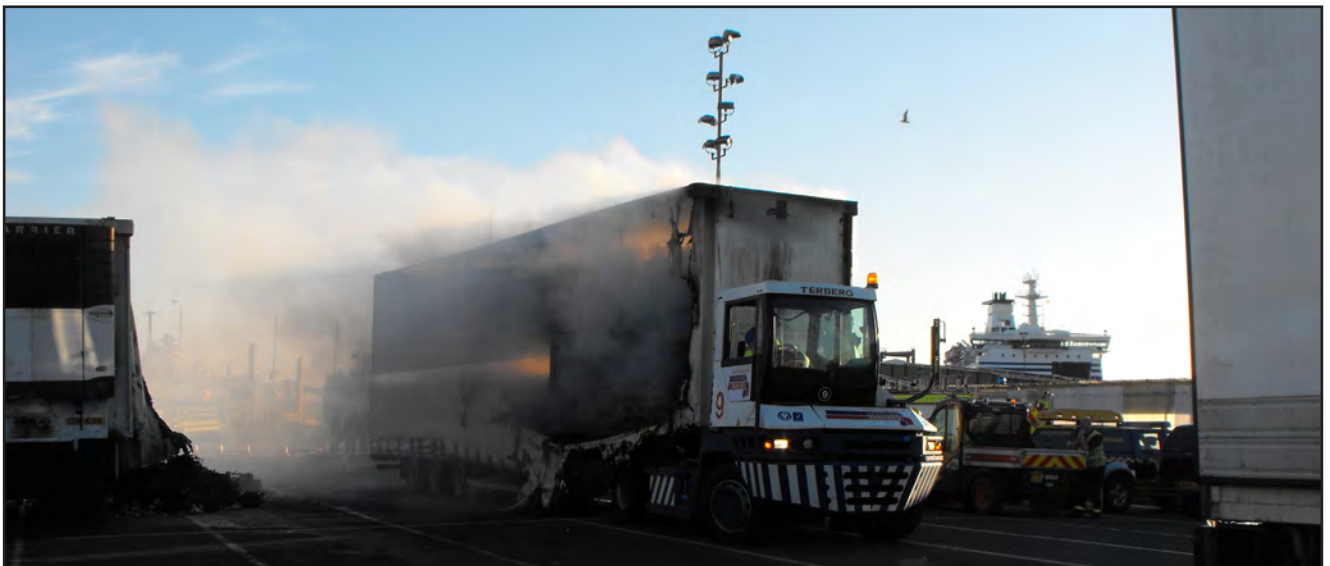
Unprotected cables and pipework running above the fire were soon damaged in the high temperatures that were generated by the burning curtain-side and cargo packaging materials. The vessel lost power to forward mooring deck winches and bow thrusters, control of the rudders was disrupted and the port rudder suddenly moved hard to starboard. Loose cargo partially blocked the deck drains and drencher water caused *Commodore Clipper* to list. Drenching was stopped while water drained to prevent further risk to the vessel's stability, but each time it was stopped, the fire grew in intensity.

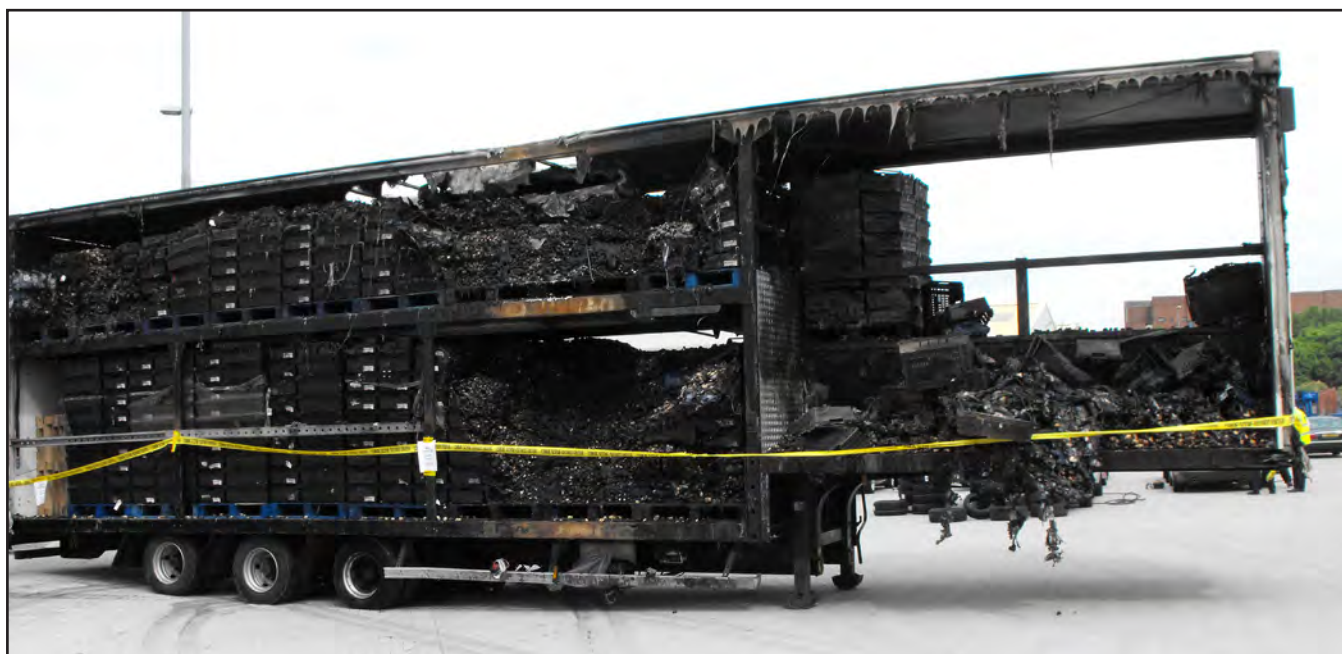
Subsequent investigation found that the fire was due to one of the ship's reefer cables being assembled incorrectly. The reefer cable plugs used 'insulation displacement connectors' (IDC) that are meant to speed up assembly by avoiding the need to strip insulation from cable ends. However, the insulation had been stripped away, and as the design relied on the insulation to help secure the cable in place, the connection became loose. This led to a local high-resistance fault and then arcing in one of the phases. The electrical protection in the vessel's circuit breakers was not able to detect this fault and heat built up inside the plug until the plastic casing ignited. The socket on the trailer was mounted close to the load-bed where the curtain-side was secured. In tests, the material ignited readily and flames spread quickly.

1. Check their vessels' vehicle decks for critical and vulnerable systems, and take action as necessary to improve their resilience to fire damage.
2. Check all reefer trailer power cables regularly. Consider upgrading existing electrical protection to a system that can detect in-line phase faults and provides residual current detection.
