## FLYER TO THE SHIPPING INDUSTRY

### Windlass damage when weighing anchor in gale force winds

**December 2012**

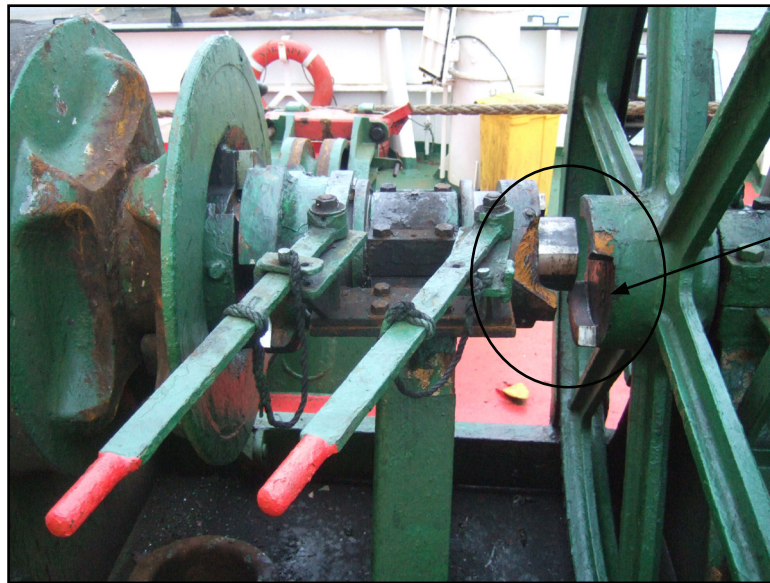
Broken dog clutch  
and bent shaft on  
port windlass

The wind strength was increasing steadily and the windlass struggled to recover the cable when, suddenly and without warning, the dog clutch shattered and the cable payed out to the bitter end. The cable was subsequently slipped and *Norcape* was taken out of service due to the damage to the windlass and the loss of her anchor.

The fact that the anchor cable rendered indicated that the cable had slipped through the guillotine bar arrangement. Investigation revealed that the locking pin, which should have held the bar in place, was not engaged when the cable rendered. It transpired that the vessel's SMS for anchoring operations contained no reference to the use of the locking pin when anchoring.

The guillotine/chain stopper housing is the strongest part of the anchoring equipment and is designed to take the load of the cable when a vessel lies at anchor. In this case, the load of the cable transferred to the windlass as the cable slipped, and this initiated the failure mechanism which culminated in the catastrophic failure of the dog clutch.

The severe yaw that developed was due to the windage of the vessel's superstructure, which generated forces in excess of the design load of the anchoring equipment.

To try and prevent such accidents occurring in the future, owners and operators are strongly advised to review their SMS procedures for anchoring to ensure they address the above safety issues and, specifically:

1. That masters have clear guidance on the capability of their vessel's anchoring system, including:
  - Any limitations of the anchor system components, including that of the windlass.
  - Effects of windage in various load conditions
  - Risks associated with excessive yaw.
2. That the SMS guidance on anchoring is vessel-specific and highlights that, when at anchor, the weight of the cable should be taken on the guillotine fittings, which should be correctly engaged (Nautical Institute, *Mooring and Anchoring Ships*, Volume 1, 2009. ISBN: 978 1 870077 93 4 refers).
