FLYER TO FISHING INDUSTRY

Our Boy Andrew: Fatal Accident to Skipper

Marine Accident Investigation Branch
17 November 2011

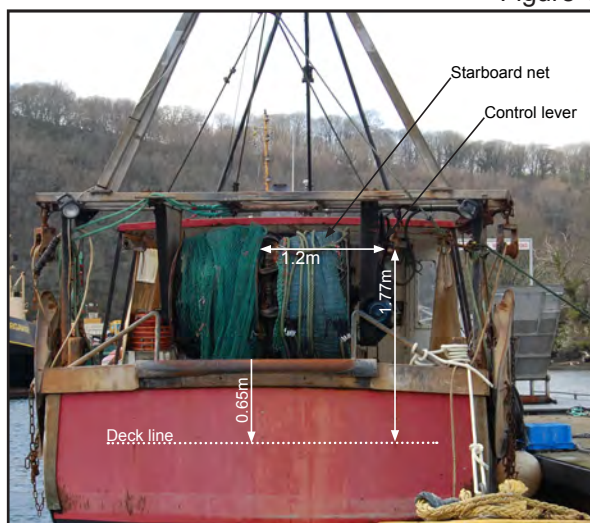
Figure 1

Our Boy Andrew, a UK registered fishing vessel, departed Looe early on the 24 March 2011 and headed south-easterly to her fishing grounds north of Eddystone Rocks. The skipper was the only person on board. At 0710, he shot the port net (**Figure 1**) and then towed it east-south-easterly until 1140, at which time he decided to haul the gear. This would have required him to haul the warps and secure the trawl doors. At about 1200, he turned the vessel onto a south-westerly heading and prepared to haul the port net. It is believed that he set the net drum control lever to the 'haul' position and then stood between the net drum and stern bulwark (**Figure 2**) so that he could manually guide the net onto the drum.

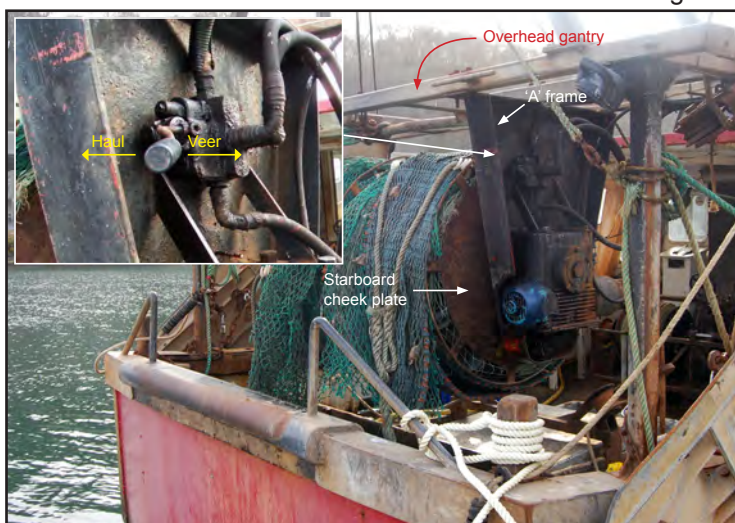
Figure 2

1. The equipment and process used on *Our Boy Andrew* to haul in her fishing gear compromised safety for a single-handed fisherman because:
 - It was necessary to manually feed the net onto the net drum, and this exposed the fisherman to the hazard of being snagged by the net and dragged onto the drum.

- The fisherman was required to move away from the winch controls to feed the net onto the drum.
 - There were no emergency stop controls fitted to the system.

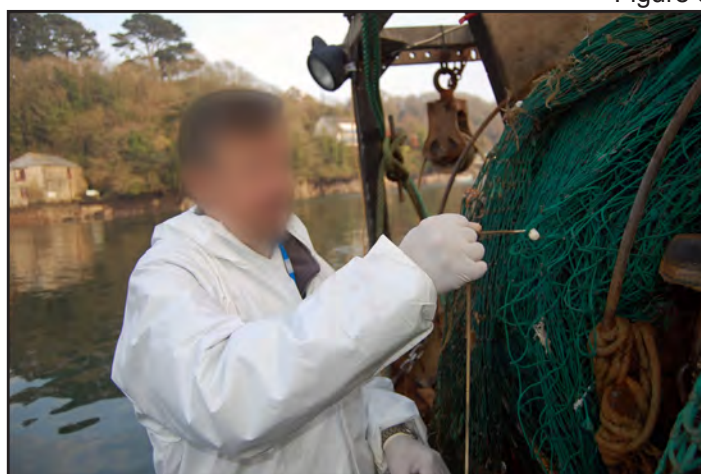
Figure 3

A drawstring toggle on the left-hand side of the stormhood on the skipper's jacket became entangled in the net (**Figure 3**) when the cod end was about 10 metres from the net drum. This would have caused the skipper to be pulled towards the rotating drum. Evidence indicates that he then reached towards the operating lever to stop the motor but was unsuccessful. The net drum stopped rotating when the cod end became wedged between the net drum and the overhead gantry. The skipper died as a result of injuries to his upper body.

3. Although it would have been preferable for the skipper not to have had to work in close proximity to the moving net, the risk of an accident within the confined area adjacent to the net drum could have been lowered by ensuring that any snag hazards on the clothing he was wearing were reduced to a minimum.
