## FLYER TO THE SHIPPING INDUSTRY

### *Wah Shan*: Fatal injuries to a crewman while securing a tug's tow wire

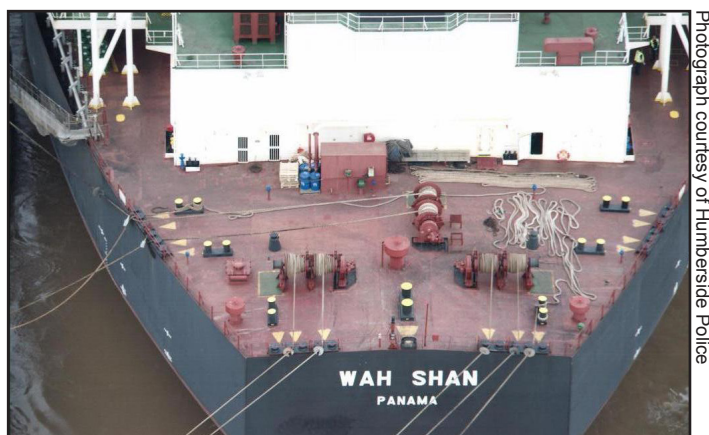
**Figure 1:** Layout of mooring equipment on the aft deck

On 2 October 2012, the carpenter on board the capesize bulk carrier *Wah Shan* was struck and killed by a messenger line while he was attempting to secure a tug's tow wire in preparation for the vessel berthing. His neck was fractured by the blow. The investigation found that: the configuration of the aft mooring deck did not provide an obvious method of using a winch to heave up the towline safely (**Figure 1**); the risks involved in securing the tug's tow wire had not been properly considered; and the aft mooring party used poor line-handling practices and did not function as an effective team. These factors resulted in the crew using an unsafe method to heave the tow wire on board, and led to the messenger line slipping under tension and causing fatal injuries to the carpenter.

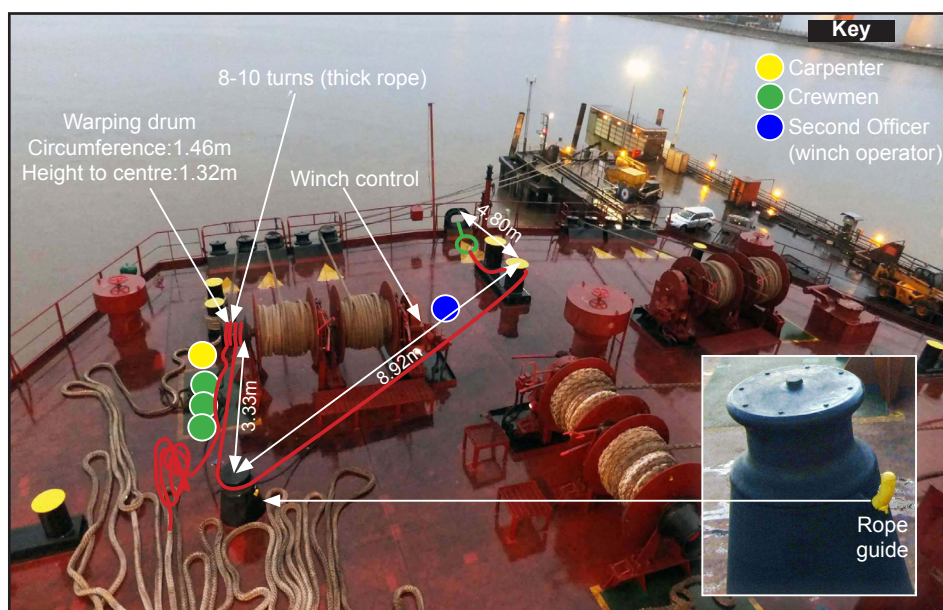
**Figure 2:** Layout of mooring equipment and messenger line routing at the time of the accident

The ship's crew initially tried to hoist the tow wire by hand, but the tug's mate asked them to use their winch. The carpenter took the messenger on to the warping drum on the port side as indicated in **Figure 2**.

He wound the messenger on to the warping drum from the underside leading it back towards the pedestal fairlead. Around eight to ten turns of the messenger were taken on the drum and due to the unfavourable angle of the lead onto the drum the rope was bunched towards its outboard end. As the drum rotated riding

turns developed, causing the excess length of the messenger line which was coiled on deck to be pulled back into the drum. The messenger line slipped off the outer end of the drum several times causing the tow wire, which was nearly at the aft bitts, to drop back several metres down to the tug.

The carpenter asked the other crewmembers to help him push the messenger line back on to the drum while the second officer operated the winch. In order to do this, the carpenter stood close to the warping drum with his head a few centimetres away from the outboard end (**Figure 2**). Suddenly, he was heard to cry out. He was found slumped forward onto the messenger line. The coastguard was informed and it was decided to berth the vessel as soon as possible to let an emergency medical team board the vessel. At 0804 the vessel came alongside at Immingham; the paramedics who examined the casualty were unable to revive him and he was declared deceased.

Heaving up a tug's tow wire is a relatively simple task on a vessel with well laid out mooring equipment. However, the arrangement of the equipment on the aft mooring deck of *Wah Shan* did not provide an obvious safe method of carrying out this task. This resulted in the mooring team adopting an inefficient and dangerous method of attaching the messenger line to the winch drum. As there may be other vessels similar to *Wah Shan*, either in operation or under construction, it is extremely important that ship yards, vessel operators and ships' crew recognise this risk and take steps to mitigate it. The role of each party in controlling the risks can be summarised as follows:

- a. **Ship builders:** When designing the layout of equipment, ensure that it is ergonomically efficient and naturally encourages people to work safely. Poor equipment layout and design invariably results in people taking short cuts and making errors.
